St. Francis Kink

Abstract

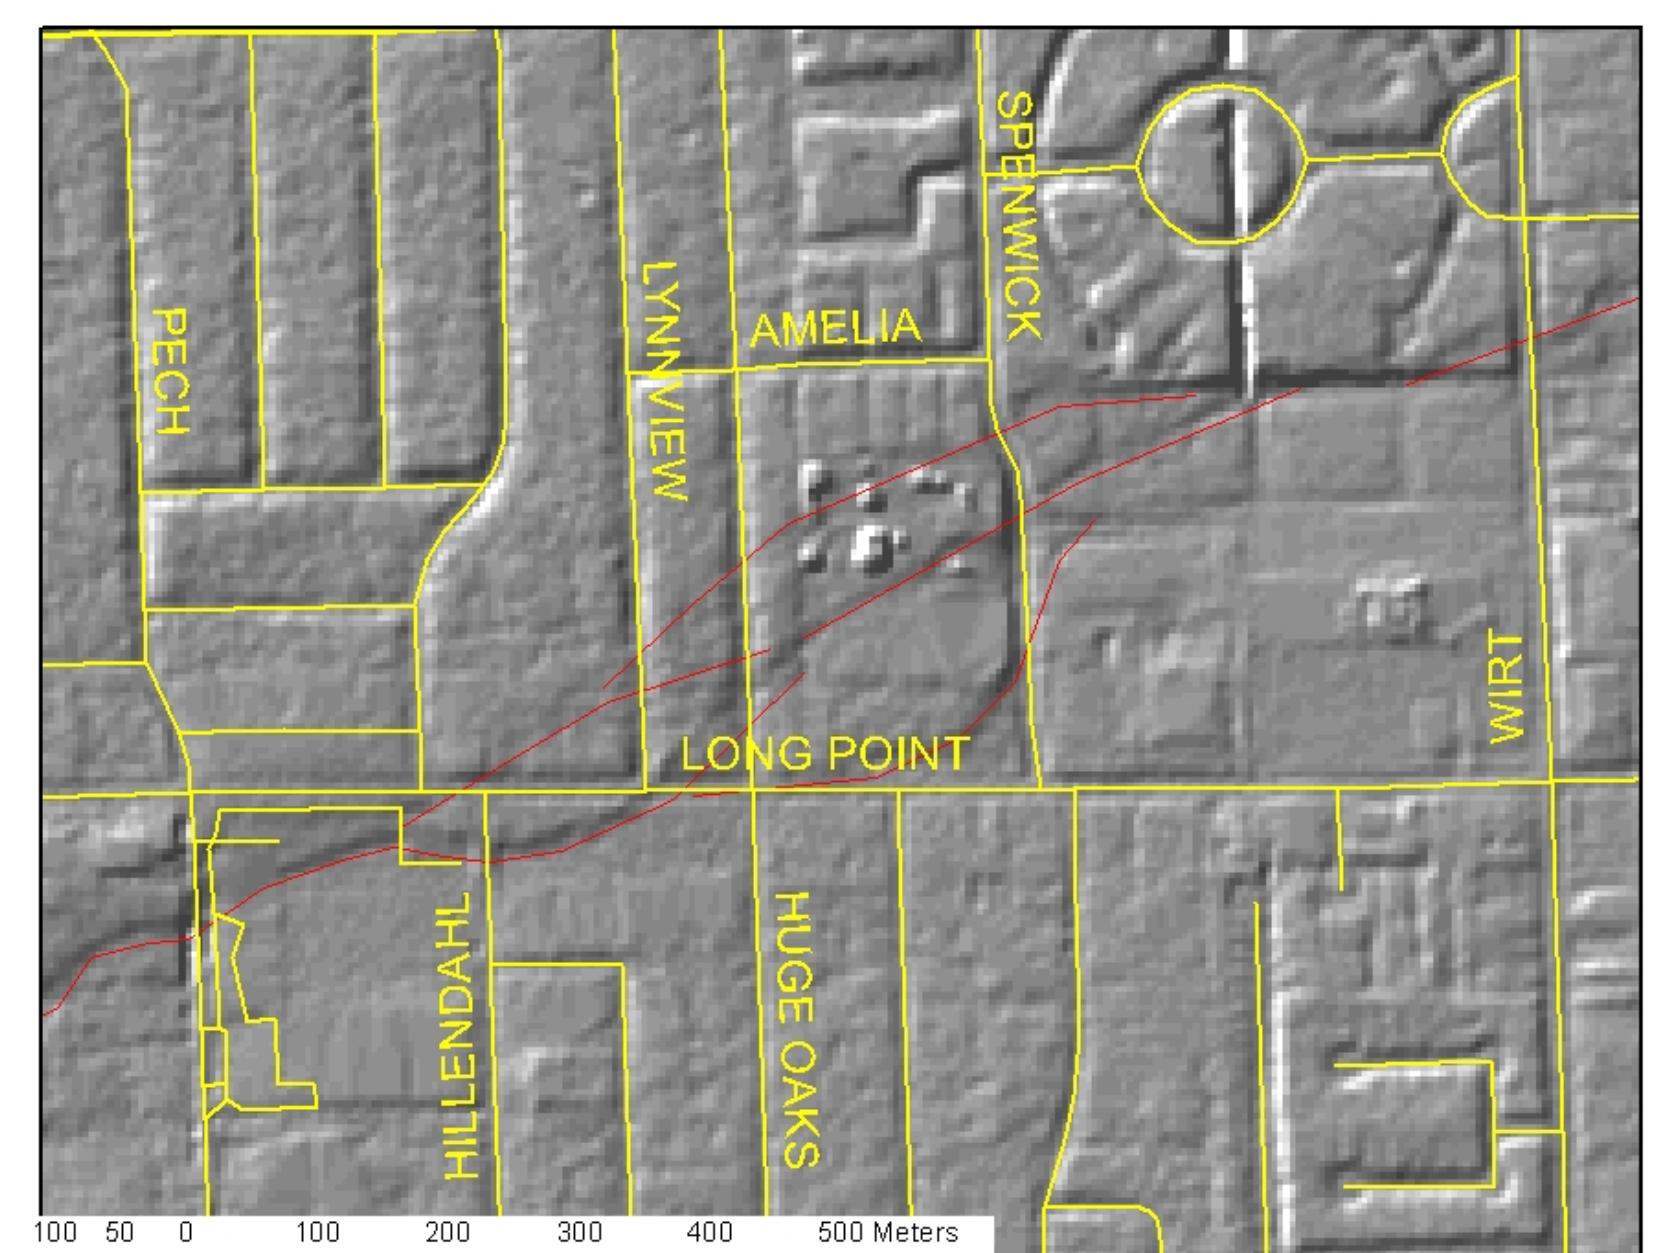
LIDAR hillshade image of Long Point fault where it crosses Long Point. Here the scarp splits into several branches.

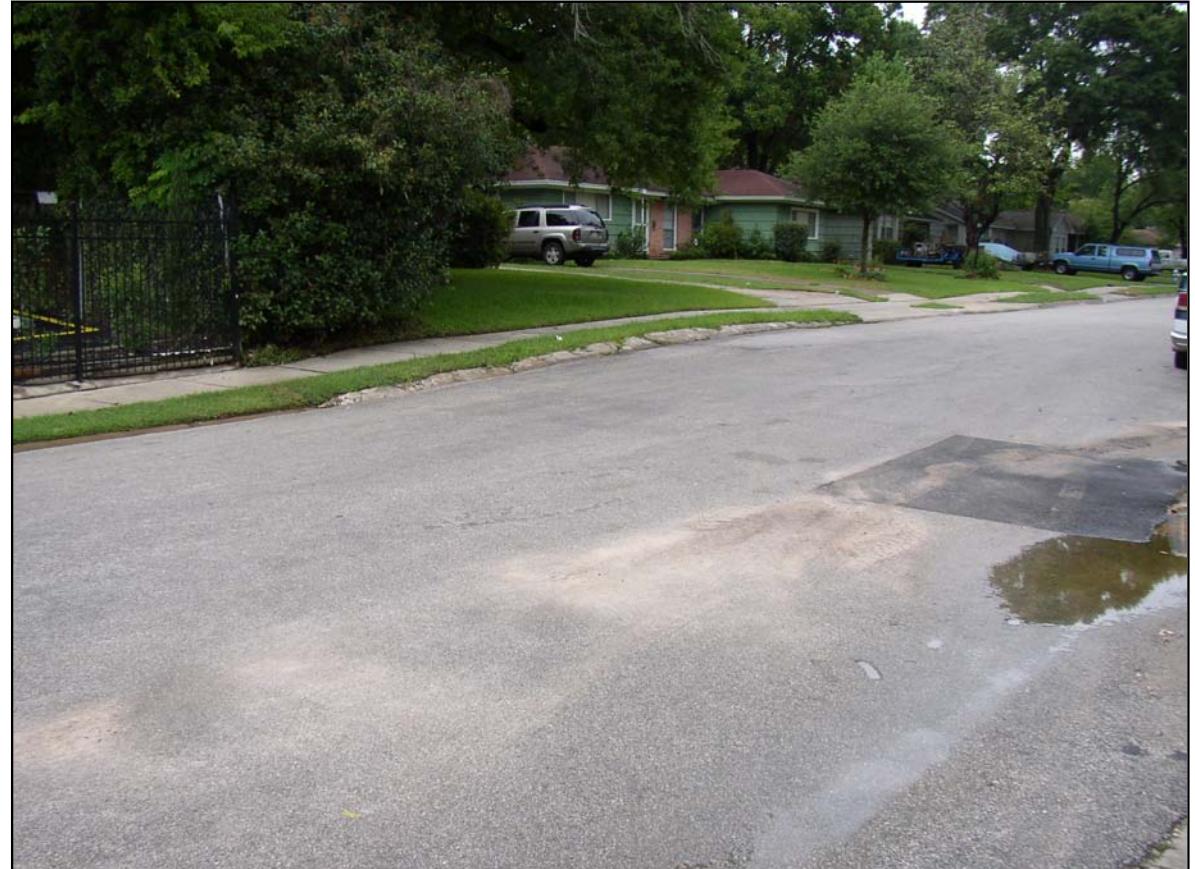
Looking NW across primary scarp

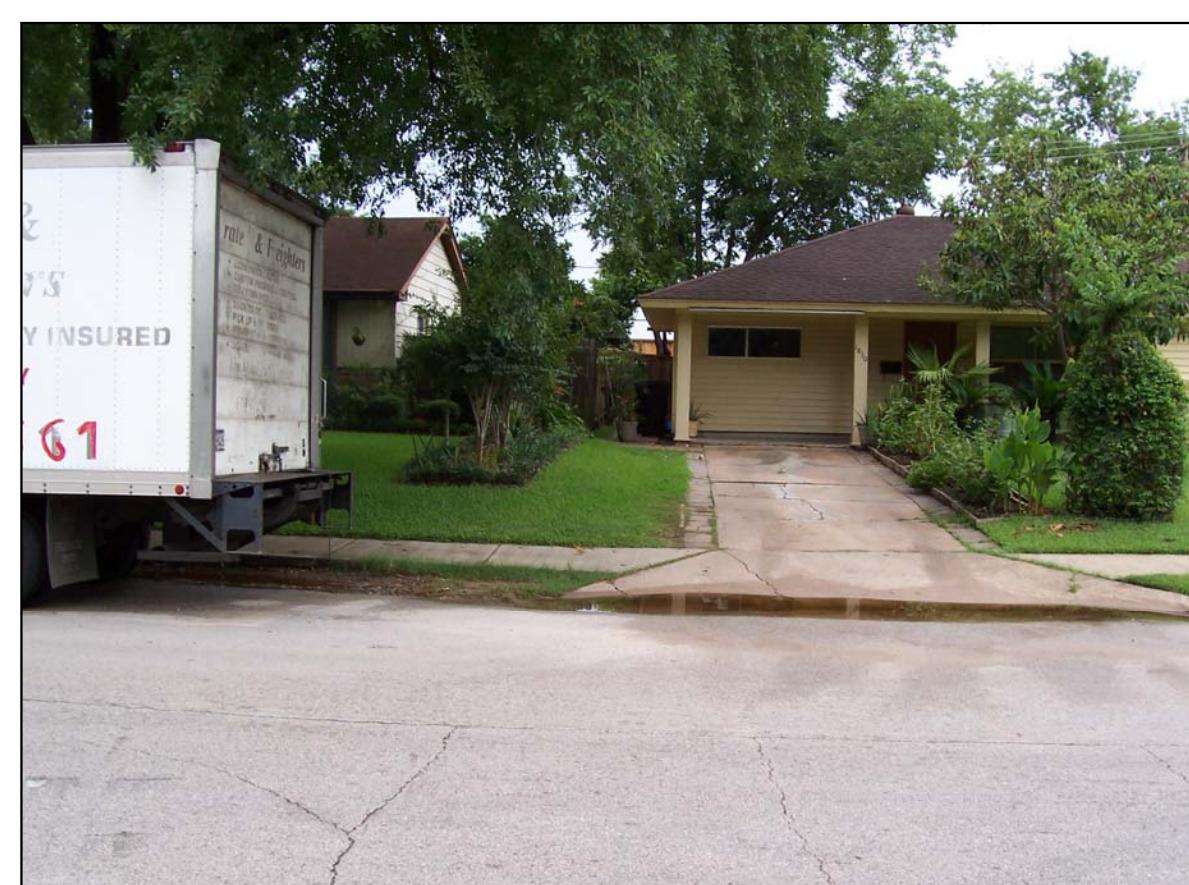
Looking E across 2nd scarp

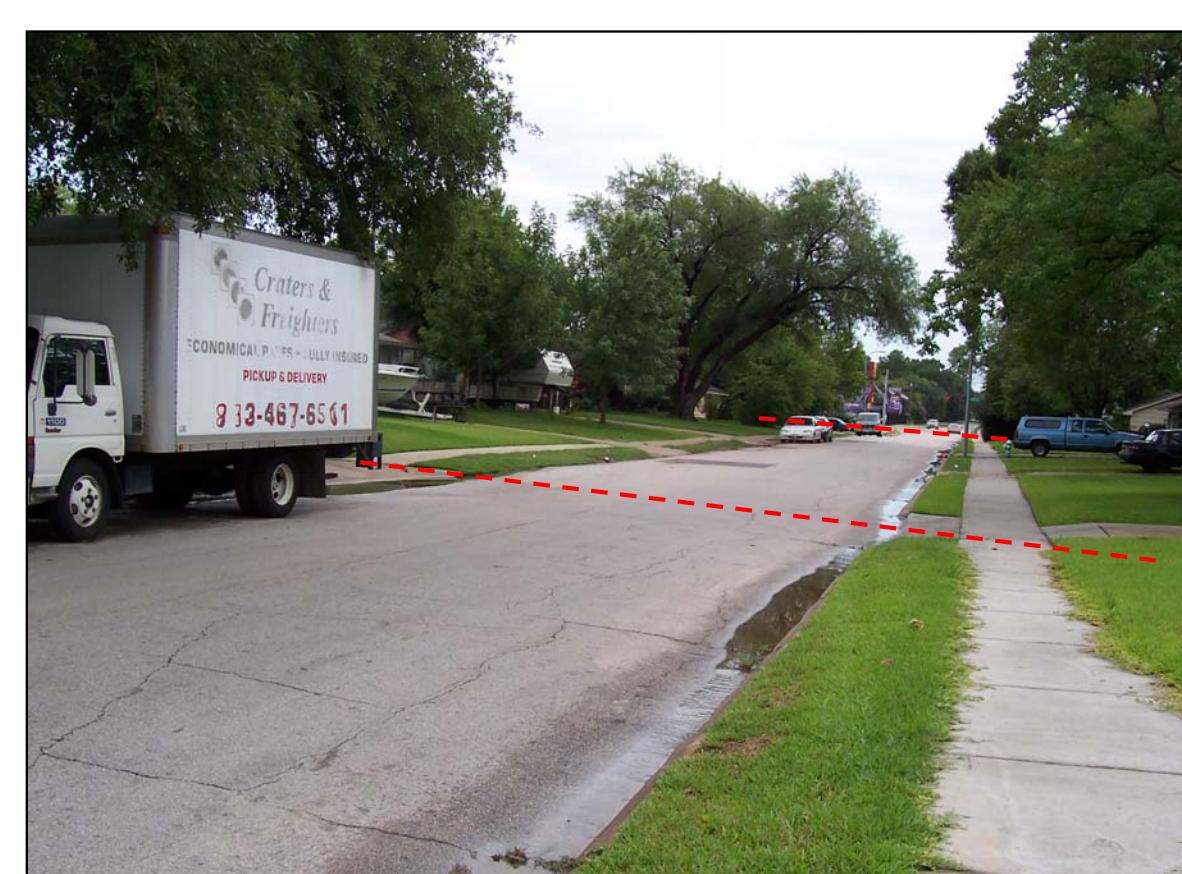
Looking S across 2nd scarp, with primary scarp in distance
