**Mapping Active
Faults
in the Houston
Area
using LIDAR Data**

- Richard Engelkemeir,
University of Houston
- Dr. Shuhab Khan,
University of Houston
- Dr. Carl Norman,
University of Houston

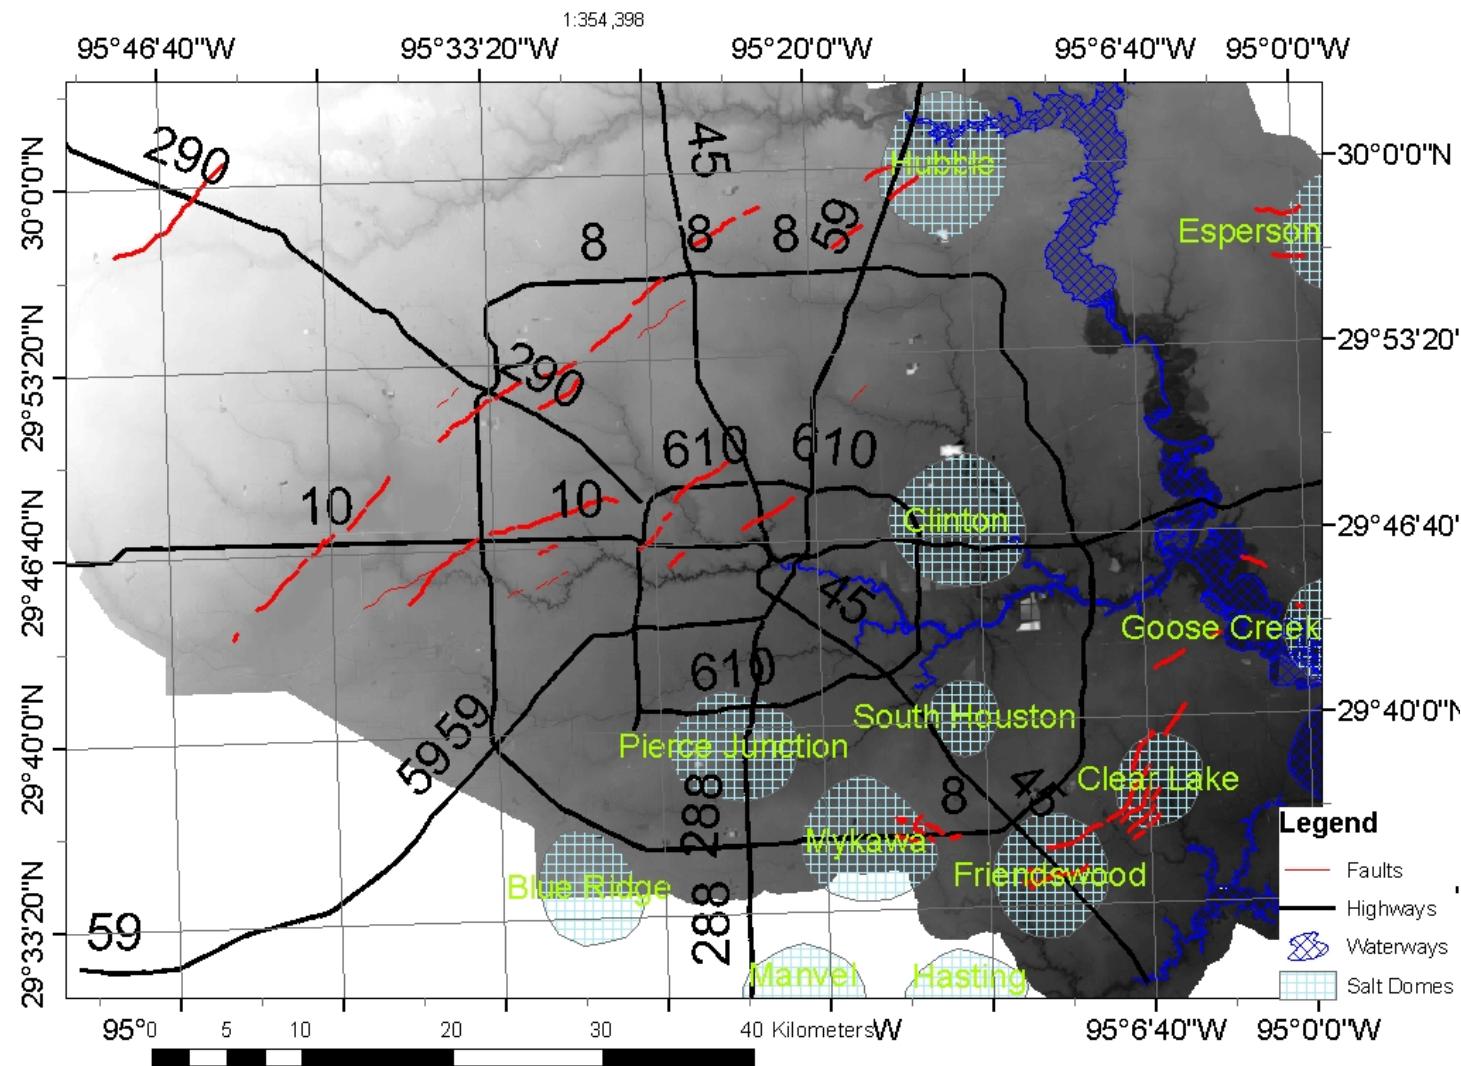
LIDAR DEM of Harris County. LIDAR mapped faults, salt dome locations.

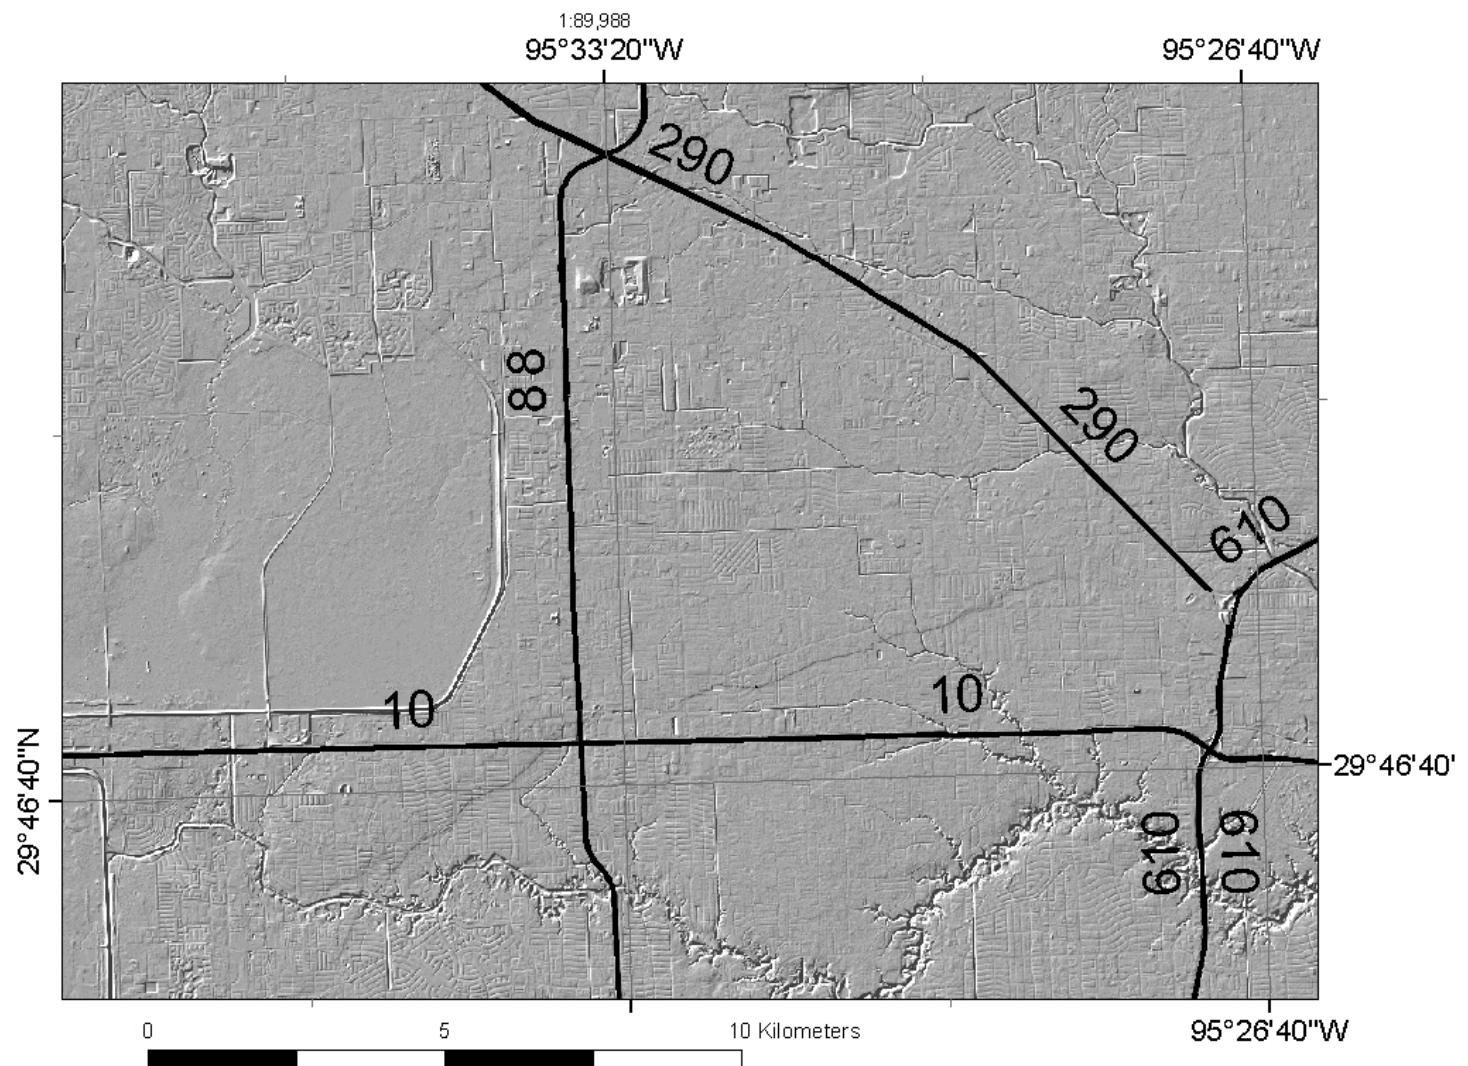
Hillshade of LIDAR DEM for northwestern Harris County, shown without faults.

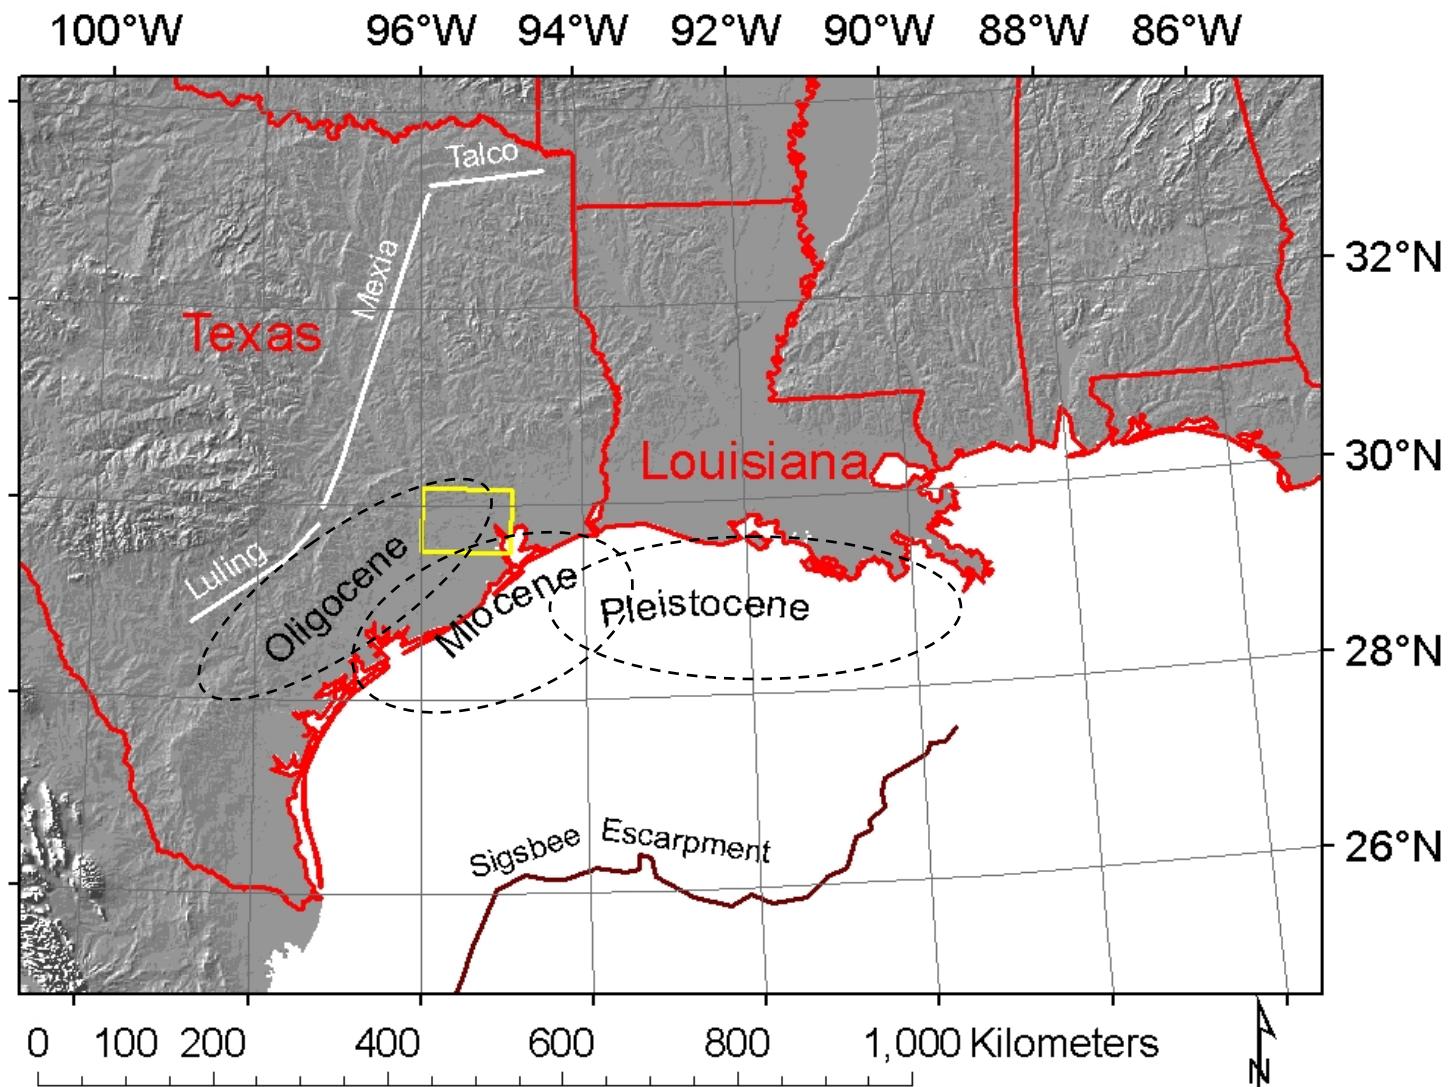
Regional map, showing the Northwestern Gulf of Mexico. The labels indicate the primary depocenters, showing the prograding into the basin along with the eastward migration of depocenters. The salt basin limits are shown. The salt basin extends from the Luling-Mexia-Talco faults to the Sigsbee escarpment.

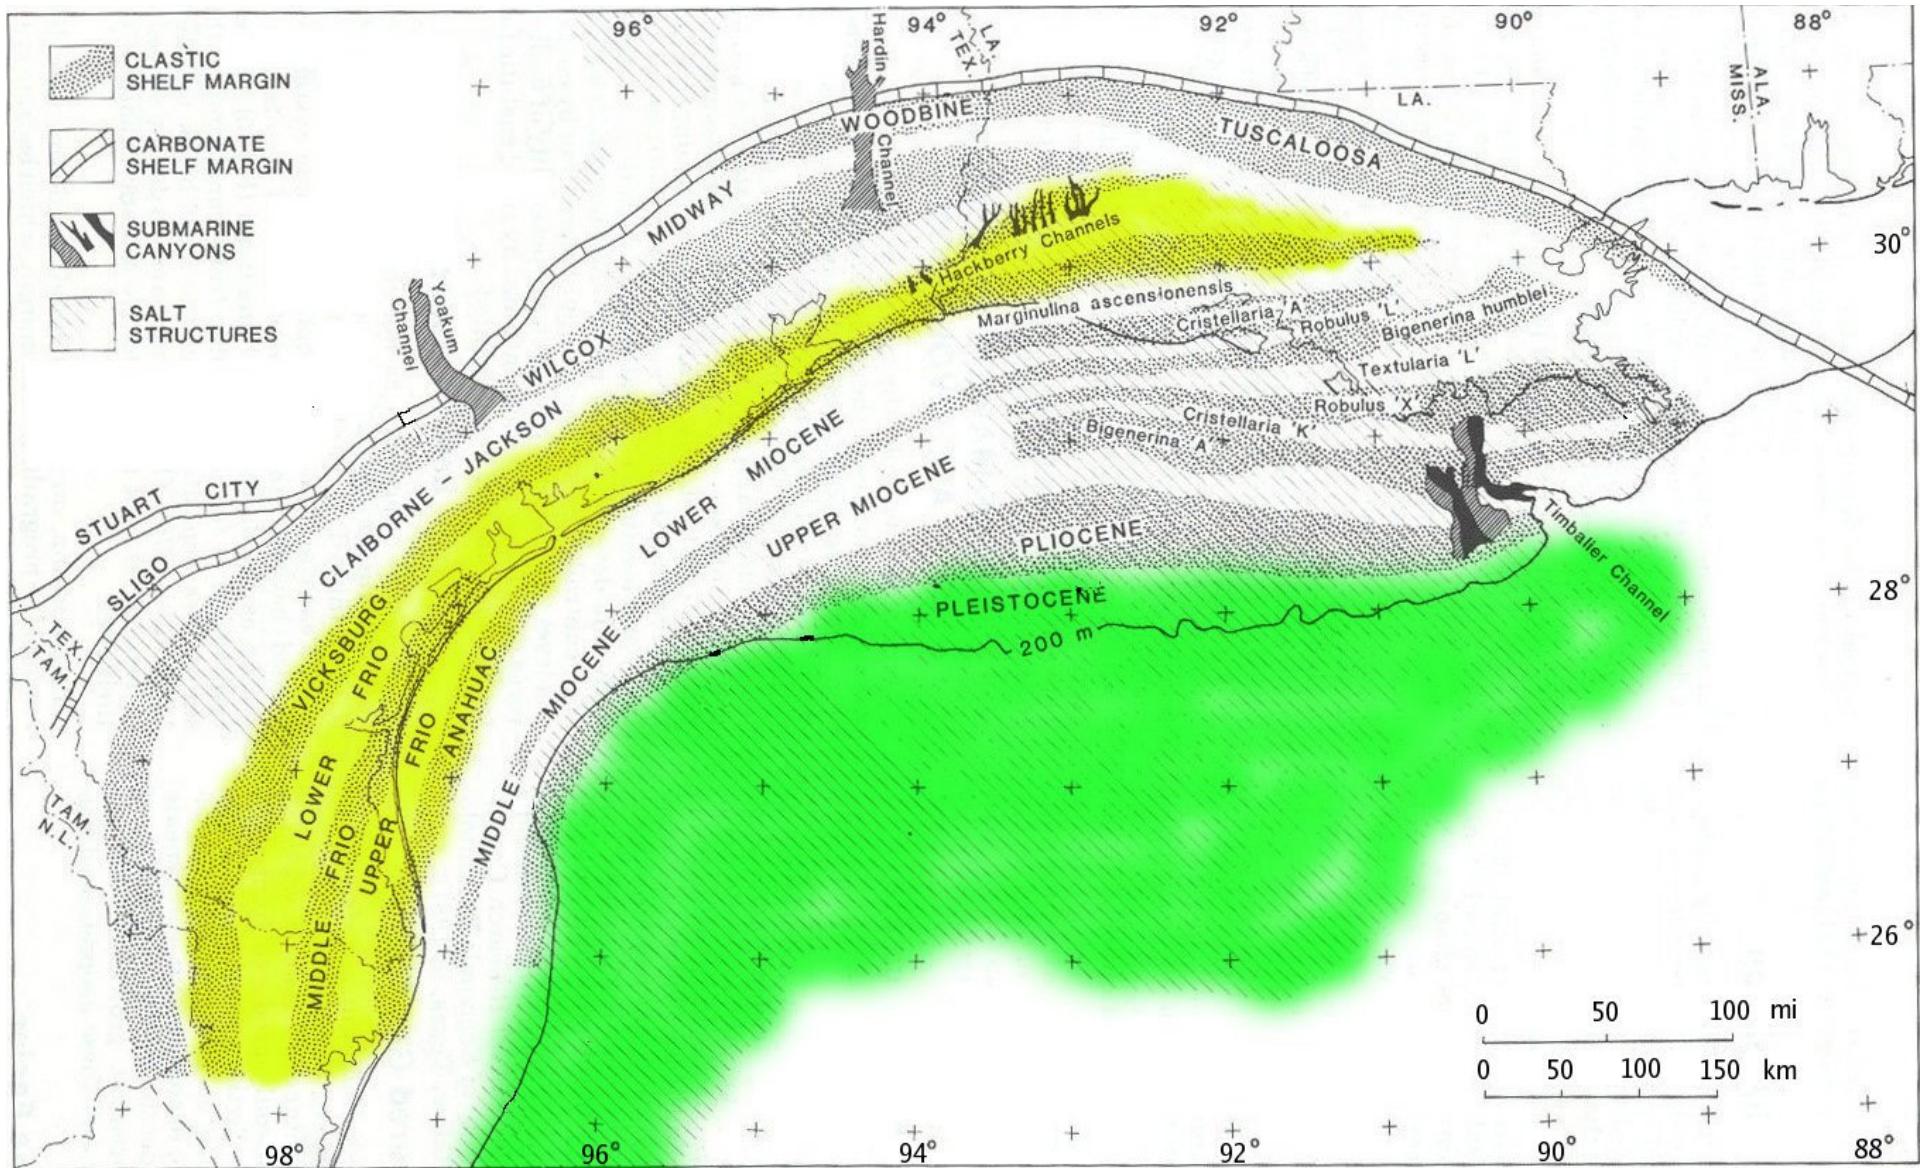
Cenozoic shelf margins (adapted from Winker, 1982). Note progradation of shelf margins throughout Cenozoic. Most active growth faulting occurs at shelf margin. Significant subsidence due to loading of sediments. Late Cretaceous – Woodbine, Tuscaloosa; Paleocene – Midway, Lower Wilcox; Eocene – Upper Wilcox, Claiborne, Jackson; Oligocene- Vicksburg, Frio, Anahuac (yellow) – Houston on shelf margin; Miocene; Plio-Pleistocene (green). Paleogene predominantly in South Texas; Neogene in East Texas and Louisiana.

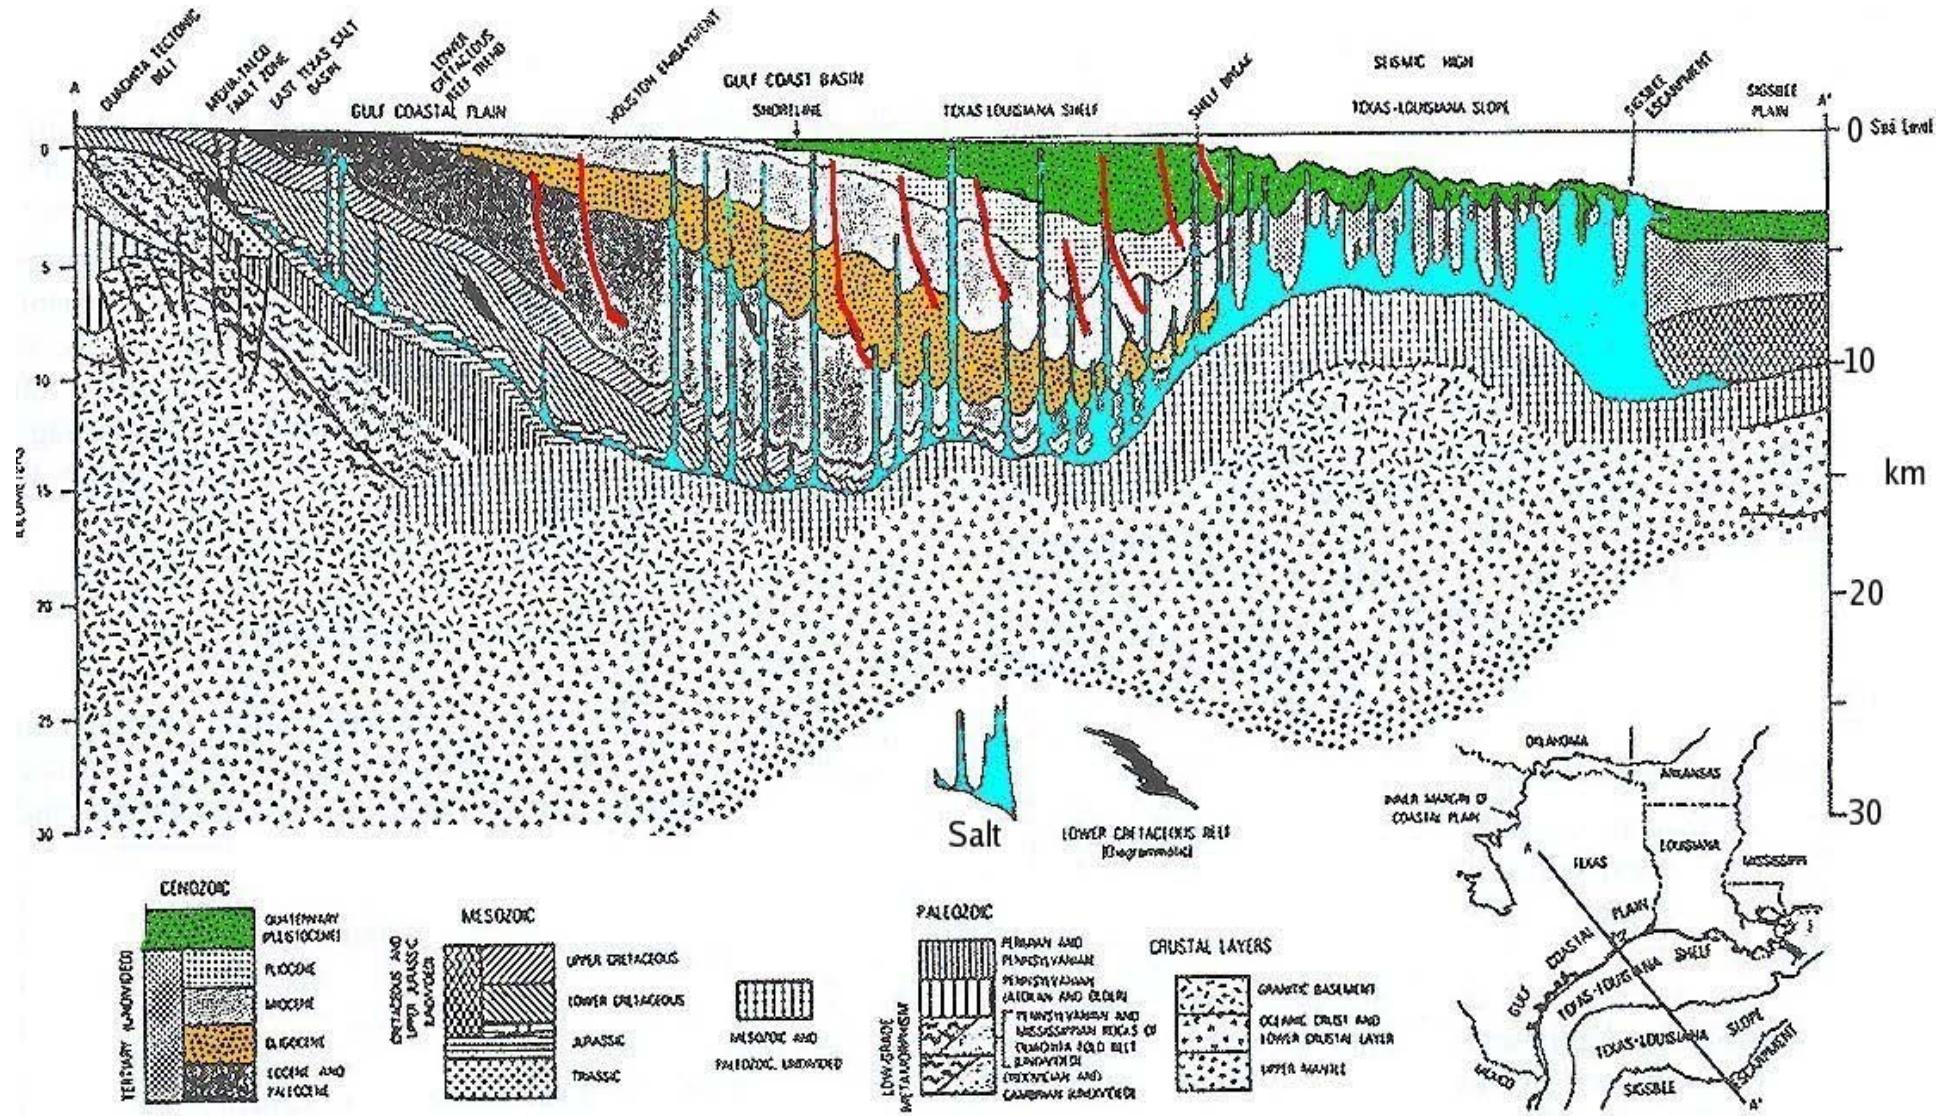
Deposition and salt migration (from Lowrie et al., 1996). Salt deposited during period of extension which preceded sea-floor spreading in Middle Jurassic. The weight of the sediments has displaced the salt. Note that bulk of salt now to the South. Also note growth faults. The faults typically dip into the basin. We see the general basinward progression of deposition. Tectonic subsidence amplified by sediment loading. Is Basement high the northern half of the split mantle plume noted in Bird et al., 2005?

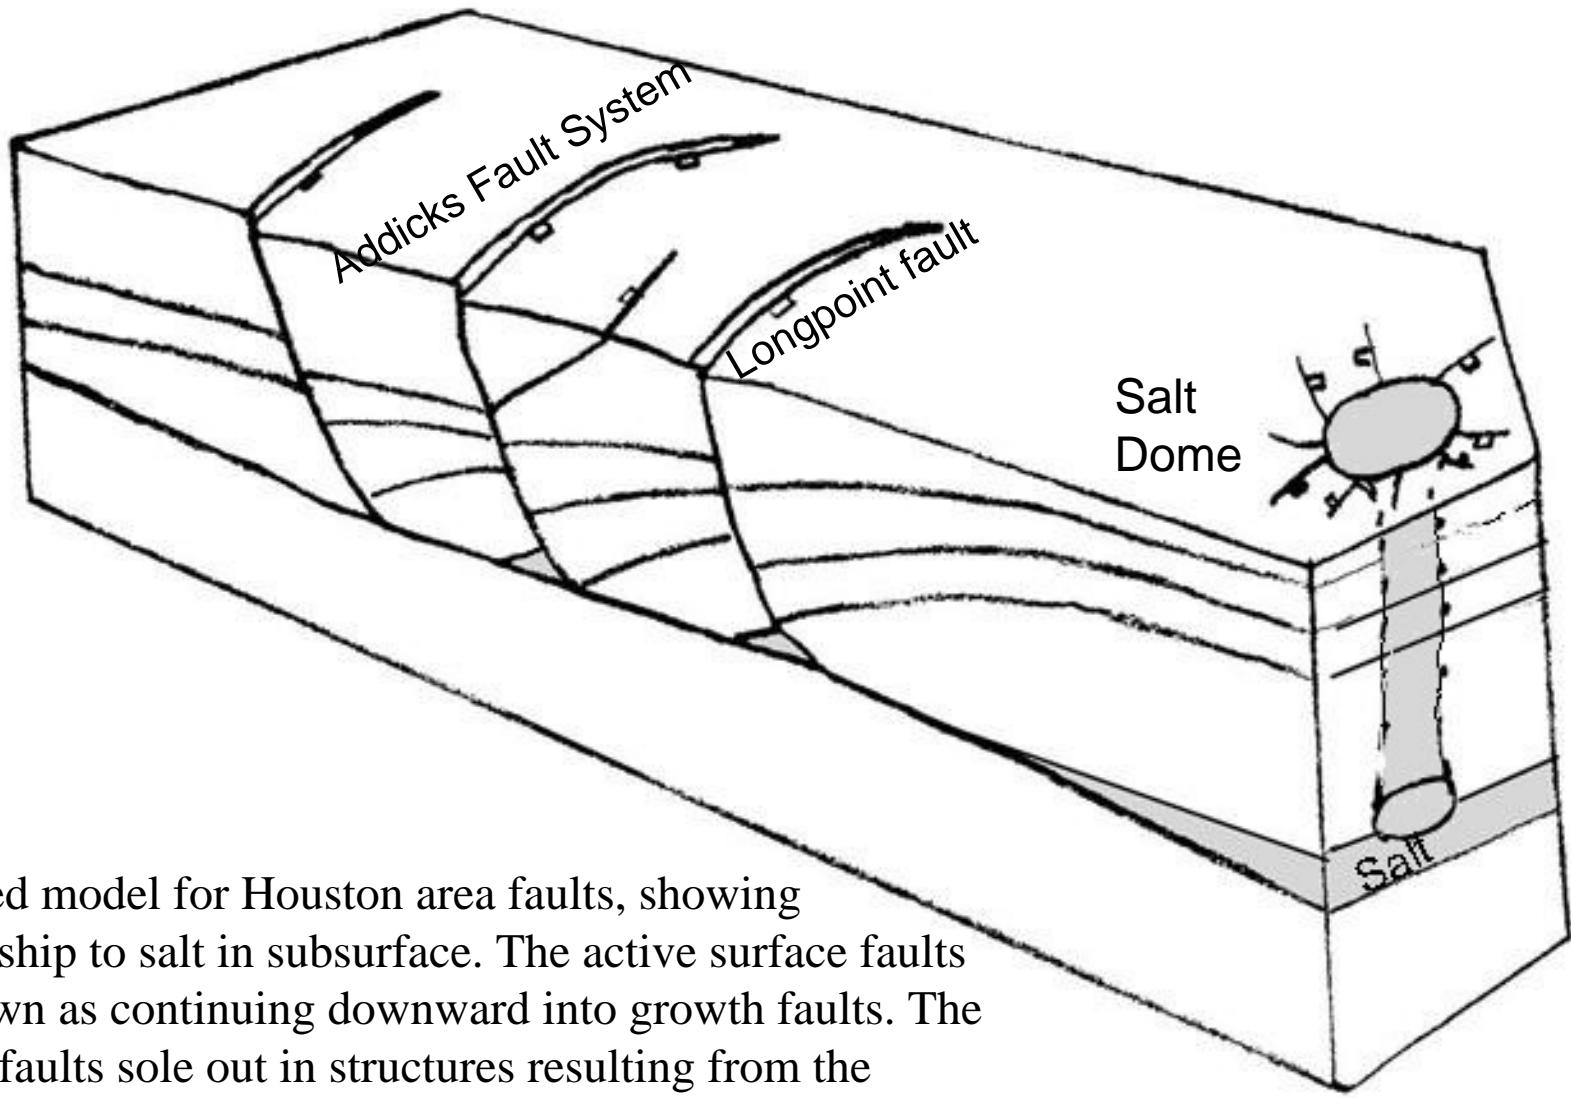
Proposed model for Houston area faults, showing relationship to salt in subsurface. The active surface faults are shown as continuing downward into growth faults. The growth faults sole out in structures resulting from the withdrawal of salt. Some of the salt rises in salt domes downdip of the faults.

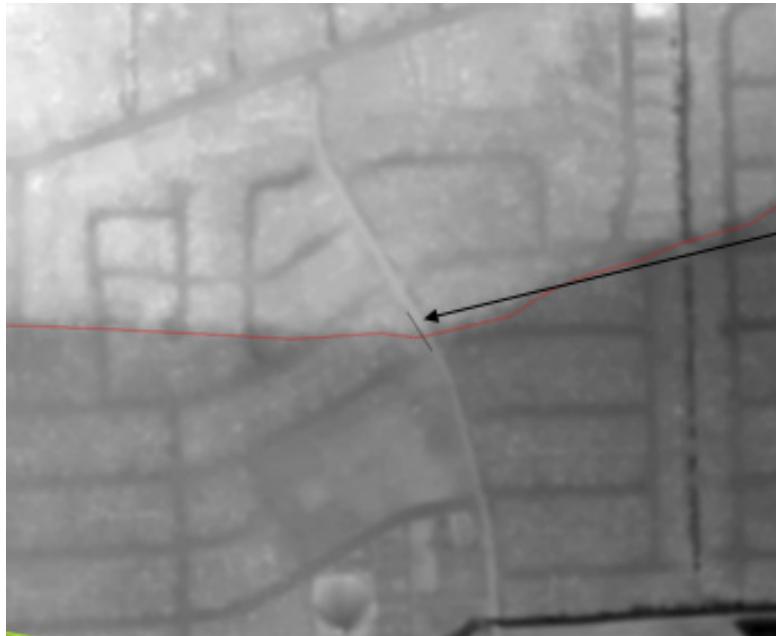
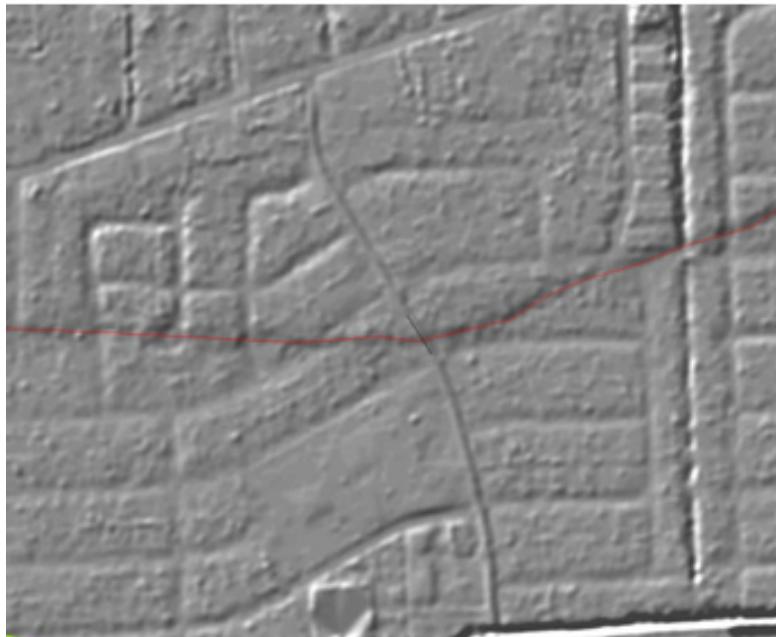
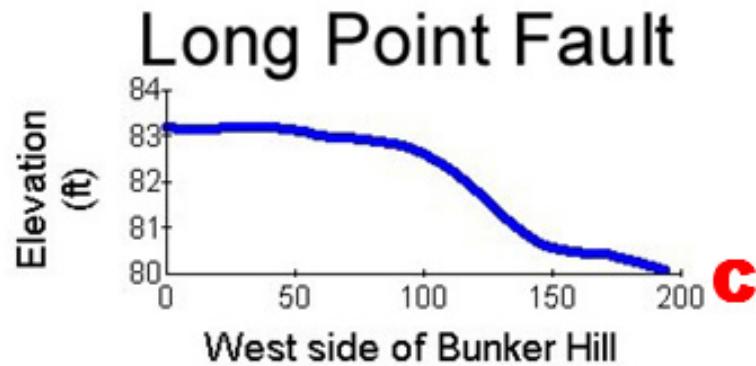
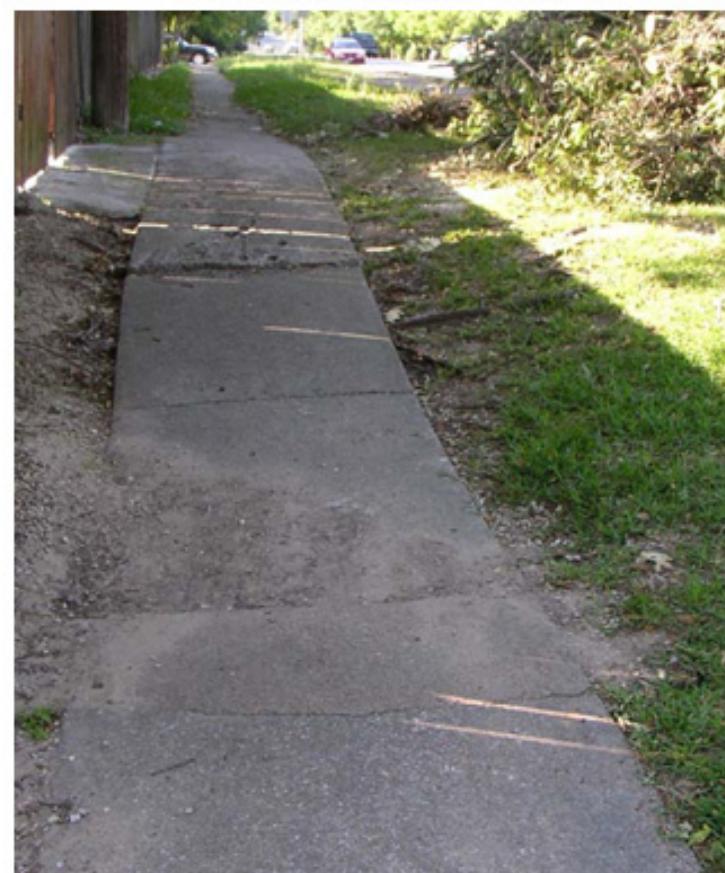
Long Point Fault at Bunker Hill. (a) LIDAR; (b) LIDAR hillshade; (c) profile along Bunker Hill; arrow shows location on DEM; (d) photo looking up-dip along profile in c. Note tilted sidewalk slabs along scarp face.

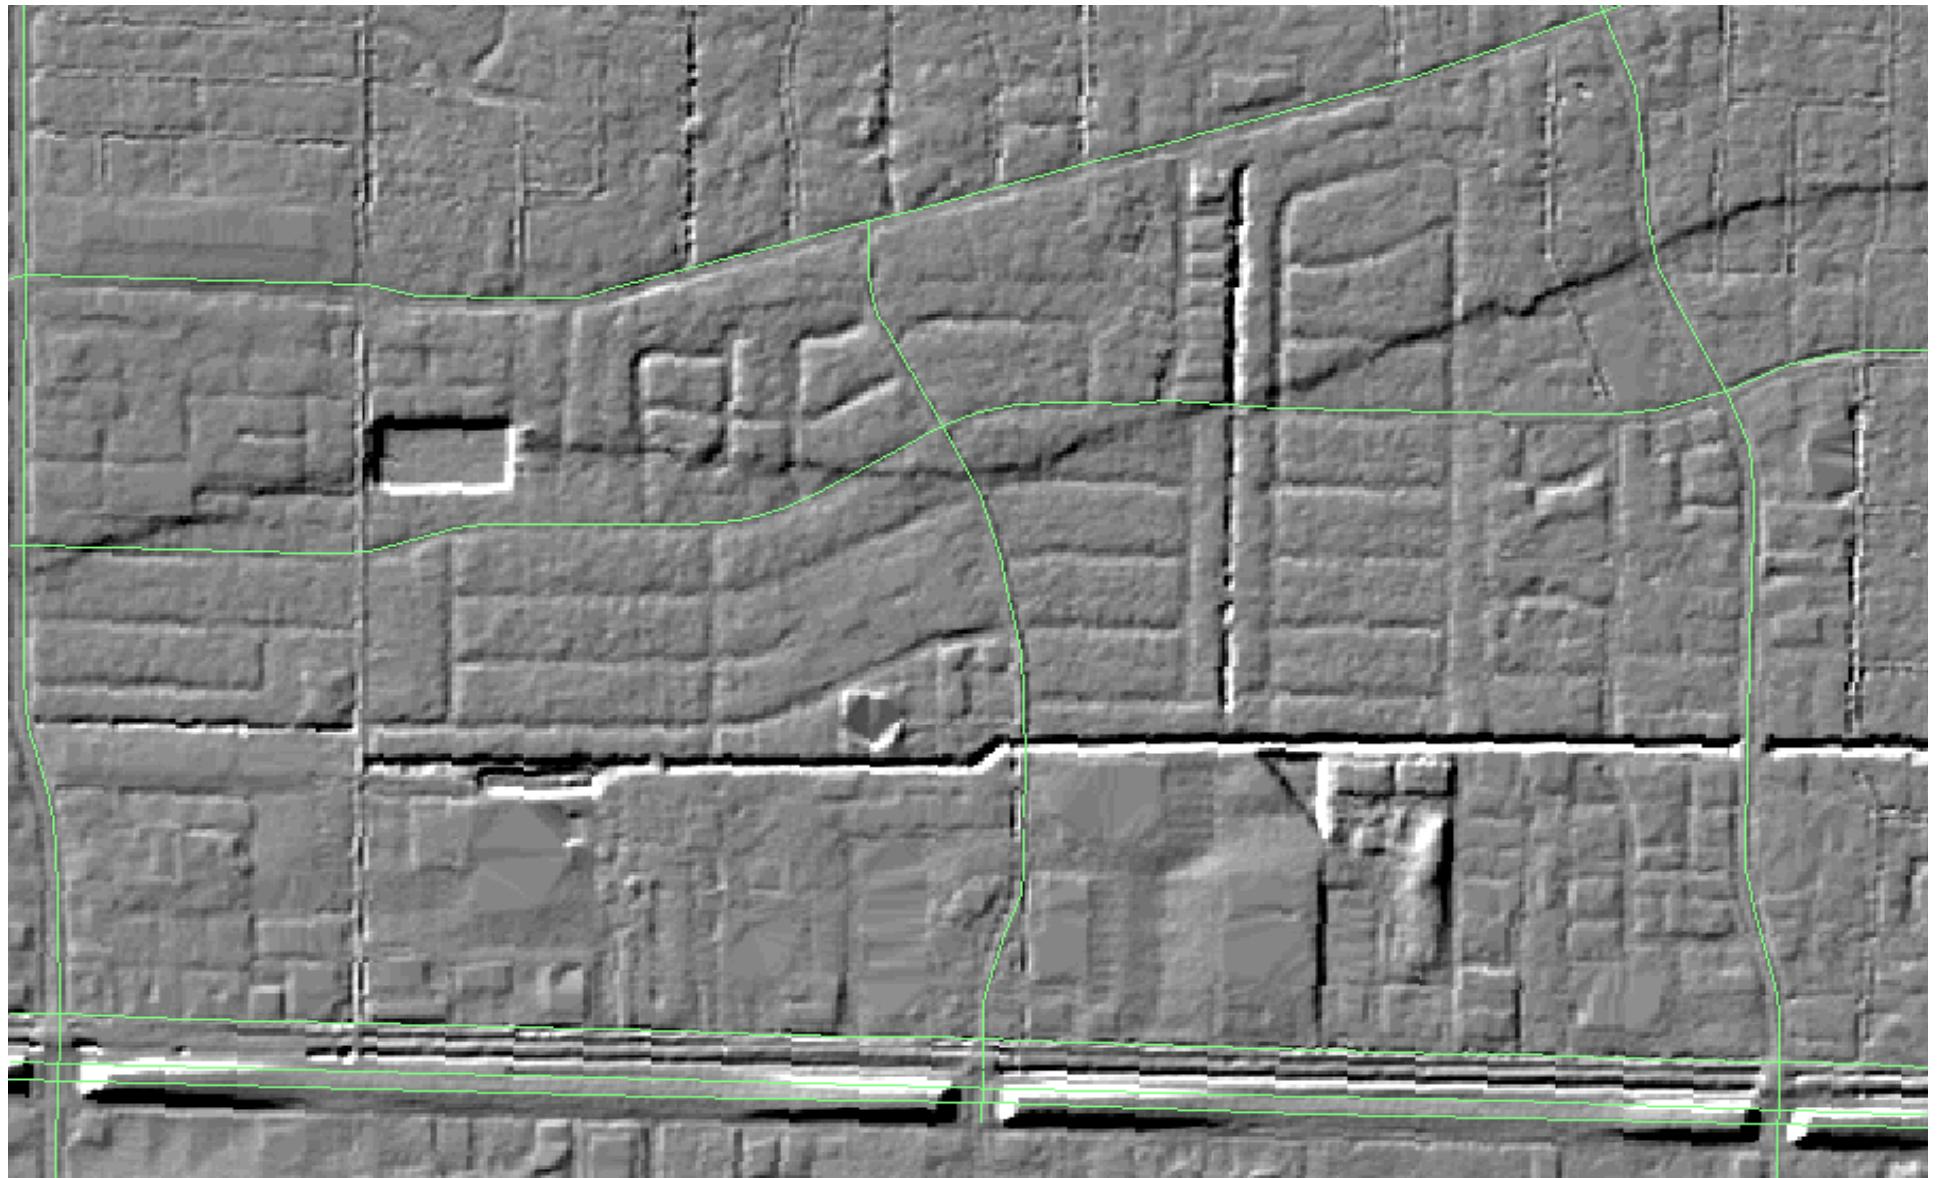
LIDAR:

15 foot grid cells

Slope map. Slope is maximum spatial rate of change of surface
Aspect maps show the direction of slope.

Better spatial resolution will result in enhanced slopes since less averaging.

LIDAR shows Longpoint Fault

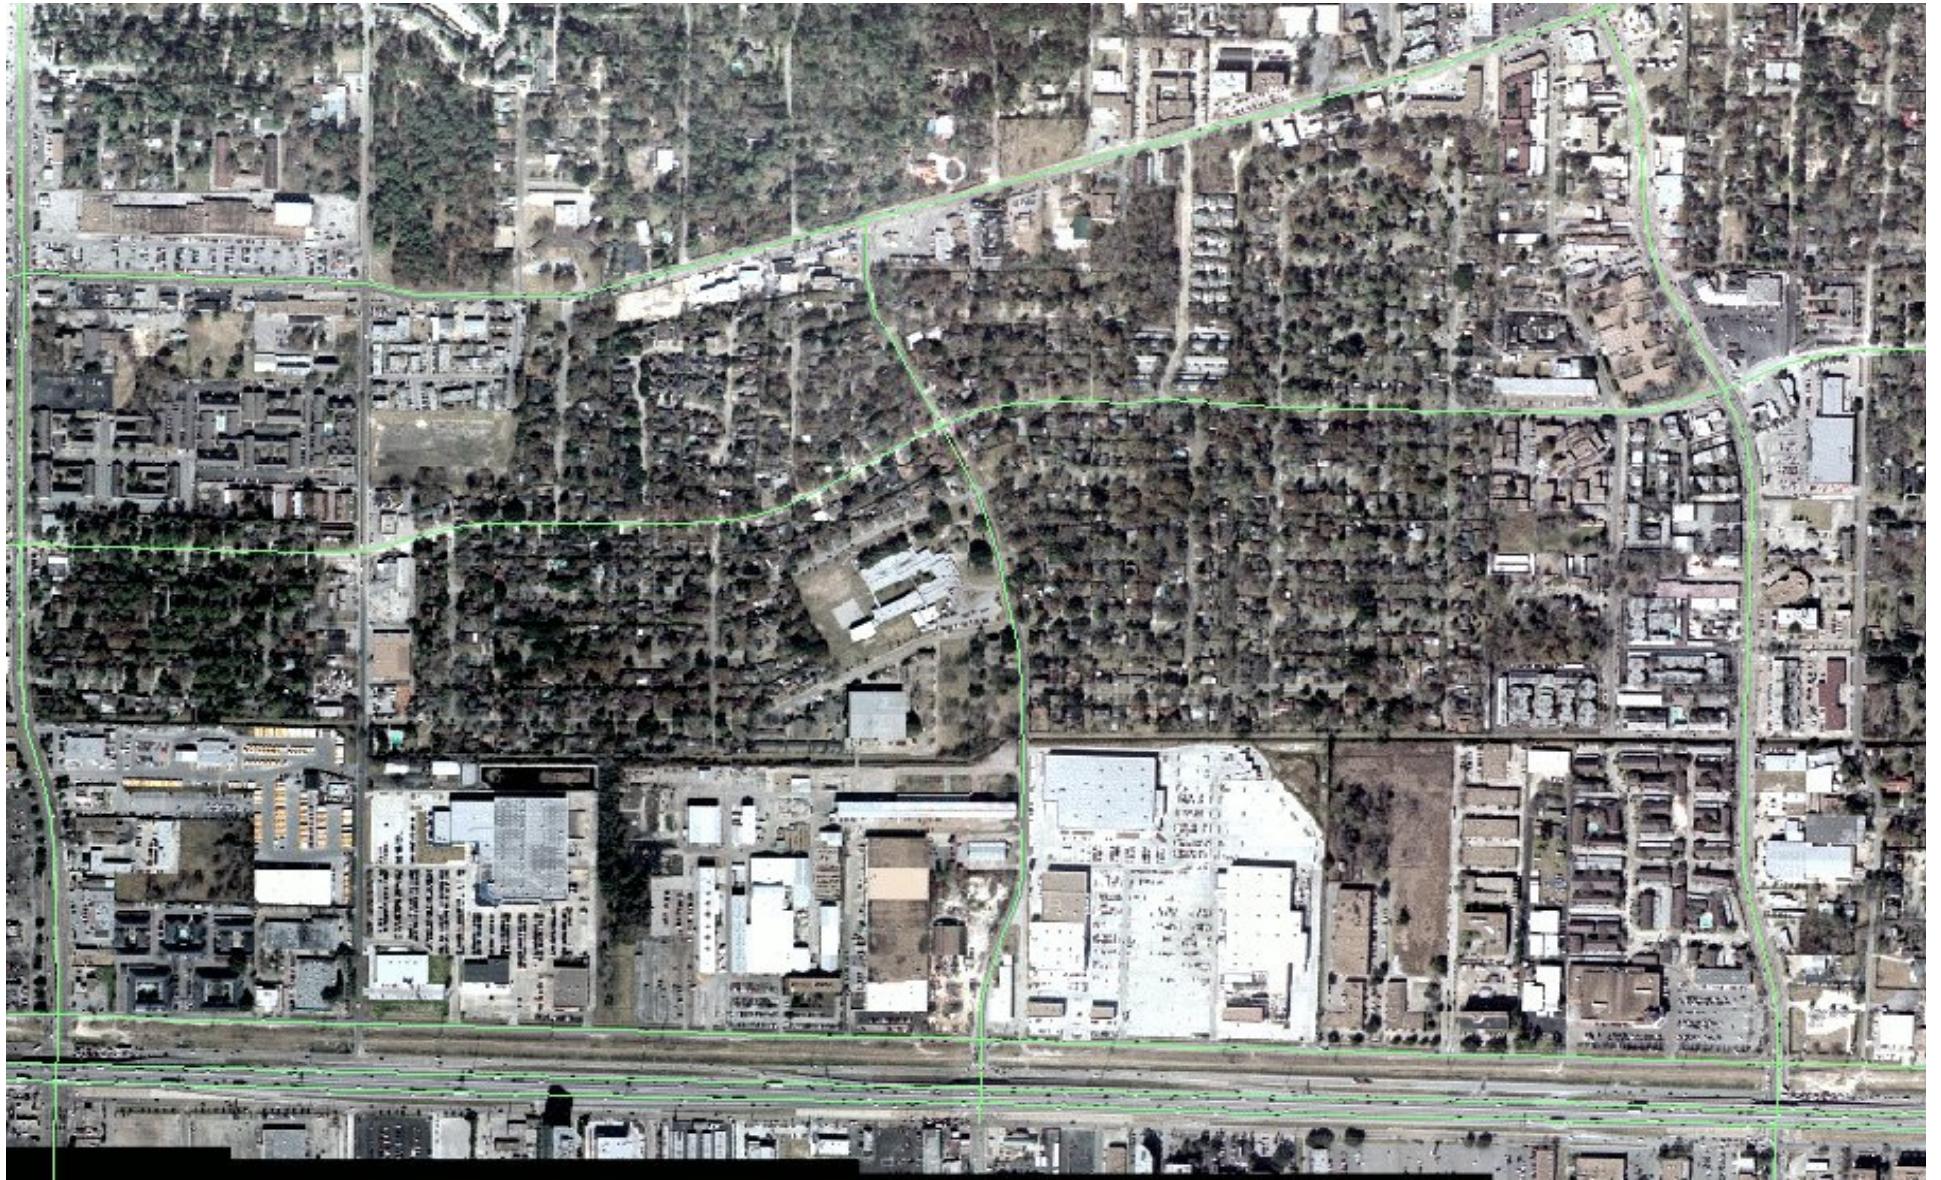
Orthophoto:

1 foot grid cells.

Have zoomed in and can ‘see’ trees (January 2002 orthophoto)

Fault not Visible on Orthophoto

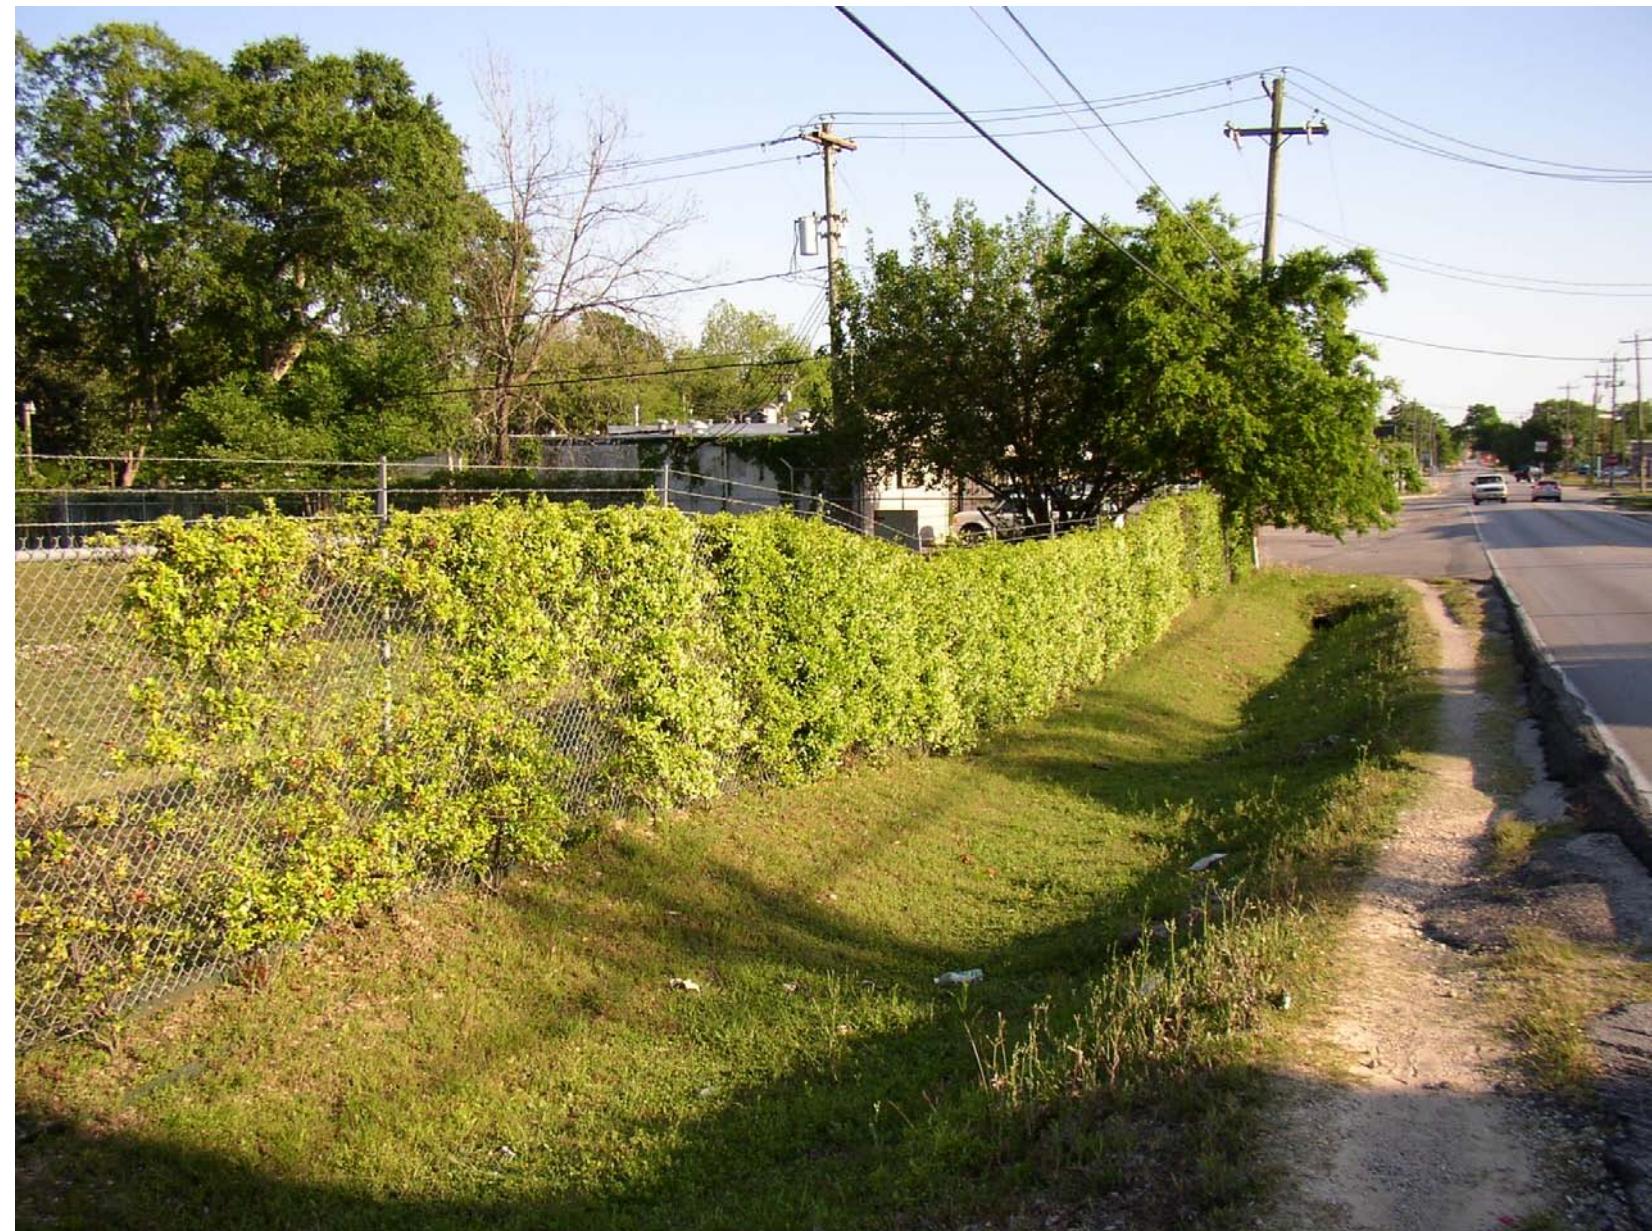
St Francis kink. Hillshade image showing Long Point fault where it crosses St. Francis Street. East-west segment of trace on east side of St. Francis runs along property line between 2 houses. The kink in the trace thus appears to be man-made. With ongoing fault movement the house on the south side of the scarp is at risk.

Looking E. Ramp on property line explains kink

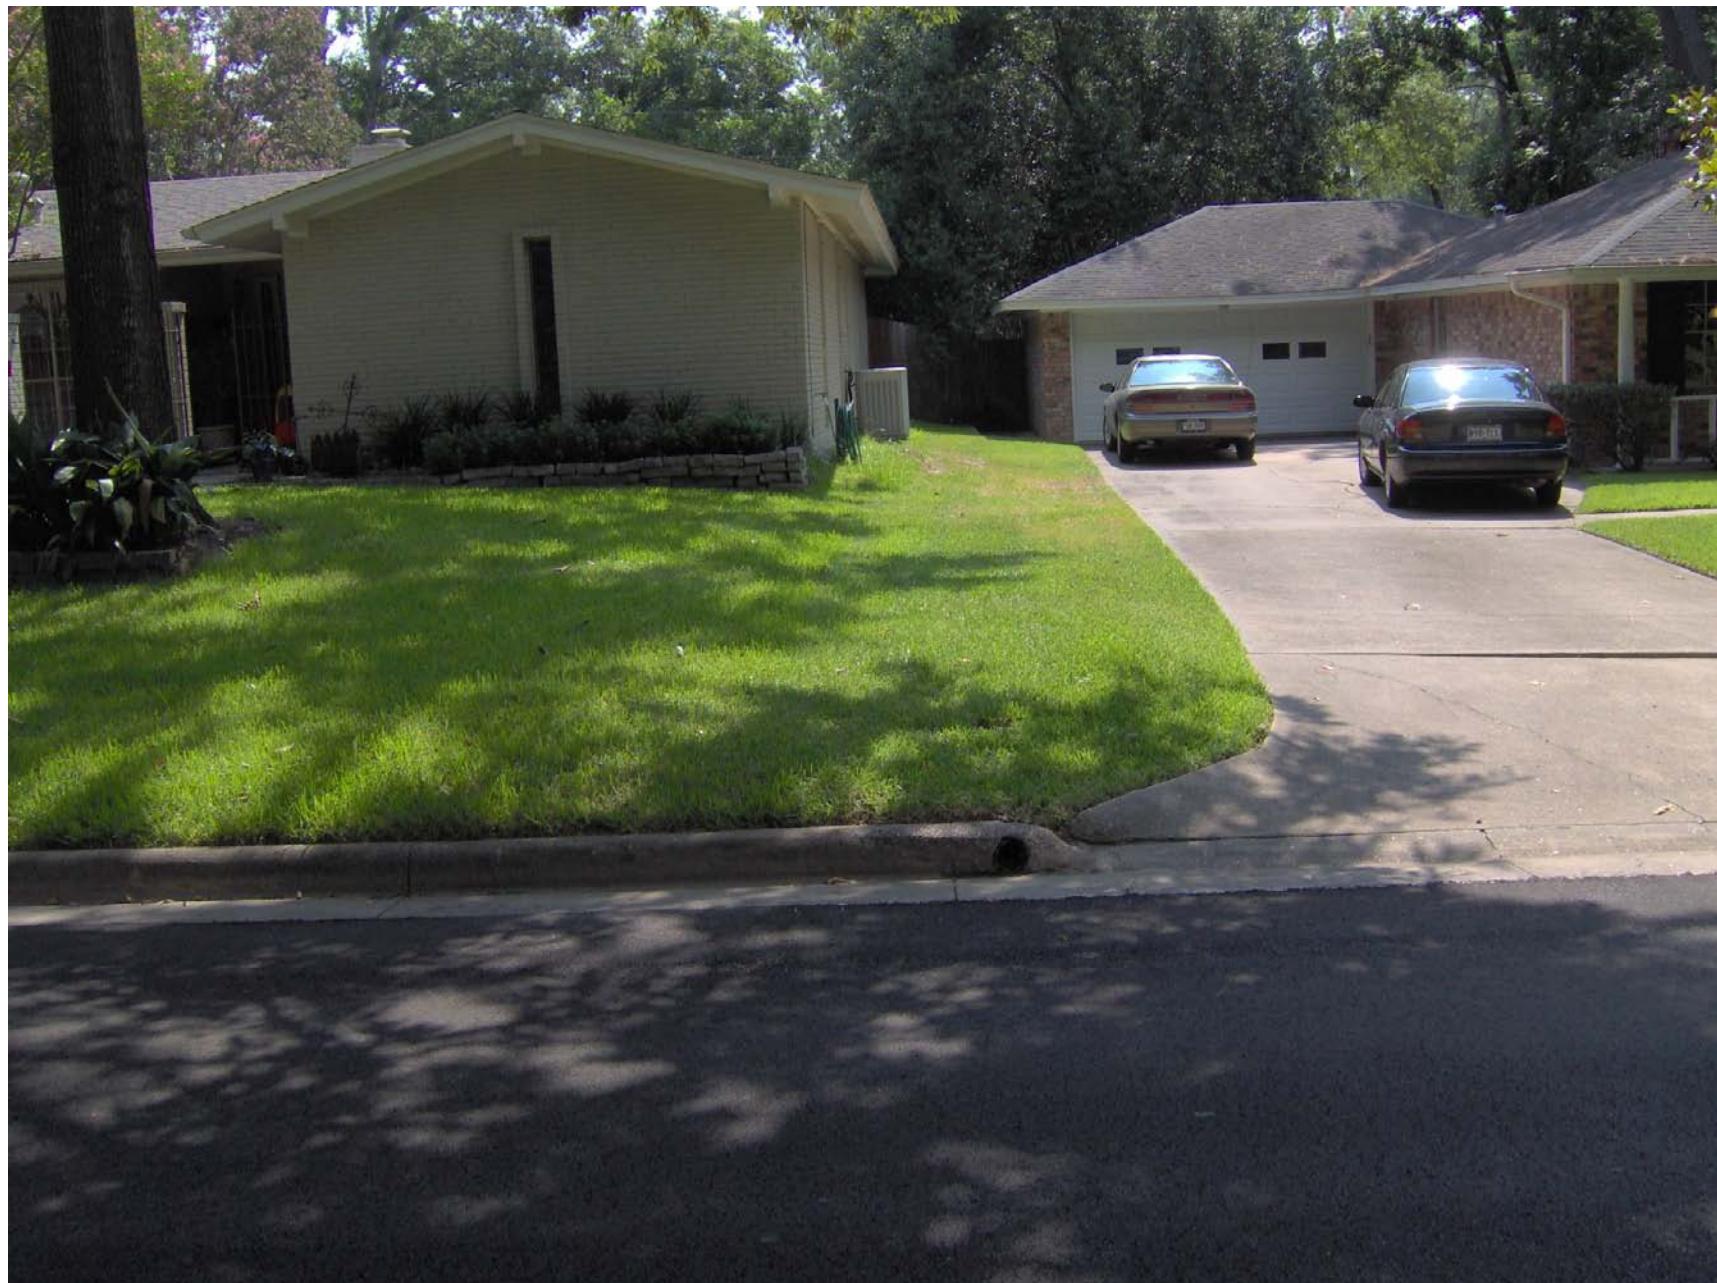
Long Point fault splits. LIDAR hillshade image of Long Point fault where it crosses Long Point. Here the scarp splits into several branches.

1) Looking N along Huge Oaks towards primary scarp.
