**Mapping Active
Faults
in the Houston
Area
using LIDAR Data**

- Richard Engelkemeir,
University of Houston
- Dr. Shuhab Khan,
University of Houston
- Dr. Carl Norman,
University of Houston

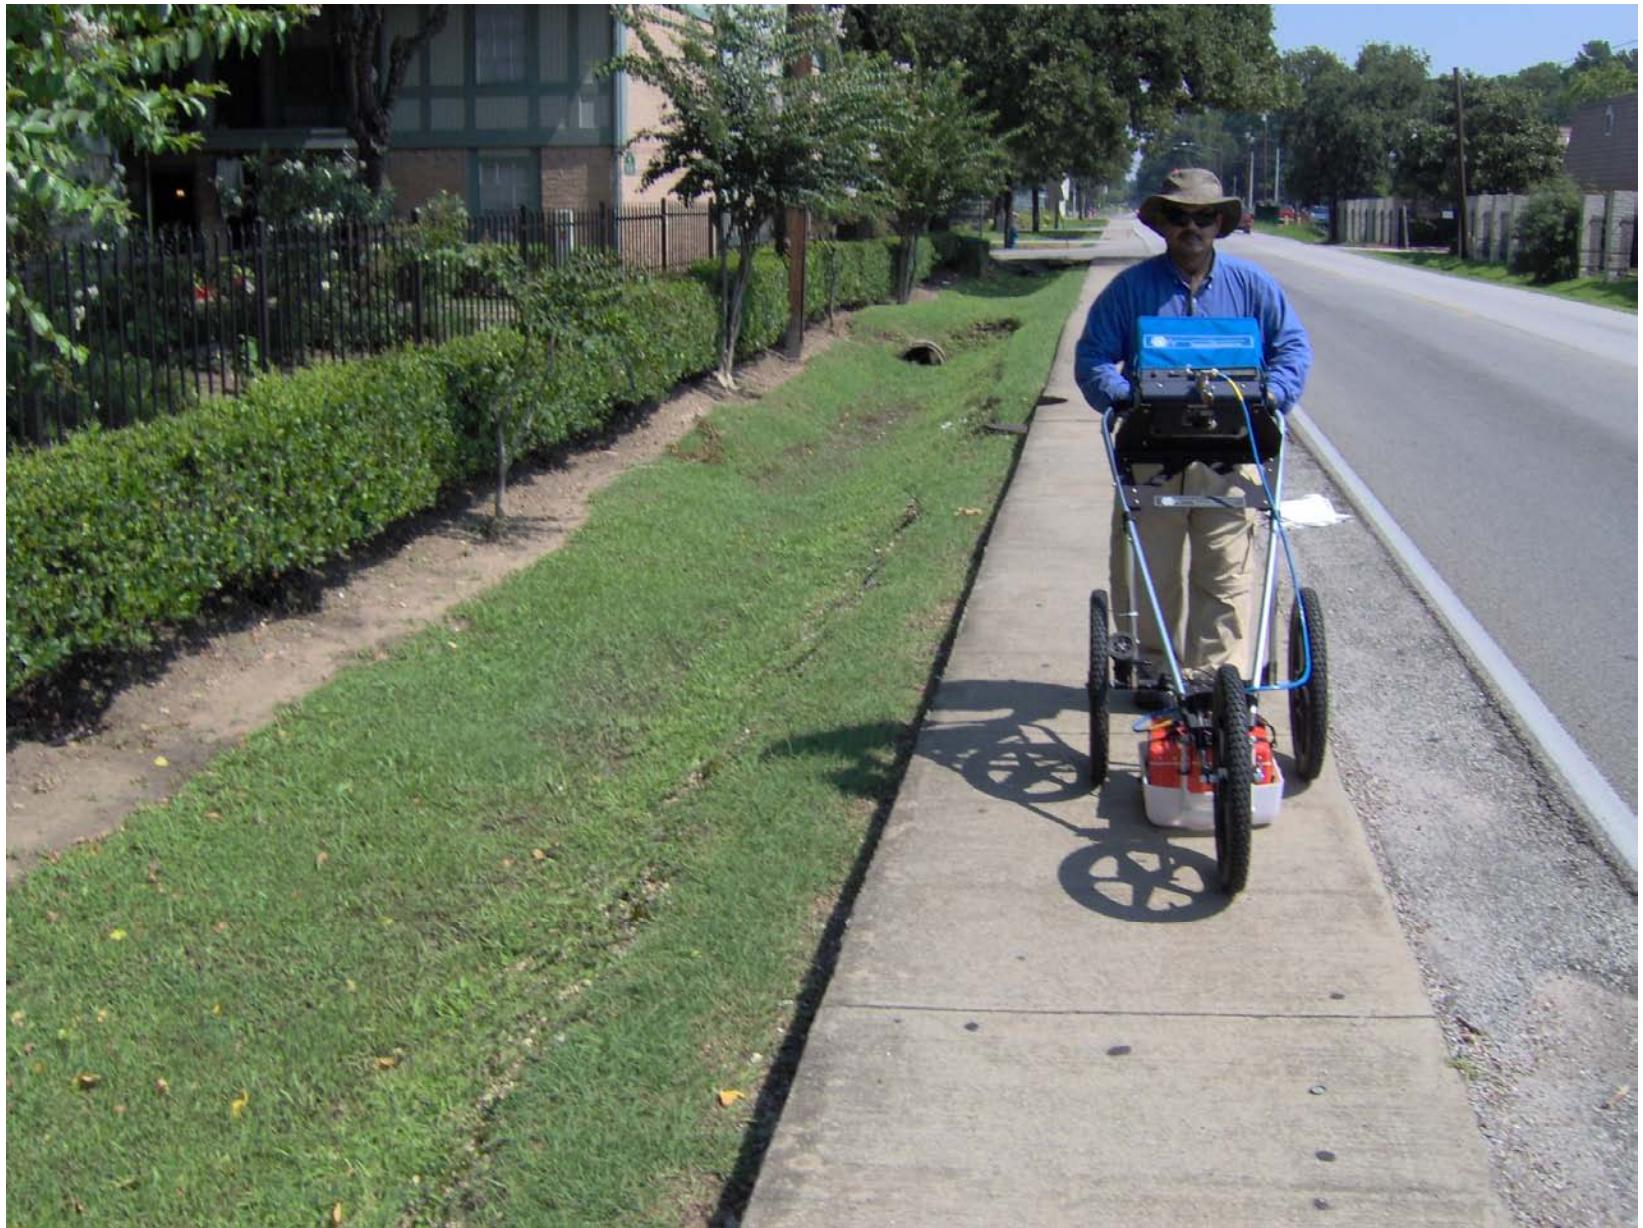
Gathering GPR data with my thesis advisor, Dr. Shuhab Khan. We used high frequency GPR (400 MHz) but were unable to find clear evidence for faulting in the subsurface. My wife and/or son accompanied me on most of my field visits.
