PS New Data and Techniques for Evaluating Subsidence from Abandoned Underground Mines in Ohio*

James McDonald¹

Search and Discovery Article #80612 (2017)**

¹Ohio Dept. of Natural Resources, Division of Geological Survey, Columbus, Ohio (jmcdonald121@gmail.com)

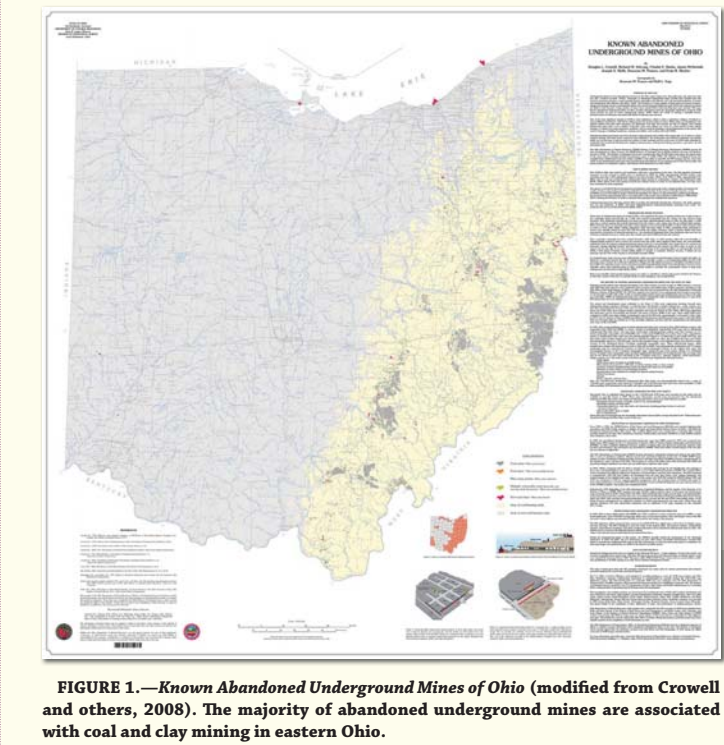
FIGURE 1.—Known Abandoned Underground Mines of Ohio (modified from Crowell and others, 2008). The majority of abandoned underground mines are associated with coal and clay mining in eastern Ohio.

Underground mining for coal in Ohio was first reported in 1800 (Crowell, 1995). The majority of the underground mining takes place in coal- and clay-mining areas of eastern and southern Ohio (fig. 1). Other commodities have been mined underground within Ohio, including salt, gypsum, limestone, shale, and even peat. Geologists have estimated that over 8,000 mines have been in operation over the last 200 years (DeLong, 1988). With such a large number of mines being developed over a long period of time, there is an increasing probability that mines will collapse and subside as they age and deteriorate and as development occurs across the Ohio landscape.

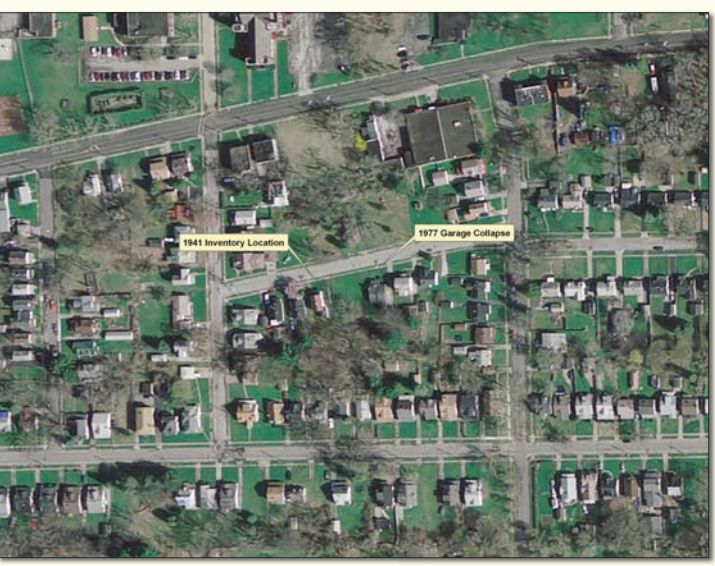
FIGURE 2.—Aerial photograph showing location of mine subsidence in Youngstown, Ohio. In 1941, a property was inventoried by Fuller and Sturgeon (1941) as containing an abandoned mine shaft of the Foster #1 mine, which was abandoned in 1884 and was the most productive mine on the south side of Youngstown. Fuller and Sturgeon also noted that in 1876, a block of sandstone measuring 4' x 4' x 7' was taken out of the shaft and exhibited at the Centennial Exposition in Philadelphia. It won a gold medal for the best stone block on exhibition. In 1977, a garage collapsed into a mine shaft on a nearby property (Crowell, 1980; DeLong, 1988).

Mine subsidence in Ohio has been a problem that only has been recognized in the last 40 years. In 1977, a mine shaft collapsed 110 feet within a 230 feet shaft underneath a garage in Youngstown, Ohio (fig. 2). This incident led to the Survey mapping the detailed locations of abandoned underground mines (DeLong, 1988). Other prominent incidents have occurred, such as the collapse of Interstate 70 near Cambridge, Ohio (fig. 3; Crowell, 1995), and the recent subsidence underneath a house in Sugarcreek, Ohio (fig. 4). The cost associated with the remediation of abandoned mines is high. The repair of the collapse of I-70 near Cambridge cost approximately \$3.8 million (Crowell, 1995). As of 2005, the Ohio Department of Transportation had spent approximately \$14.3 million to repair highway damage caused by mine subsidence. In 2008, the ODNR Division of Mineral Resources Management invested more than \$1.3 million to complete 32 projects related to abandoned underground mines (Gordon, 2009). As abandoned underground mines age and deteriorate, we expect the costs associated with remediation of the abandoned mines to increase.

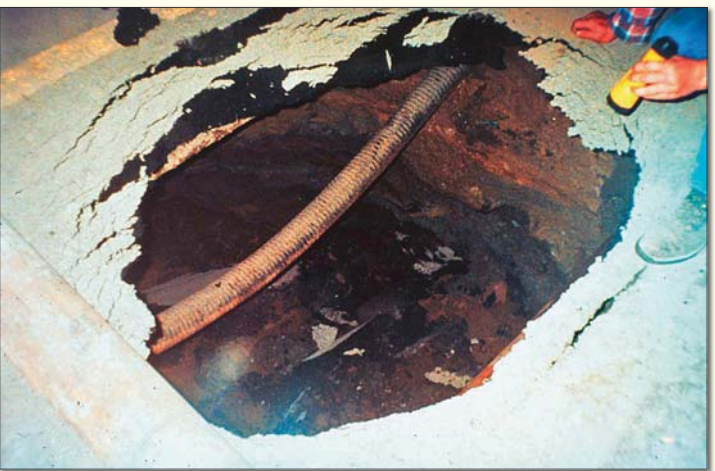
FIGURE 3.—Collapse of Interstate 70, near Cambridge, Ohio caused by mine subsidence (Crowell, 1995).

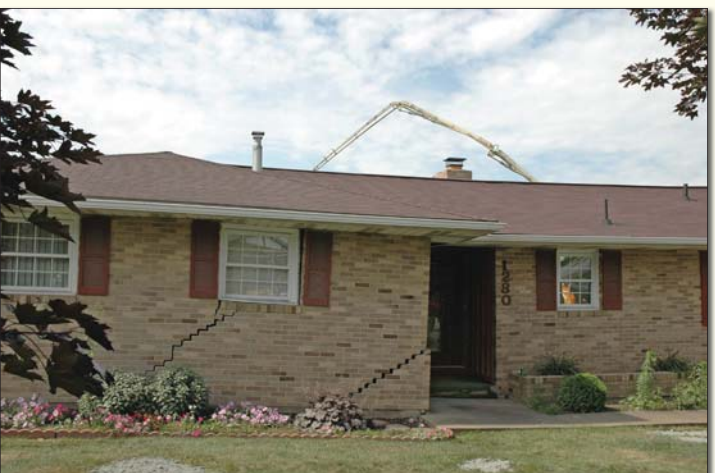
FIGURE 4.—Damage to a house from mine subsidence. Sugarcreek Township, Tuscarawas County, Ohio.

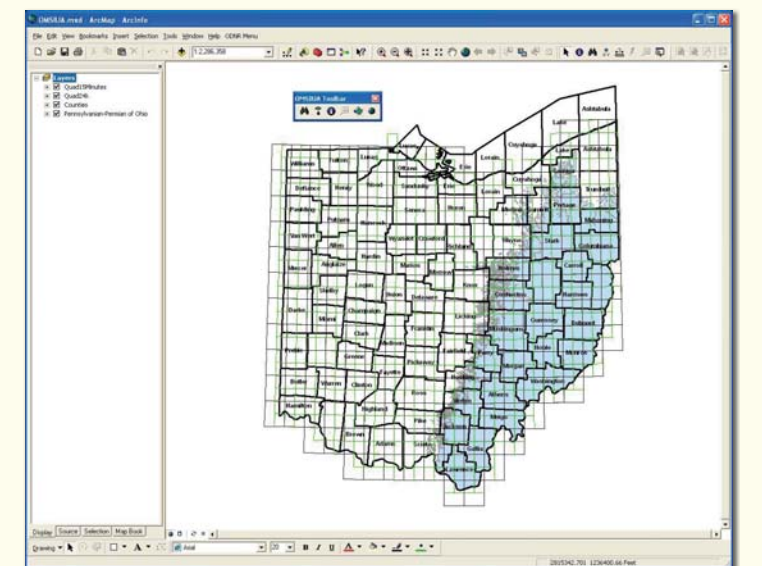
FIGURE 5.—OMSIUA Toolbar.

The OMSIUA GIS application consists of a toolbar with a number of tools. The tools contain a mixture of native ArcGIS tools and custom-designed tools using VBA for ArcObjects (fig. 5). To locate mine subsidence claims, two tools are used to zoom into the claim location and load all geologic maps and documents. The toolbar contains the native ArcGIS Find tool (fig. 6). This tool is used to locate insurance claims based upon the Address Locator function in the Find tool. The second tool on the toolbar is mine-subsidence Select Location tool (fig. 7). This tool will load all known digital geologic maps and all geologic GIS data into the ArcMap document for that location. Some of the GIS datasets include the abandoned underground mines, the permitted surface mines, the 1:24,000-scale bedrock geology, and the 1-foot resolution digital orthophotography. One of the most important historical records is the 15-minute thematic geologic maps. These maps have been scanned and indexed. The Select Location tool will identify all the scanned maps within a mile radius and load them into the ArcMap (fig. 8).

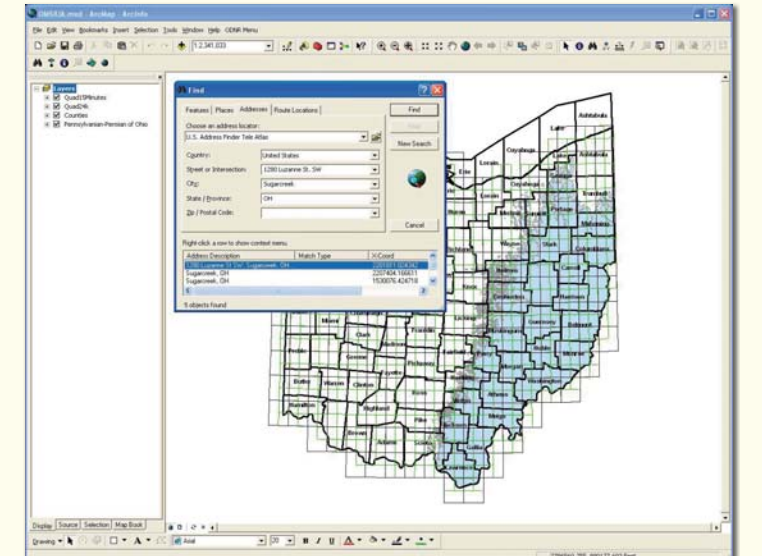
FIGURE 6.—Find tool on the OMSIUA Toolbar. The Find tool and the ESRI Address Locator are used to locate insurance claims based upon the claim address.

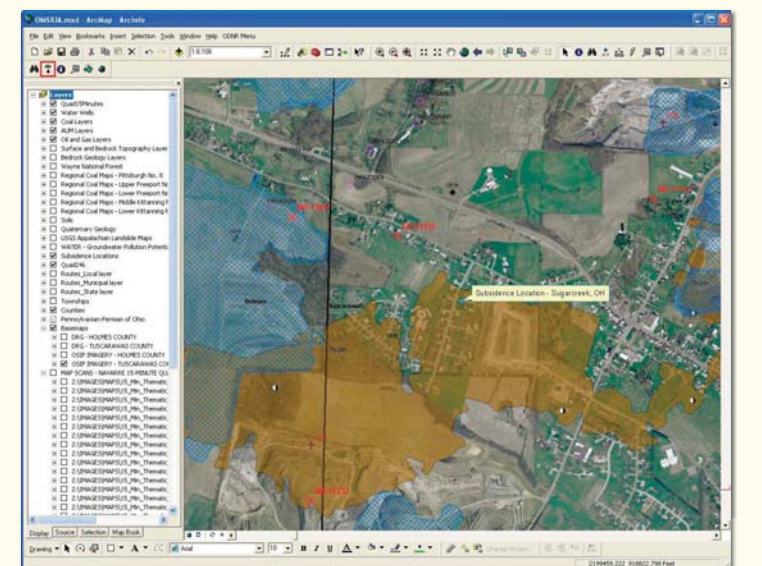
FIGURE 7.—Select Location tool. All geologic information is loaded into the ArcMap for the complainant location.

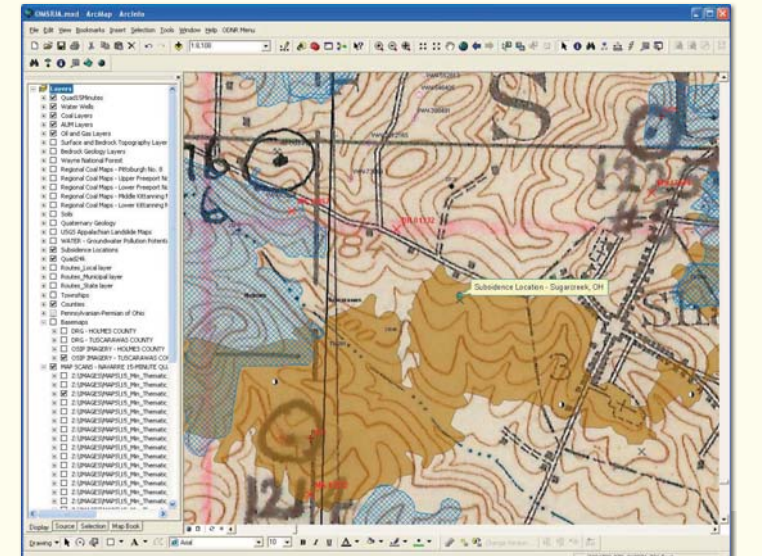
FIGURE 8.—Historic thematic 15-minute topographic map as a basemap. Map shows coal sample locations.

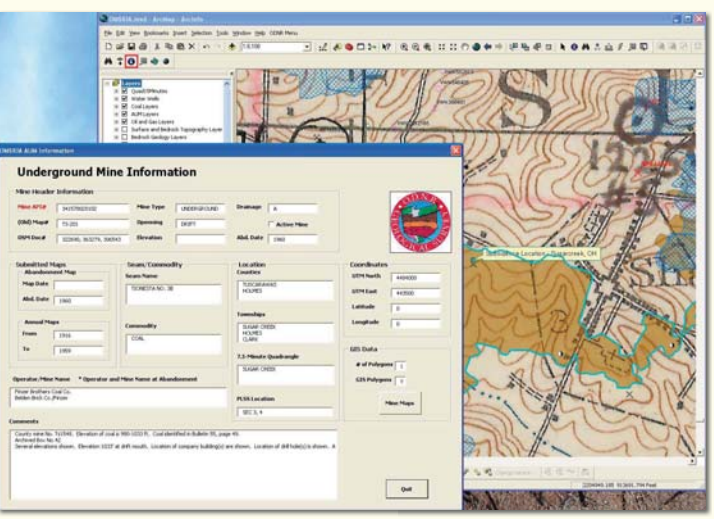
FIGURE 9A.—Underground Mine Information form.

Once the information is loaded, the geologist can conduct a preliminary mine-subsidence analysis. The Underground Mine Information form (fig. 9A) will present the attribute information on abandoned underground mines. Using the form, the georeferenced abandoned mine maps can be loaded into the ArcMap (fig. 9B). Documents can be accessed using the native ArcGIS Hyperlink tool (fig. 10). Some of the documents that can be accessed are the measured stratigraphic sections, core descriptions, and oil-and-gas well completion cards. These three types of documents can have a description of a coal bed within them and possibly the notation that an underground mine is nearby.

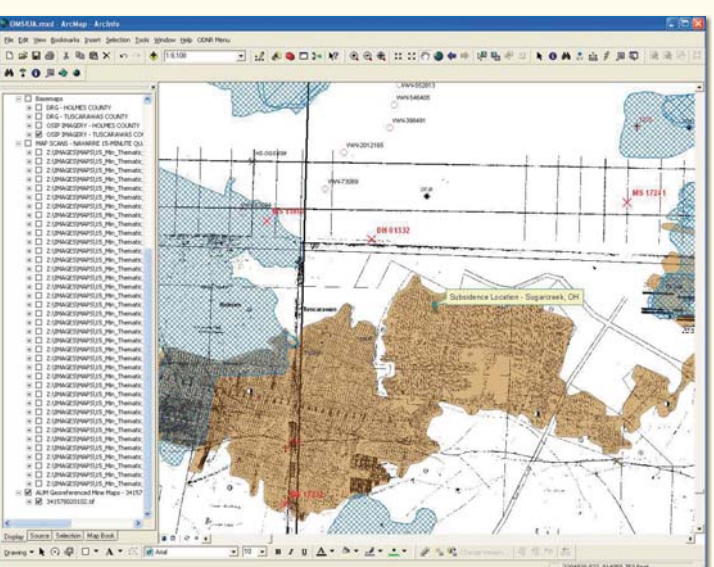
FIGURE 9B.—Georeferenced mine map can be loaded from the Underground Mine Information form.

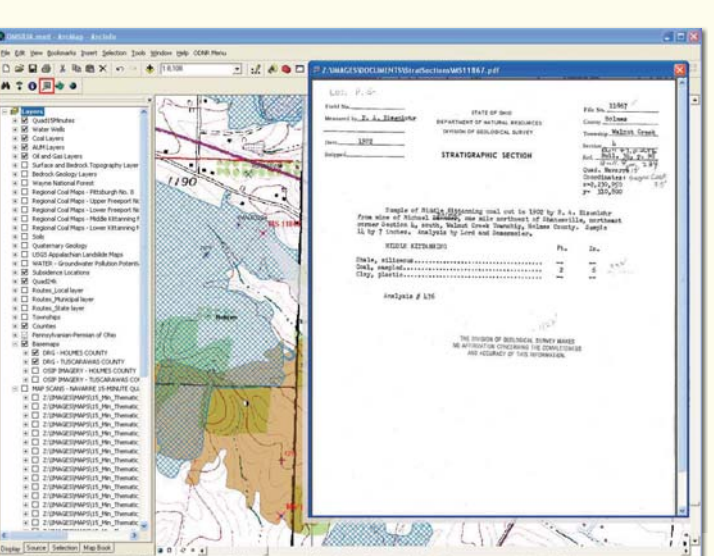
FIGURE 10.—Hyperlink to a Measured Section document.

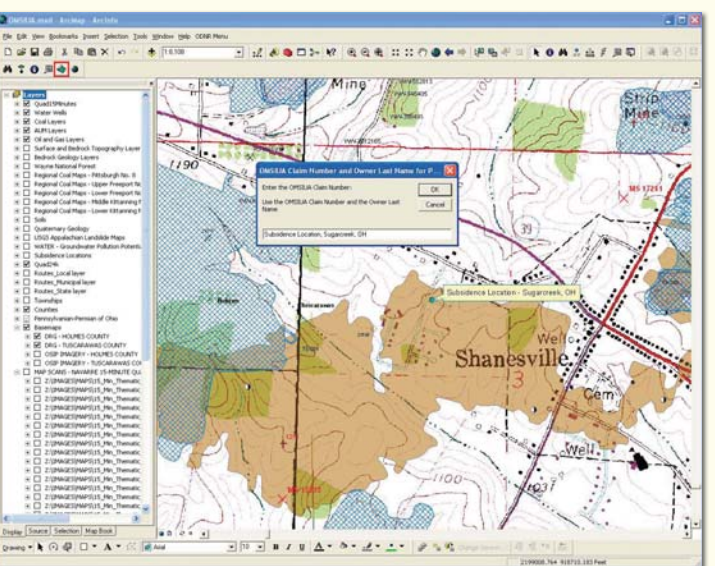
FIGURE 11A.—Automating the export of PDF maps.

After the analysis is completed, portions of the preliminary mine subsidence report can be automated. A tool will export thematic, page-size, PDF maps (fig. 11A). The page-size maps are generated with the correct titles (fig. 11B). The PDF maps, along with all the geologic documents within a half-mile of the site, will be exported to a temporary directory (fig. 11C). The geologist can then ZIP the files together and send them to the consulting engineering company for further analysis.

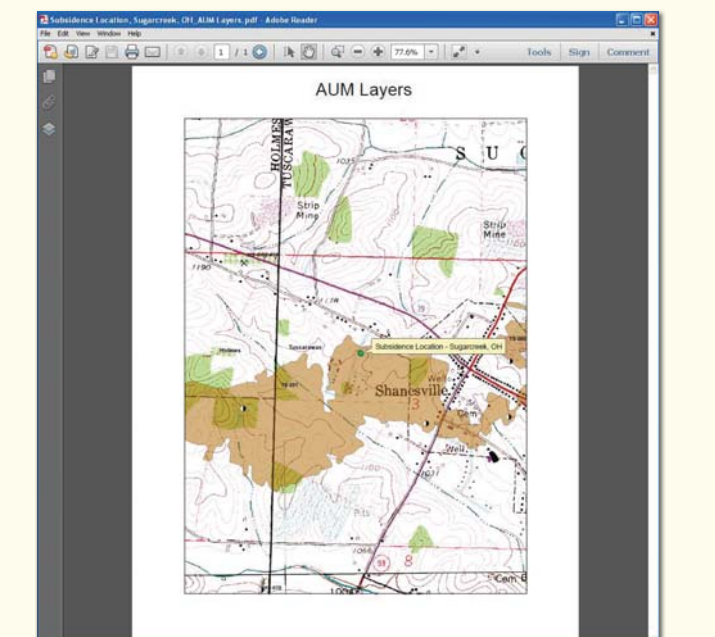
FIGURE 11B.—All automated PDF figures are generated with the correct titles.

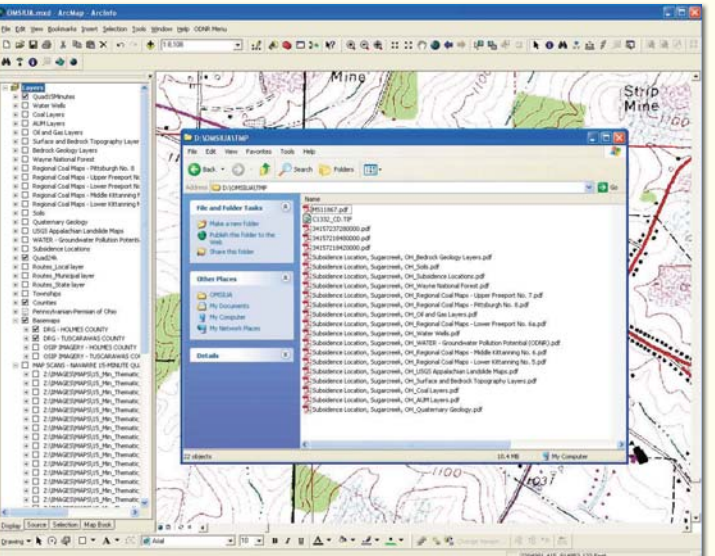
FIGURE 11C.—All documents within a half-mile radius and the PDF figures are copied to a temporary directory.

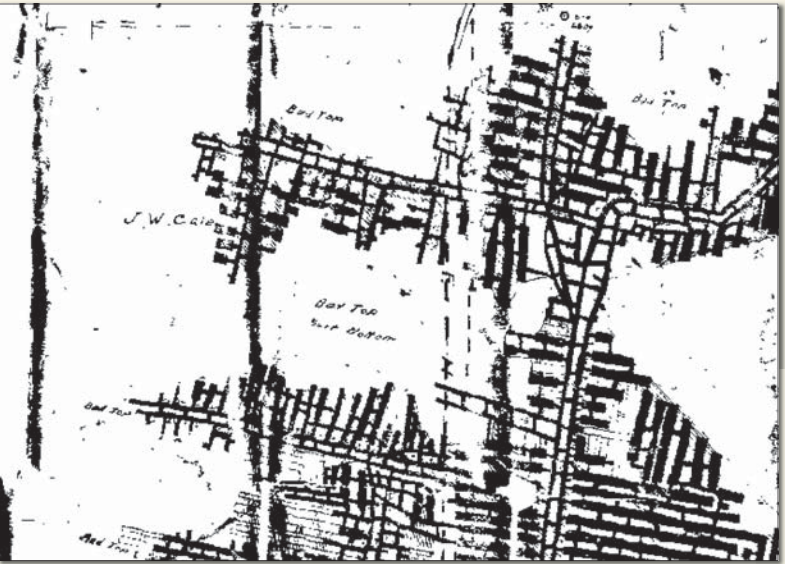
FIGURE 12A.—Low-resolution mine map image (72 dpi) of the Puritan Coal Mine (GY-006), abandoned in 1921.

Starting in early 2000s, the U.S. Department of Interior, Office of Surface Mines and the Ohio Mine Subsidence Insurance Fund board funded the scanning and georeferencing of the abandoned underground mine maps. Over 5,000 abandoned underground mine maps have been scanned at 72 dpi, 150 dpi, and 400 dpi. The 72 dpi images have been georeferenced (fig. 12A) and the 400 dpi images (fig. 12B) are currently undergoing georeferencing. The detailed mine maps allow for determining the accurate locations of the mines. The mine map images also provide detailed information on the occurrence of the room-and-pillar configuration, which can be used to aid in mine subsidence insurance investigations.

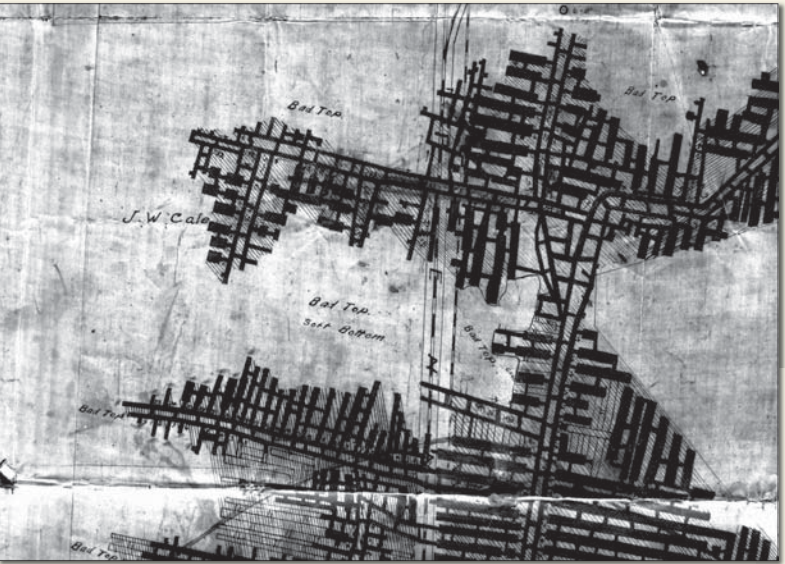
FIGURE 12B.—High-resolution mine map image (400 dpi). Note that the 400 dpi scan is far more readable than the 72 dpi images in figure 12A.

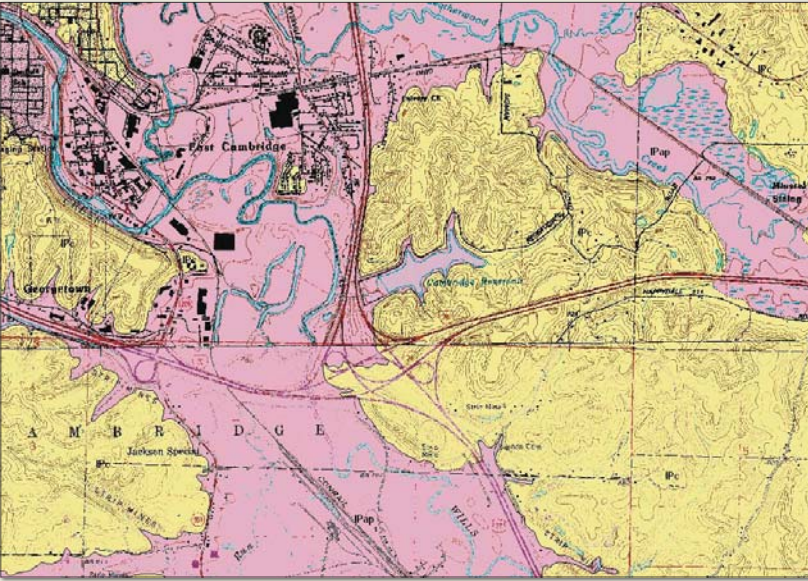
FIGURE 13A.—A portion of the 1:24,000-scale bedrock geology map in the Cambridge, Ohio area.

the 1:24,000-scale bedrock geology (fig. 13A), the bedrock topography (fig. 13B), and the bedrock structure contours (fig. 13C). The mapping project was completed in 1997, the maps were converted to GIS datasets by 2003 (McDonald and others, 2003) and released to the public in 2006. These GIS datasets are useful for identifying particular coal beds and for calculating the unconsolidated drift thickness within alluvial valleys and glaciated portions of the state.

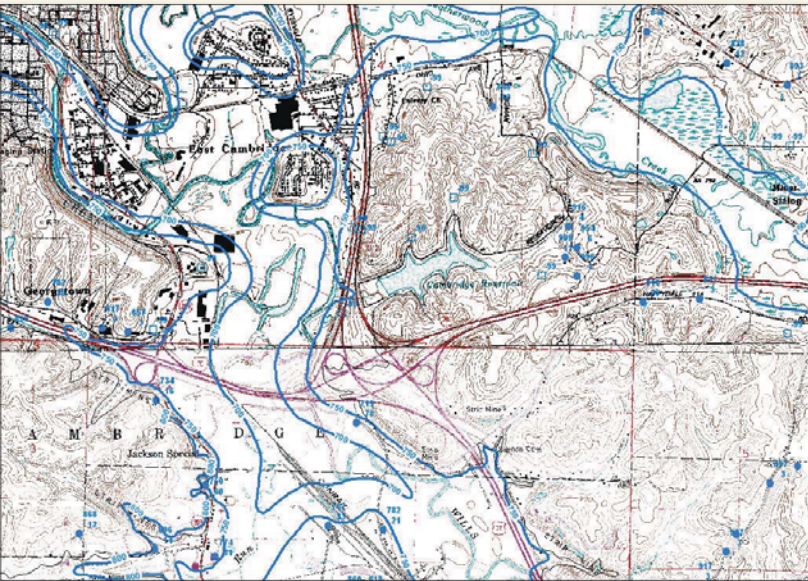
FIGURE 13B.—A portion of the 1:24,000-scale bedrock topography map in the Cambridge, Ohio area.

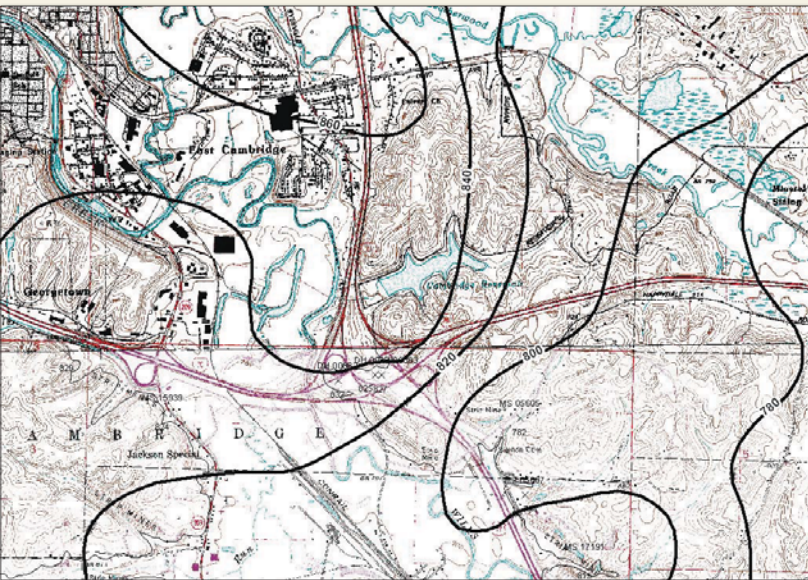
FIGURE 13C.—A portion of the bedrock structure contour map of the Upper Freeport coal bed in the Cambridge, Ohio area.

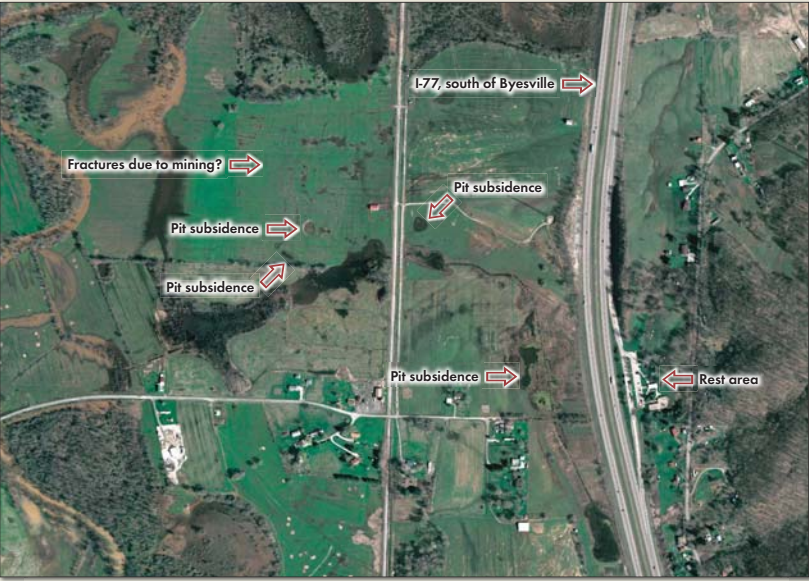
FIGURE 14A.—Location of historic mine subsidence features south of Byesville, Ohio (Nowell, 1970).

In 2006 and 2007, the State of Ohio collected high-resolution, digital orthophoto imagery (1-foot resolution), and LiDAR for the entire state. A historical mine subsidence site (Nowell, 1970) is used to show how the high-resolution imagery and the LiDAR data can be used to identify pit subsidence features (Figs. 14A–14D).

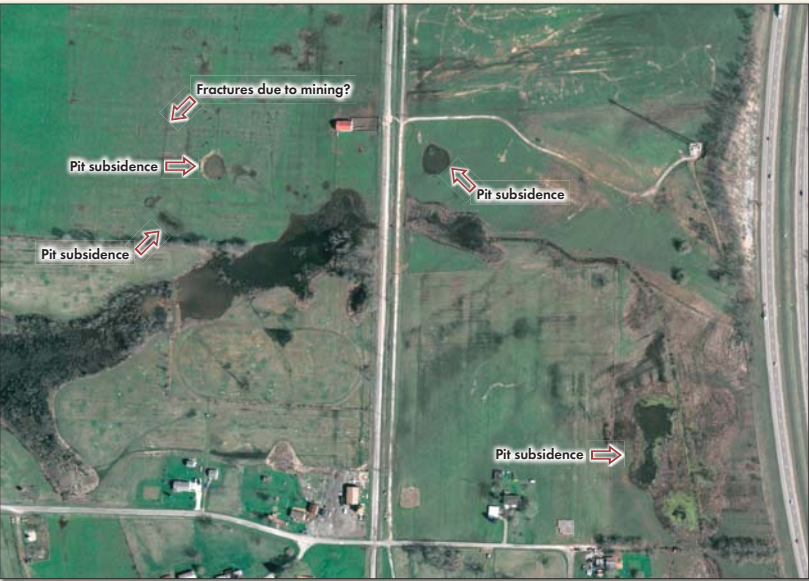
FIGURE 14B.—Zoomed-in view of the mine subsidence features south of Byesville, Ohio.

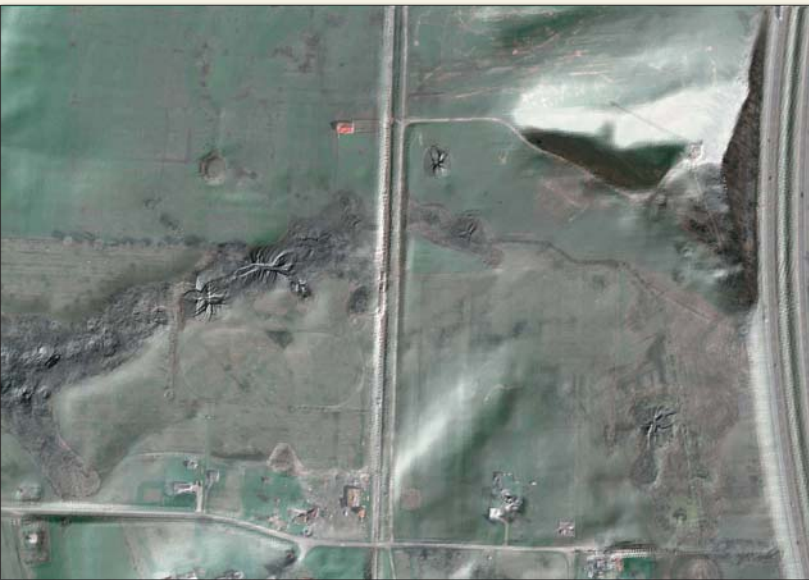
FIGURE 14C.—Hillshade overlay of the gridded LiDAR dataset. Some of the pit subsidence features can be easily identified, especially if the pit subsidence feature has a vertical resolution of greater than the LiDAR accuracy.

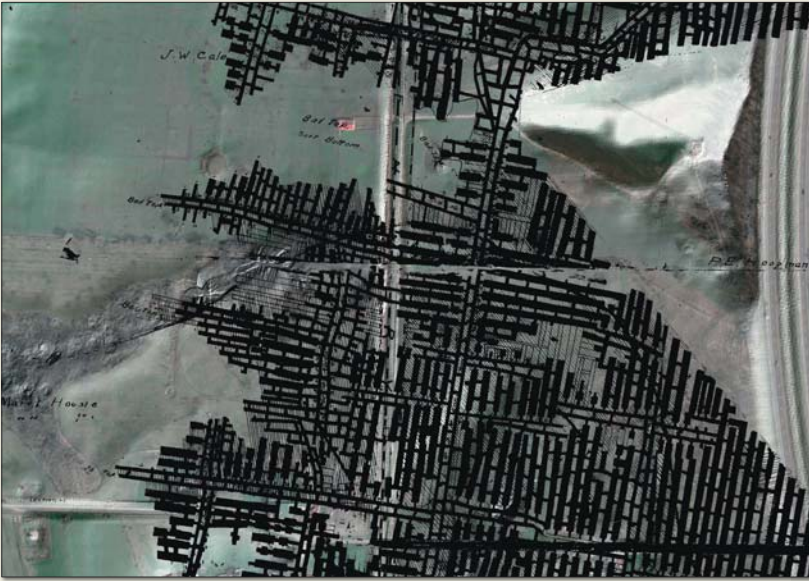
FIGURE 14D.—Overlay of the detailed abandoned mine map. Some of the pit subsidence features lie outside of the mapped mine workings, possibly indicating that the detailed mine map does not completely show the full extent of the mine workings.

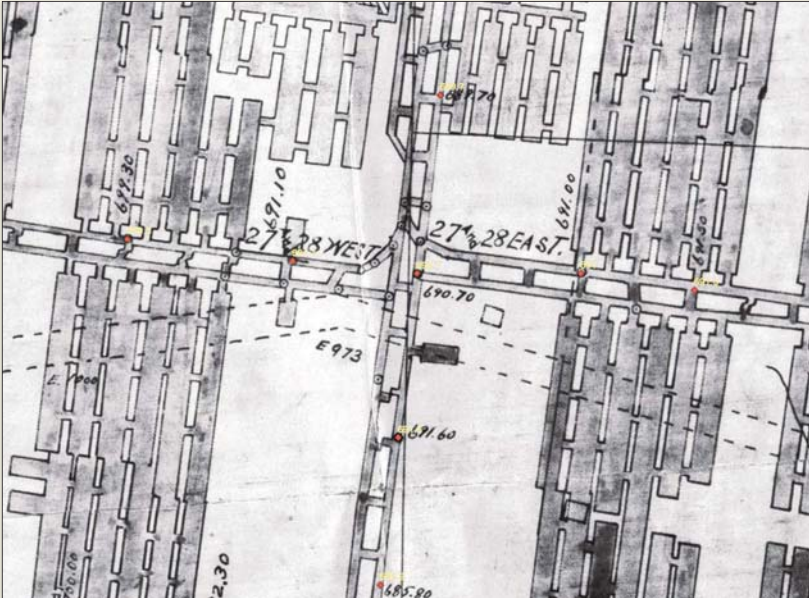
FIGURE 15.—Example elevation data points digitized from an abandoned underground mine map.

The georeferenced mine maps have additional information that can be captured within the GIS. Elevations and thickness points are being captured from the mine maps (fig. 15). Roof rock and mined-out features are currently being captured from the georeferenced abandoned underground mine maps. In figure 16A, the mine map indicates a “Fault.” A fault or “horsebacks” indicate a fluvial sandstone channel that cut down through the overlying roof rock and into the coal bed. The edges of the sandstone fluvial channels are areas of weakness within the mine and are potential areas whereby a collapse can occur. Other typical features captured in the GIS include “Horseback” and “Bad Roof” (fig. 16B).

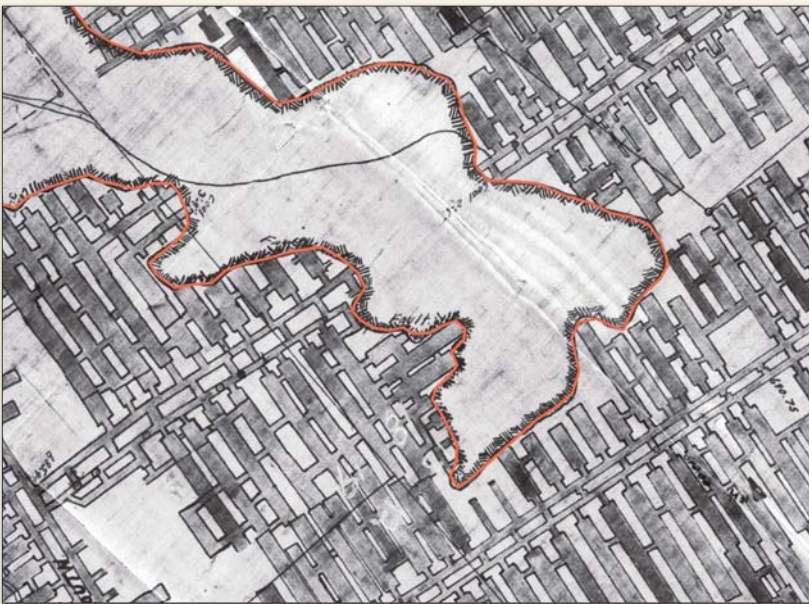
FIGURE 16A.—Roof rock features that have been captured from an abandoned underground mine map. In this figure, the mine map indicates a “Fault.” A fault or “horsebacks” indicate a fluvial sandstone channel that cut down through the overlying roof rock and into the coal bed. The edges of the sandstone fluvial channels are areas of weakness within the mine and are potential areas whereby a collapse can occur.

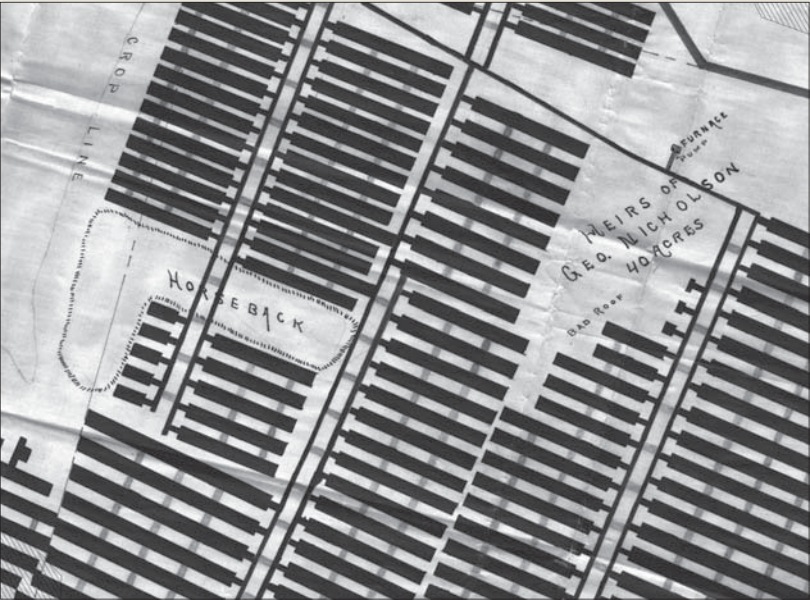
FIGURE 16B.—Roof rock features labeled “Horseback” and “Bad roof.” Again, these are areas of weakness whereby a collapse can occur.

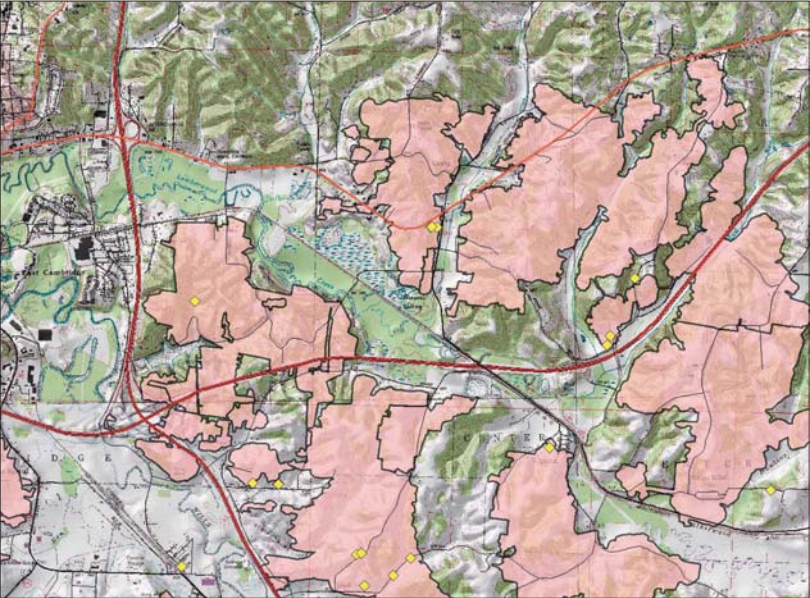
FIGURE 17.—Example map showing the mapped subsidence events and the abandoned underground mines near the I-70/I-77 interchange near Cambridge, Ohio.

The last dataset used in this study includes publicly available mine subsidence events information from the U.S. Department of Interior, Office of Surface Mines (fig. 17).

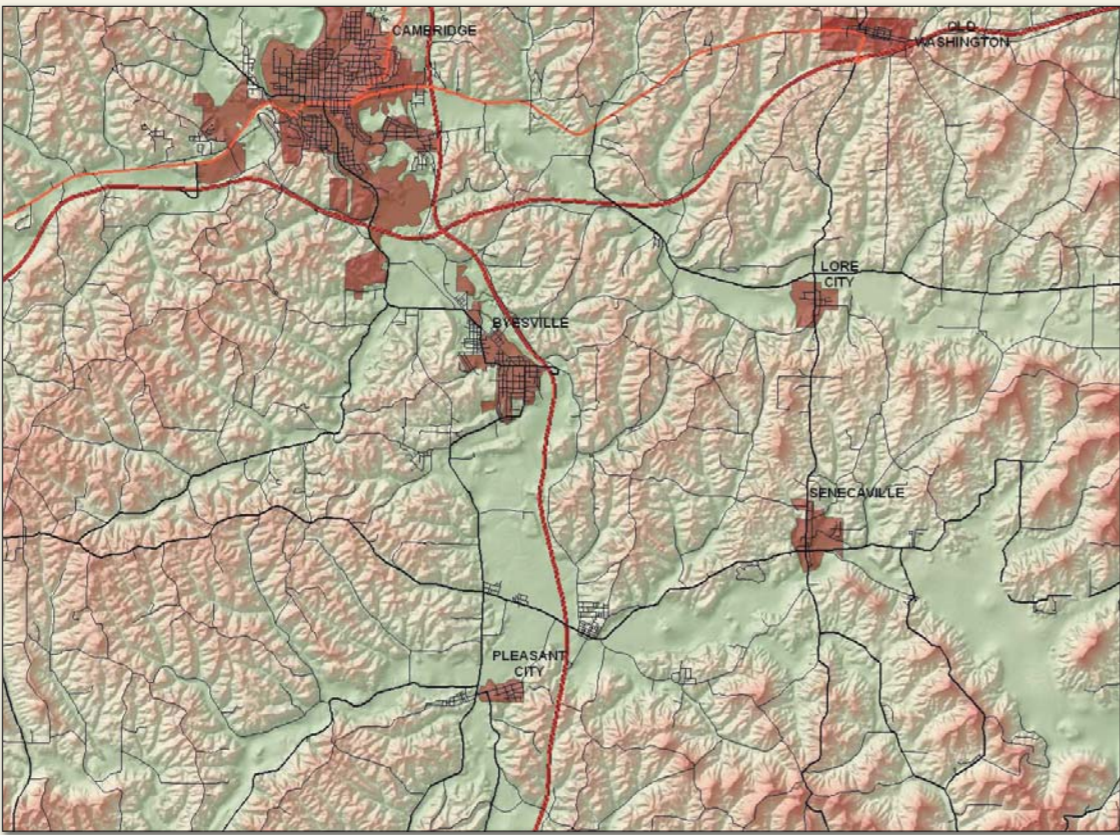
FIGURE 18.—Map showing the location of the pilot project study area in the Cambridge coal field, near Cambridge, Ohio.

In 2012 a pilot study was initiated to determine areas that are at risk for mine subsidence from abandoned underground mines. The pilot project area was located near Cambridge, Ohio (fig. 18). In 1995, there was a collapse of a mine underneath Interstate 70, near the I-70/I-77 interchange. Due to the large area covered by the Cambridge coal field, the age of the mines, and the potential danger of mine subsidence to damage the road network, the area encompassed by the Cambridge coal field was selected for the pilot project.

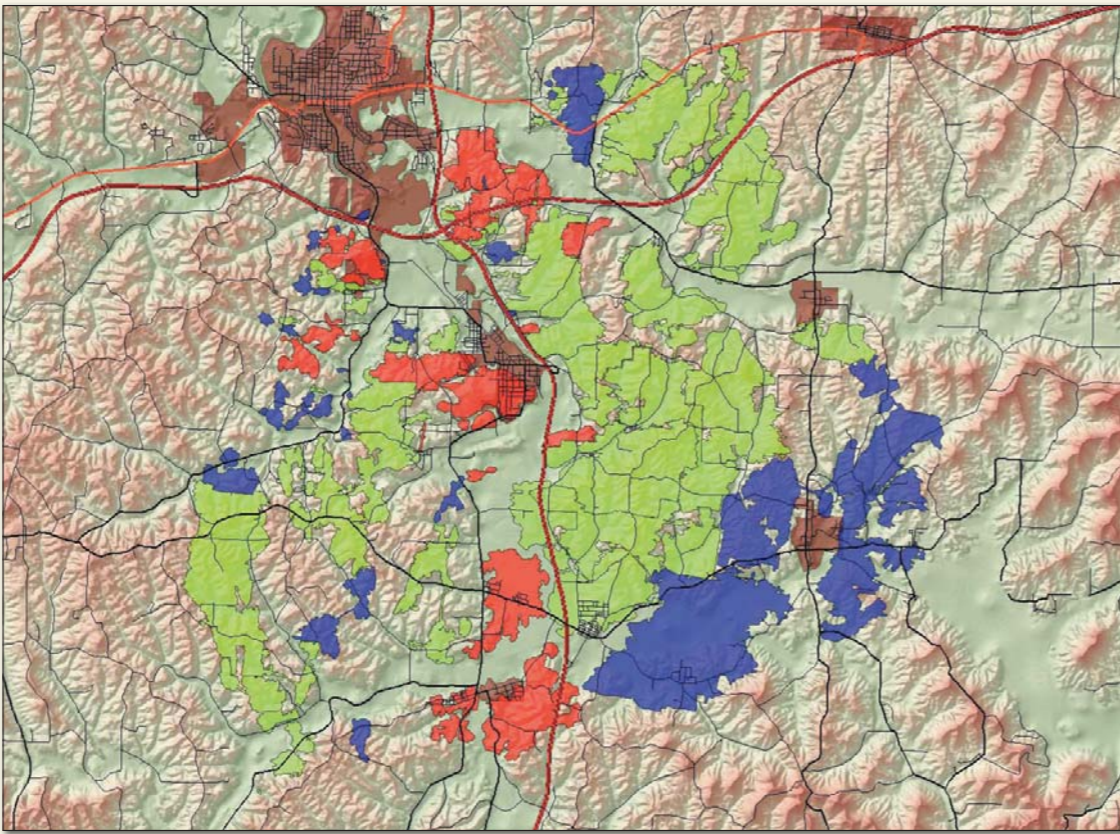
FIGURE 19.—Map showing the abandoned underground mines in the Cambridge coal field. The mines are color classified as to age of abandonment. Mines symbolized in RED were abandoned between 1890 and 1919; mines symbolized in GREEN were abandoned between 1920 and 1939; and mines symbolized in BLUE were abandoned between 1940 and 1960, when the last coal mine in the field was abandoned.

A number of different variables that may affect mine subsidence were examined. Variables analyzed as part of this study included age of a mine, depth to a mine, amount of unconsolidated overburden, and roof rock lithology. As mines age, it is thought that the deterioration of the mines will increase. Figure 19 shows a map of the coal mines in the Cambridge coal field, classified by age of abandonment. Figure 20 shows the subsidence events by age of abandonment of the mine. There is a weak correlation between subsidence events and abandonment date. This weak correlation probably is due to older mines being at a shallower depth, more than the increasing deterioration of the mine over time.

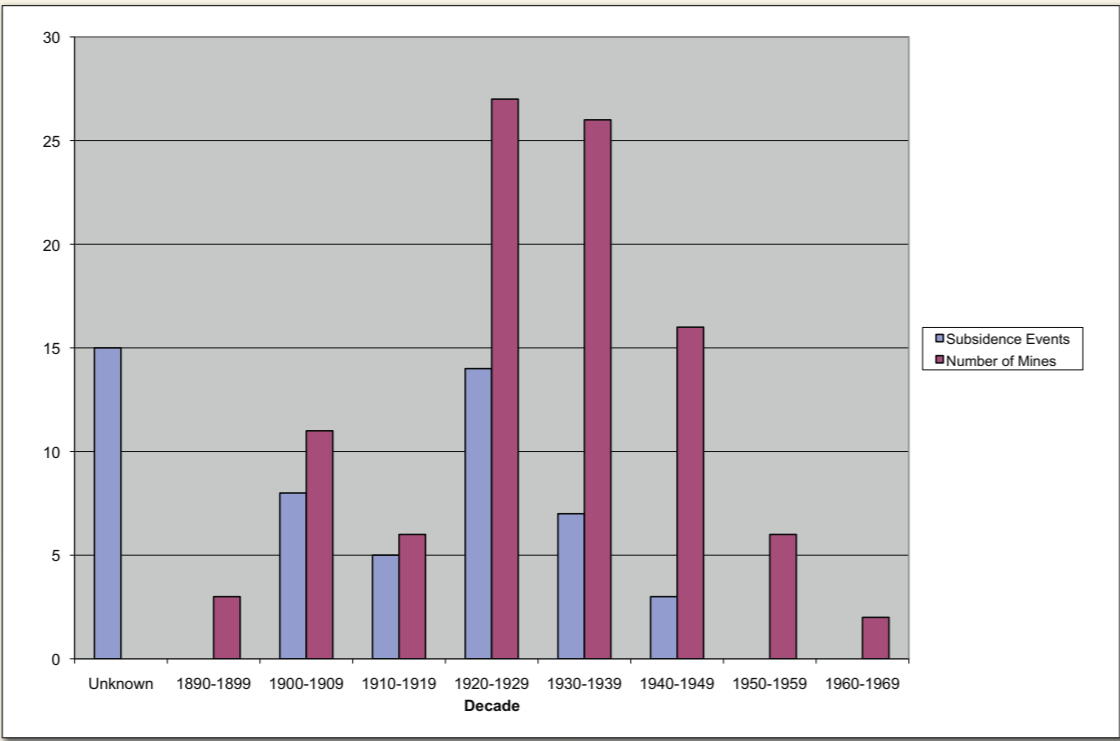
FIGURE 20.—Chart showing the date of abandonment and the subsidence events that correspond to the mine abandonment date. There is a weak correlation between subsidence events and abandonment date. This weak correlation is probably due to older mines being at a shallower depth, more than the increasing deterioration of the mine over time.

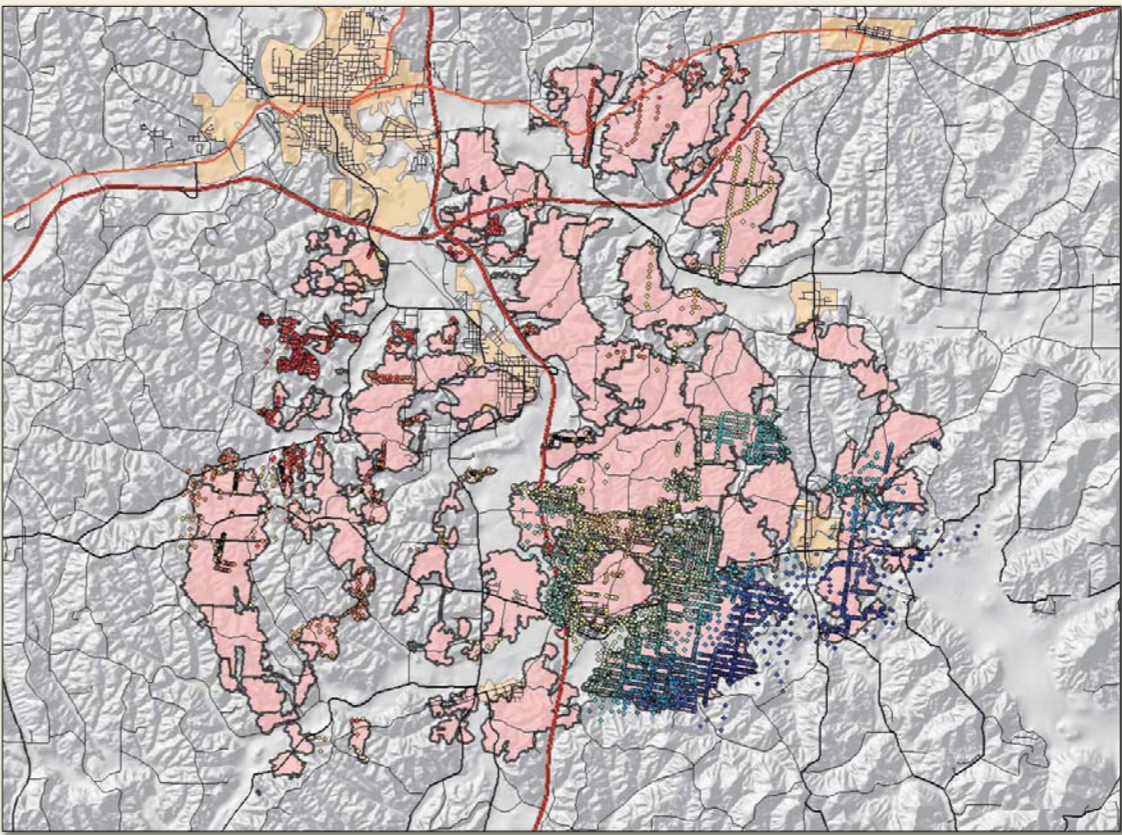
FIGURE 21.—Distribution of the mine elevation data points used to model the coal elevation surface.

Using the NCRDS dataset and the mine elevation points (fig. 21), a detailed coal bed elevation surface can be created (fig. 22). The high-resolution overburden depth is created by subtracting the Upper Freeport elevation surface from the bald earth LiDAR DEM (fig. 23).

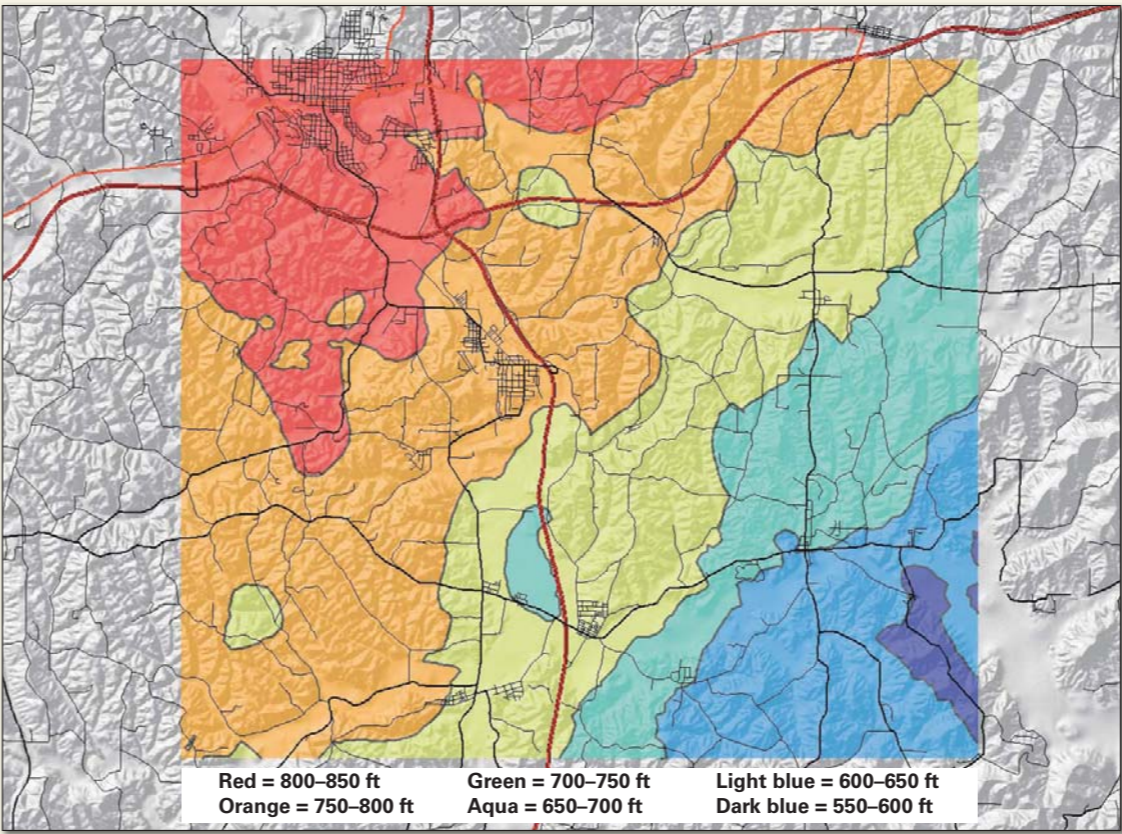
FIGURE 22.—Upper Freeport coal bed elevation surface. Data to model the surface included the mine elevation points, surface measured stratigraphic sections, core descriptions, and mine reclamation drill holes.

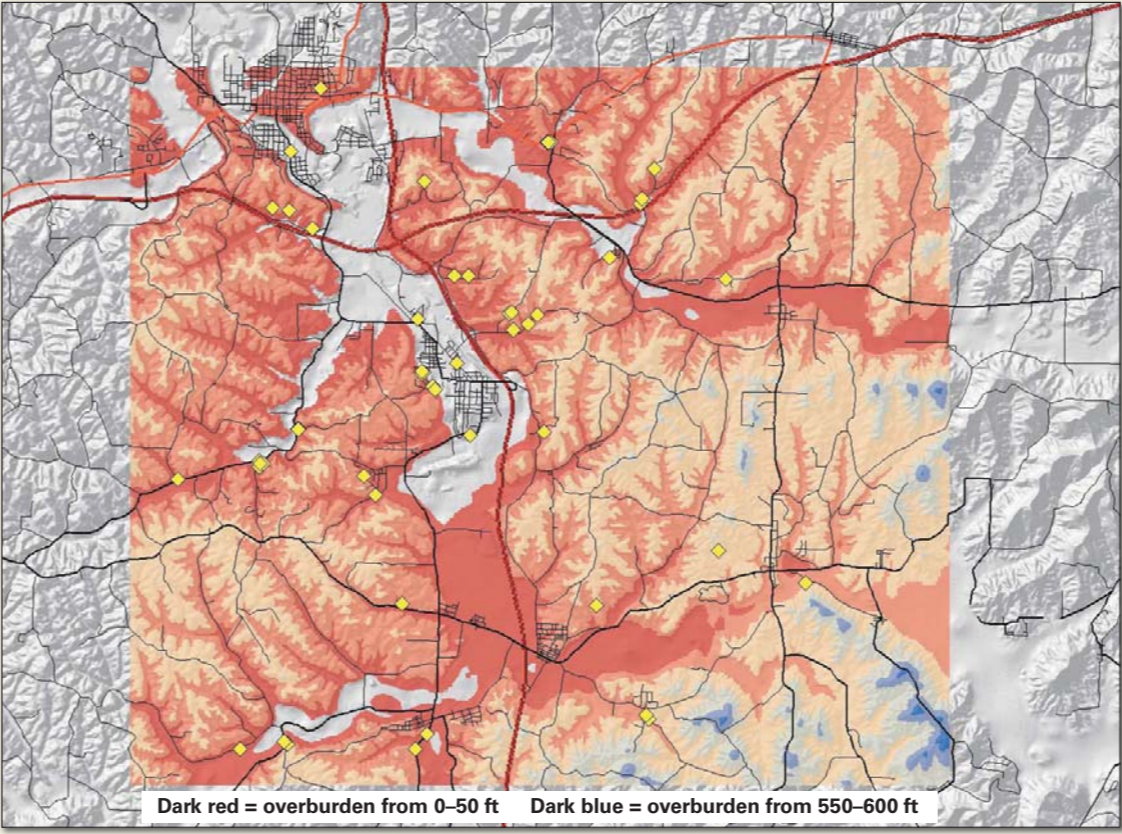
FIGURE 23.—Map showing the overburden thickness and the mine subsidence events. The high resolution overburden thickness is created by subtracting the Upper Freeport elevation surface from the bald earth LiDAR DEM.

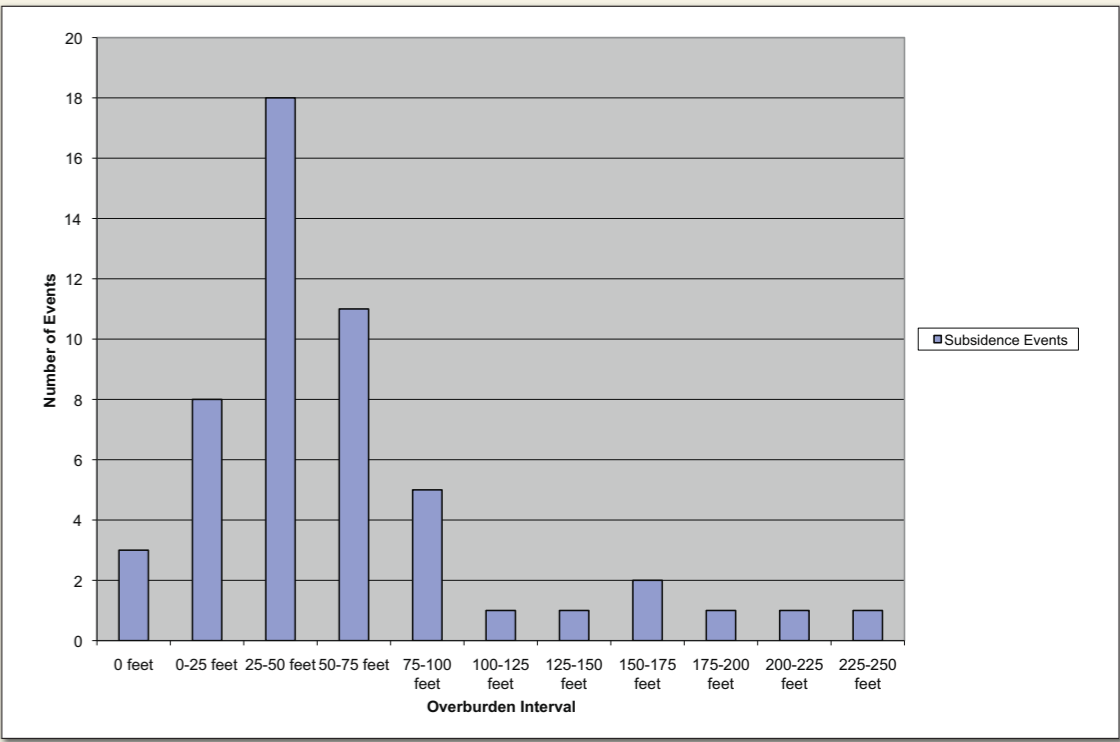
FIGURE 24.—Chart showing the depth to the mine and corresponding mine subsidence event. There is a good correlation showing that most of the mine subsidence events occur at an overburden depth of less than 100 feet.

When the mine subsidence events are correlated with overburden depth to the mine workings, there is a good correlation showing that most of the mine subsidence events occur at an overburden depth of less than 100 feet (fig. 24). Using this result, the overburden depth to the mines of less than 100 feet can be extracted from the overall overburden grid surface. The extracted layer can then be used to identify highways, roads, properties, and structures that may be susceptible to mine subsidence damage (fig. 25).
