PS New Data and Techniques for Evaluating Subsidence from Abandoned Underground Mines in Ohio*

James McDonald¹

Search and Discovery Article #80612 (2017)**

¹Ohio Dept. of Natural Resources, Division of Geological Survey, Columbus, Ohio (jmcdonald121@gmail.com)

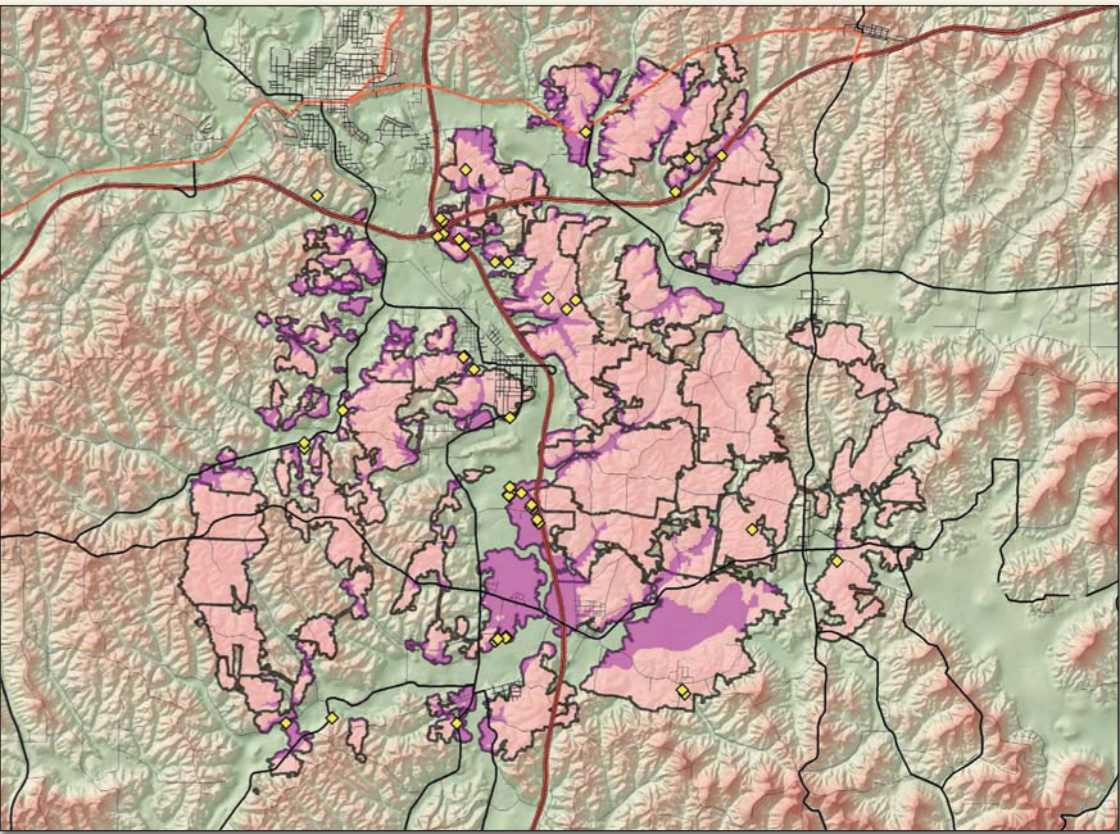
FIGURE 25.—Map showing the overburden depth of less than 100 feet and the highway infrastructure that may be affected by mine subsidence. Mines are represented by light purple while the overburden thickness of less than 100 feet is represented by dark purple.

When the mine subsidence events are correlated with overburden depth to the mine workings, there is a good correlation showing that most of the mine subsidence events occur at an overburden depth of less than 100 feet (fig. 24). Using this result, the overburden depth to the mines of less than 100 feet can be extracted from the overall overburden grid surface. The extracted layer can then be used to identify highways, roads, properties, and structures that may be susceptible to mine subsidence damage (fig. 25).
