AV Detailed Structural Interpretation Using 3D Seismic Curvature Analysis, Neuquen and San Jorge Basins, Argentina*

Search and Discovery Article #110102 (2009)
Posted August 25, 2009

*Adapted from oral presentation at AAPG Annual Convention, Denver, Colorado, June 7-10, 2009

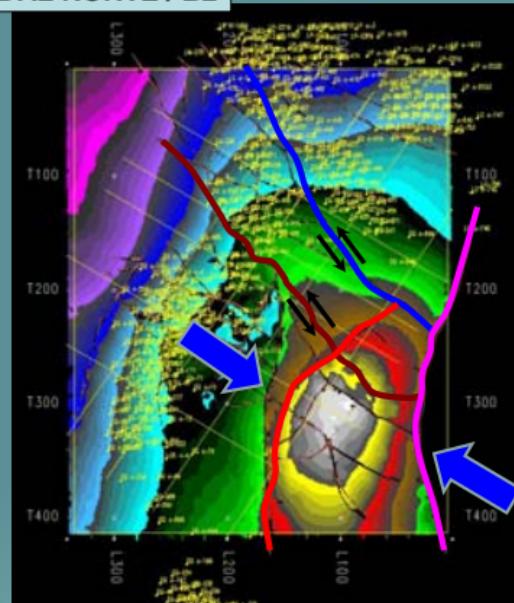
EL GUADAL NORTE / B2

- Extension in Mesozoic
- NW-SE Trending Normal Faults
- Andean (Tertiary) Compression
- NE-SW Elongate Structures and Reverse Faults
- Compression Parallel to Normal Faults - Reactivation of Pre-Existing Faults
- Strike-Slip, Reduced Throw

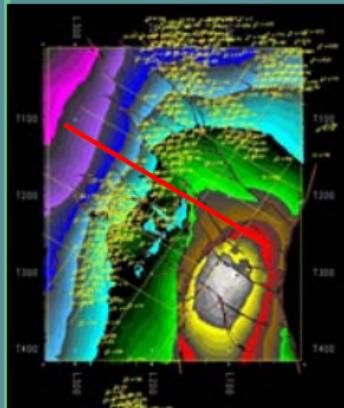
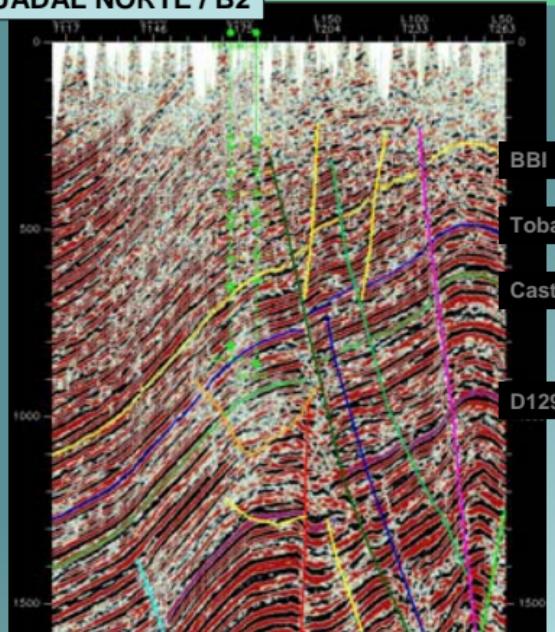
EL GUADAL NORTE / B2

- Structure Increases in Magnitude, Fault Complexity
- Secondary Faults Clear, Form in Response to Structural Growth
- Opportunity for Additional Drilling – Structurally Higher

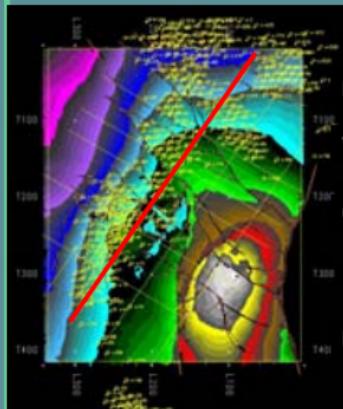
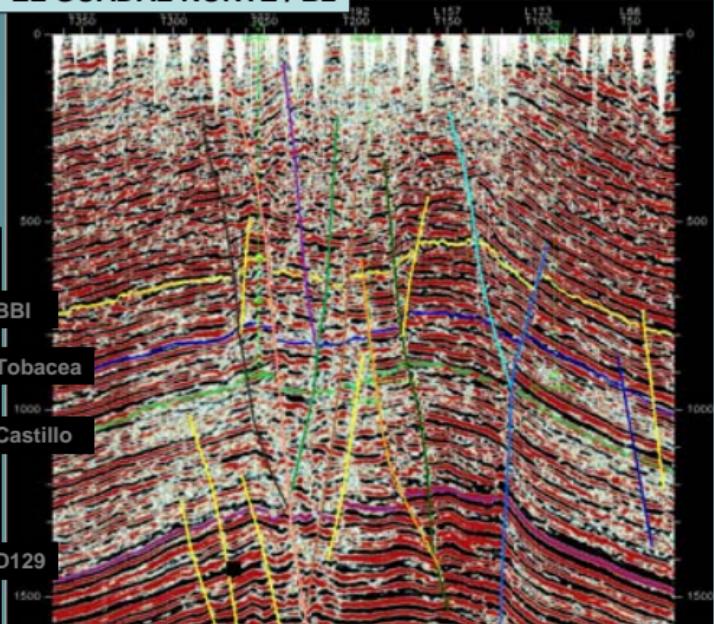
EL GUADAL NORTE / B2

- Complex System of Faults
- Complexity Increases At Structural High
- Requires Care and Reviewing Time Slices, Curvature Information

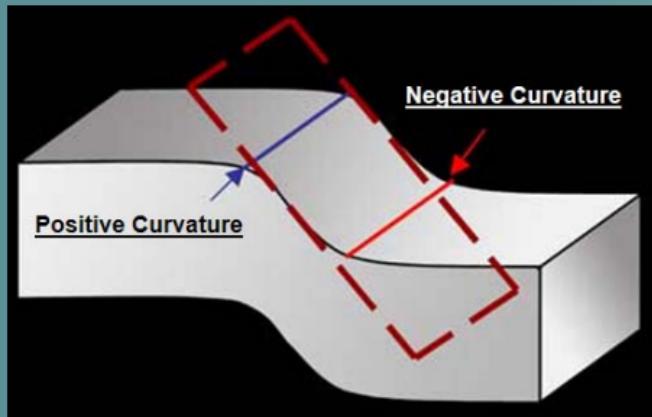
3D SEISMIC CURVATURE

- Curvature Inherent in 3D Seismic Volume
- Each Sample Correlated to its Nearest Neighbors
- Creates Essentially a 3D Dipmeter Volume
- Positive Curvature - Anticlinal
- Negative Curvature - Synclinal
- Parallel Lines of Positive and Negative Indicate Faults
- Most Positive Curvature, Most Negative Curvature Indicate Possible Fractures

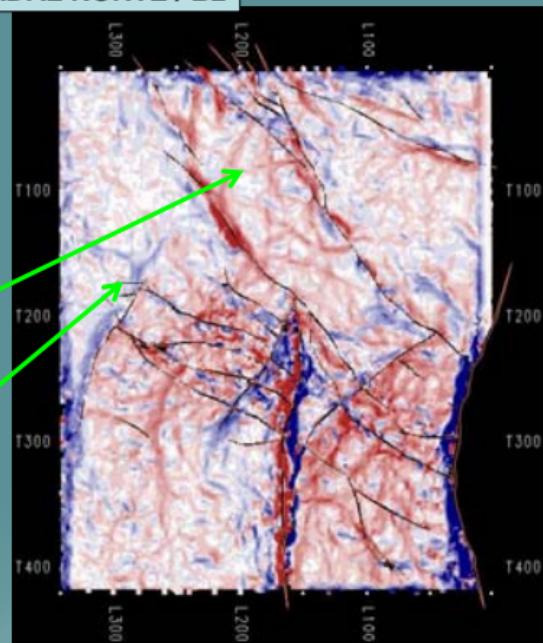
- Abrupt Change in Positive Curvature (Anticlinal) to Negative Curvature (Synclinal)
- Many of the Larger Faults Interpreted from 3D Volume
- Visualize Small Faults and Fractures (Flexure)
- Maximum Curvature Extracted Along Horizon Indicates Longer Extent
- Definition of Fault System

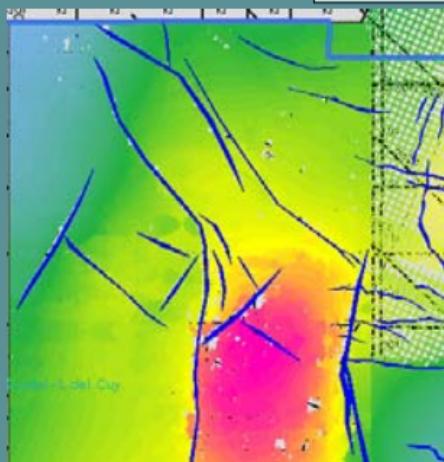
Two-Way Time
Conventional Seismic Data

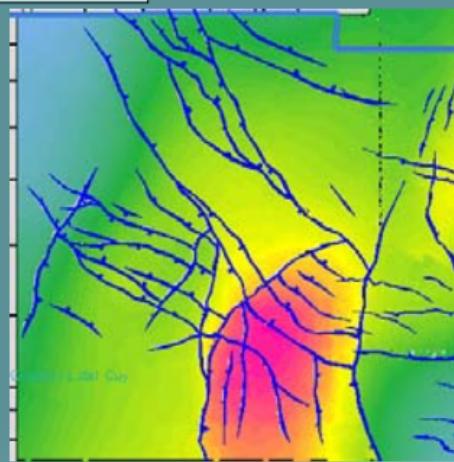
Two-Way Time
3D Curvature Data

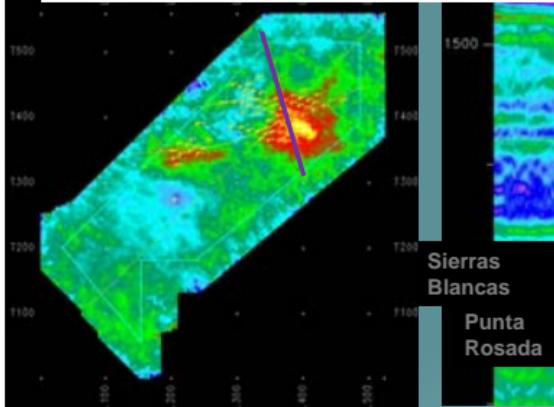
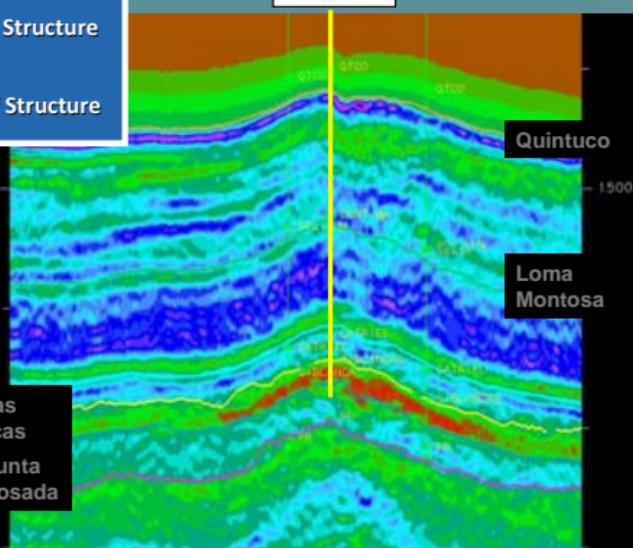
BP-24

- BDP-24 Well Excellent Producer
- Low Impedance in Sierras Blancas On Structure
- Additional Area to the SE
- Low Impedance in Loma Montosa Off Structure

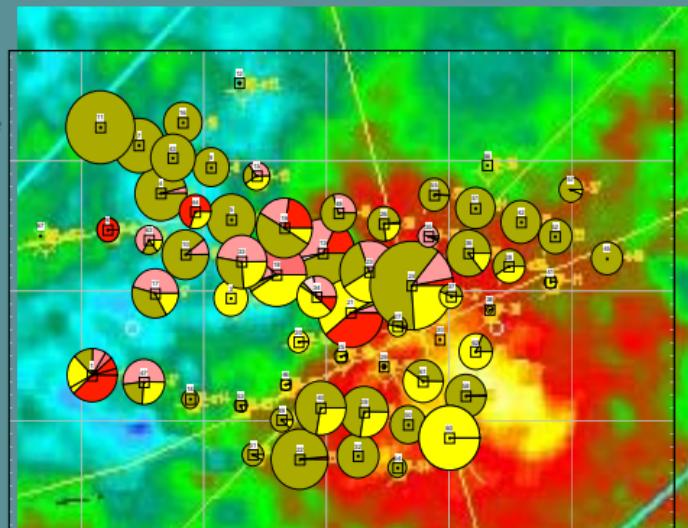
RMS Acoustic Impedance – Sierras Blancas

- Best Producing Wells Not on Lowest Impedance Areas
- Composite Effect of Structure and Stratigraphy
 - Structural Position
 - Low Impedance

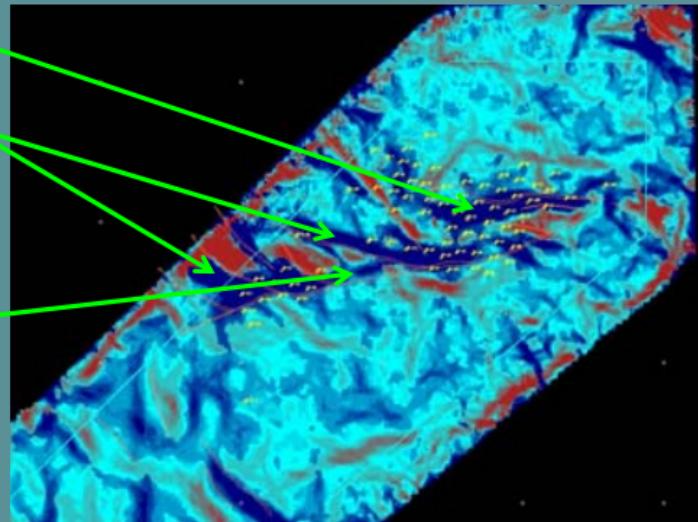
Maximum Curvature

- Majority of Wells on Positive Curvature
- Undrilled Positive Curvature Areas Remain
- Test Against Structure Map, Stratigraphy, Engineering Data
- Identification of South Fault

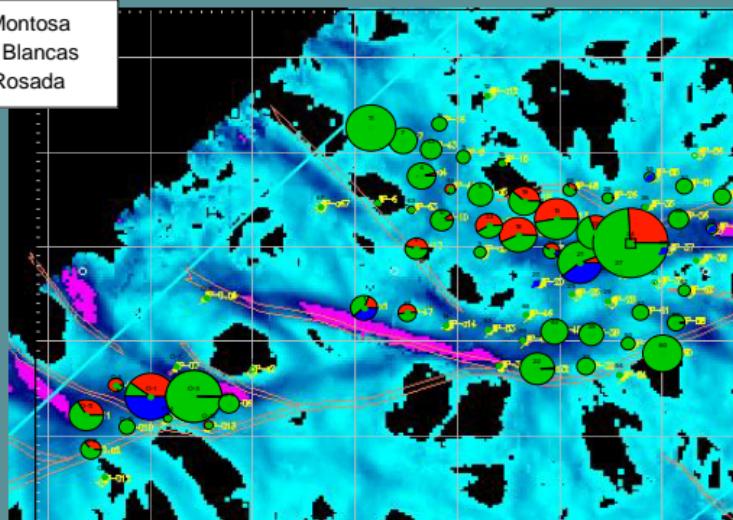
- Loma Montosa
- Sierras Blancas
- Punta Rosada

- Best Wells on Positive Curvature Highs
- Poor Wells in Area of Low Curvature
- Fracturing

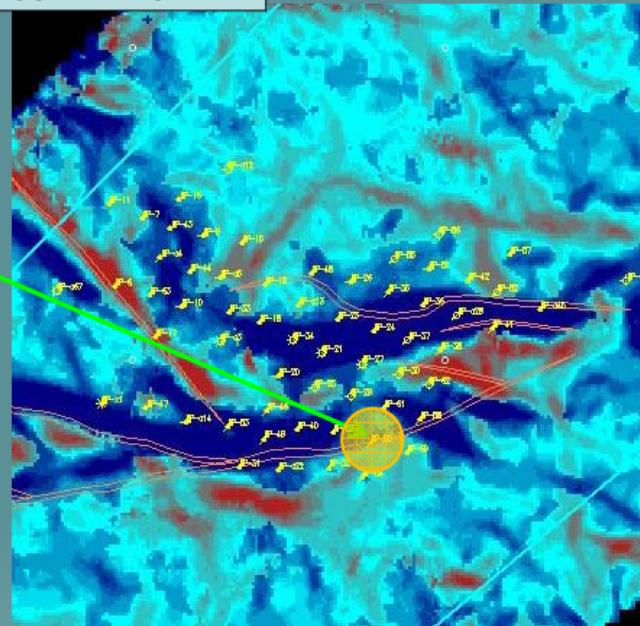
Sierras Blancas Structure

- South Fault Displays Reverse Dip-Slip Displacement - Transpression
- South Fault Extent Identified Mainly by Curvature Volume
- Integrate with Well Control, QC

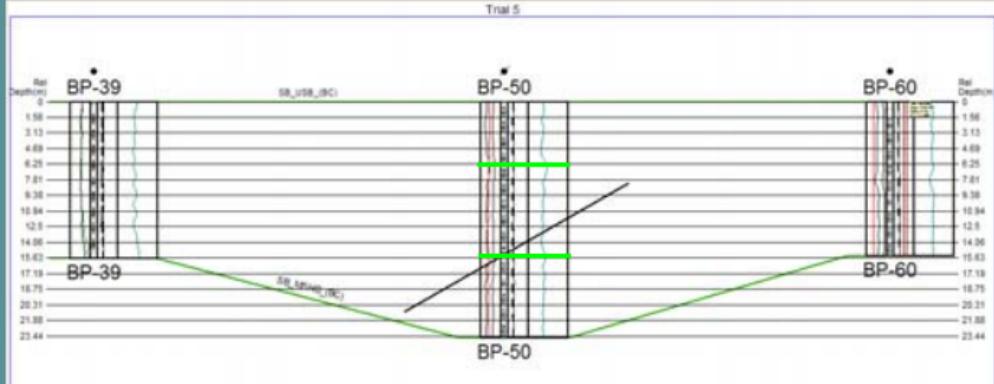
Trial 5

- BP-50 Well Cut by Fault Within Sierras Blancas
- Repeated Section

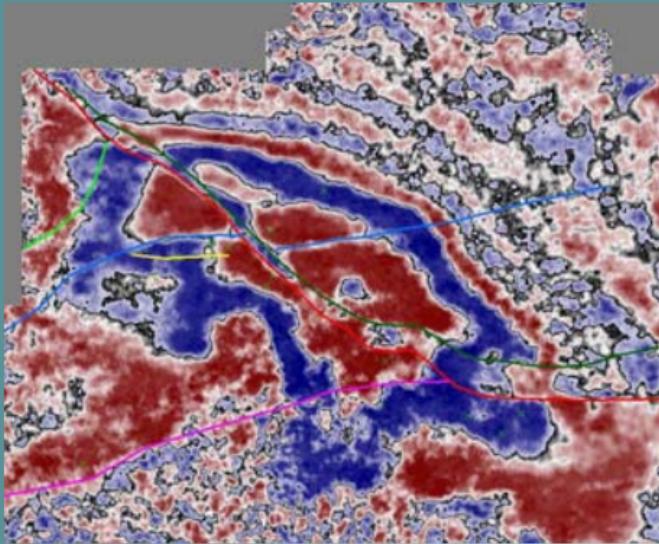
Time Slice 1440 msec

- Definition of Major Faults
- Different Fault Orientations
- Subtle Faults?

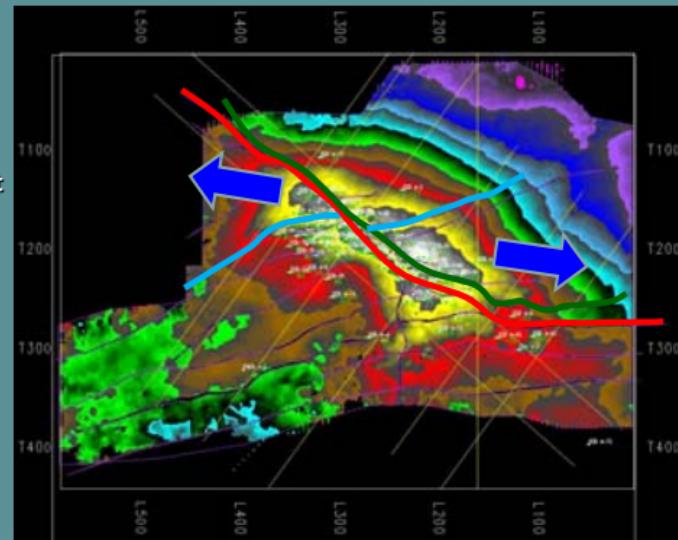
- Extension WSW-ENE Trending Normal Faults
- Main Fault (Red) and Antithetic (Green) Cut Pre-Existing
- Shows Right-Lateral Offset on Structural Crests and Transverse Faults
- Trans-Tension – Releasing Bend in Fault
- Inversion

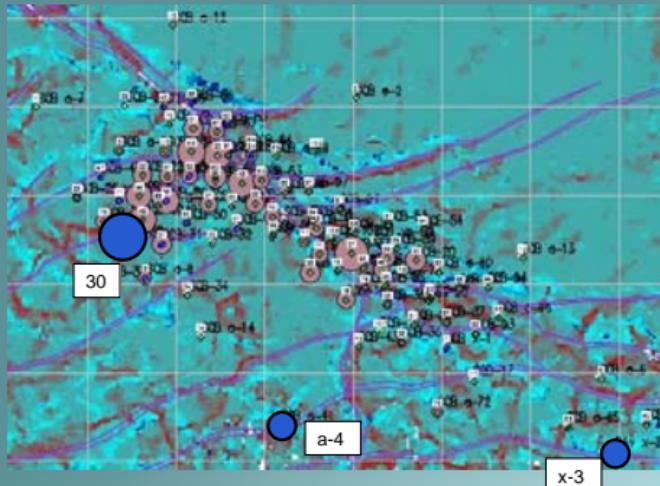
Cum Water Production Overlay

- Well 30 – Very High Water Cut
 - Shallow
 - Odd Interpretation of Aquifer
 - Cut by E-W Fault
 - Explains Production Behavior
- Other Wells with High Water Cut are Located on E-W Faults, Fractures
- E-W Faults Appear Open
- N-S Faults Appear Closed
- Implications for Rock Mechanics / Stress Field
- Directional Drilling

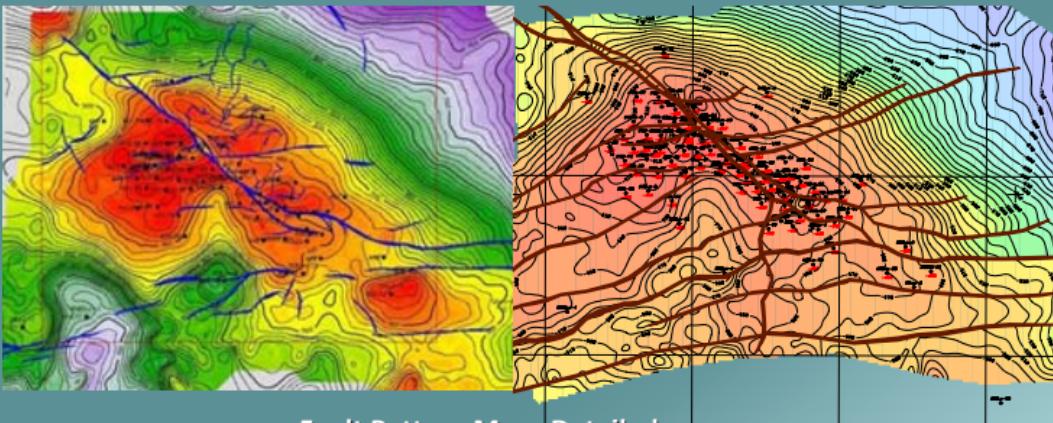
BEFORE

AFTER

- Fault Pattern More Detailed
- Faults More Continuous
- Explains Structural Style
 - SW-NE Trend on West Side
- Explains Production Anomalies
