Using Borehole Image Logs to Characterize a Major Fault in the Ventura Avenue Field*

Search and Discovery Article #20255 (2014)**

The focus of this study is the Taylor 73 Fault (named for the well where the fault was originally identified). This major south verging thrust acts as an effective seal, separating most of the productive reservoir intervals from shallower zones above. The reservoir facies are turbidite sandstones that include thickly bedded amalgamated units, thinner inter-bedded sandstone and mudstone units, and intervals that are predominantly mudstone. The facies act as contrasting mechanical units that can affect the character of the fault zone. The position along the fault plane is also a primary factor. Not surprisingly, it is often difficult to identify specific fault planes in the flat-on-flat fault position. Identifying the fault zone in ramp positions is much more obvious, although the character and fault expression are highly variable. Fault cores and damage zones range in thickness from tens to hundreds of feet, and can consist of sheared and fractured intervals, intact rotated blocks, and cemented intervals. Our ongoing work investigates position along the

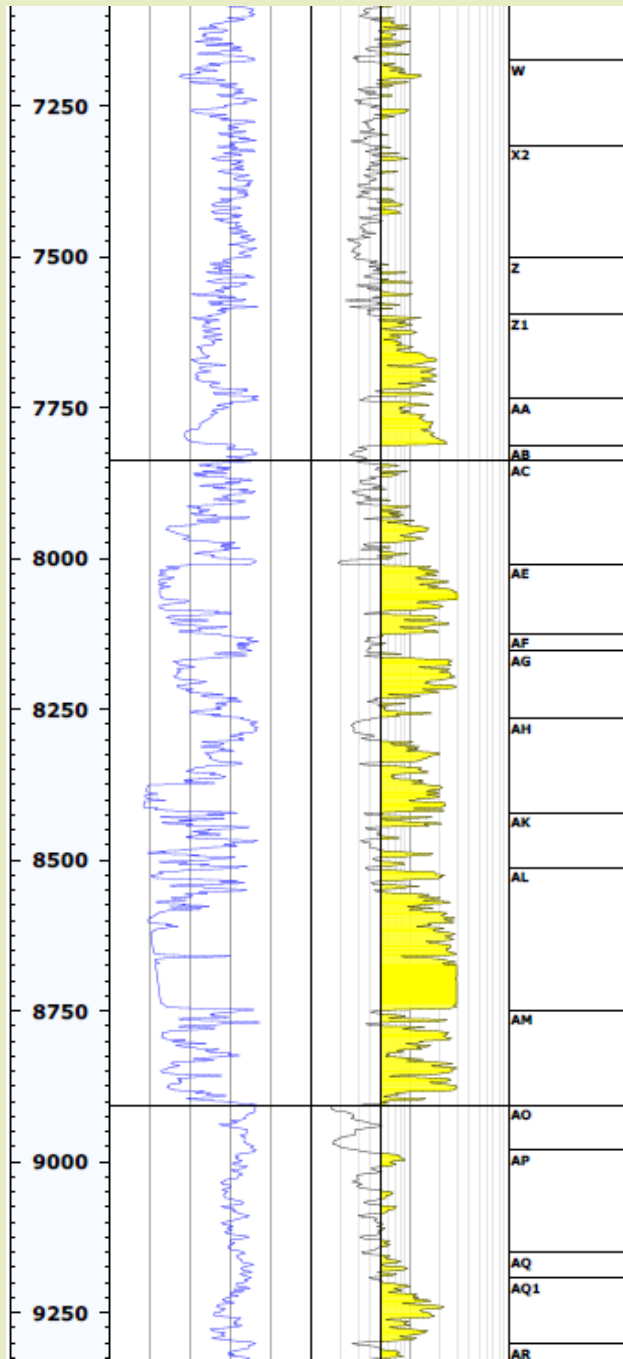
Generalized Stratigraphy

- Over 10,000' of stacked turbidites
- Contrasting mechanical properties of interbedded sandstones and mudstones
- **Numerous possible detachment horizons**

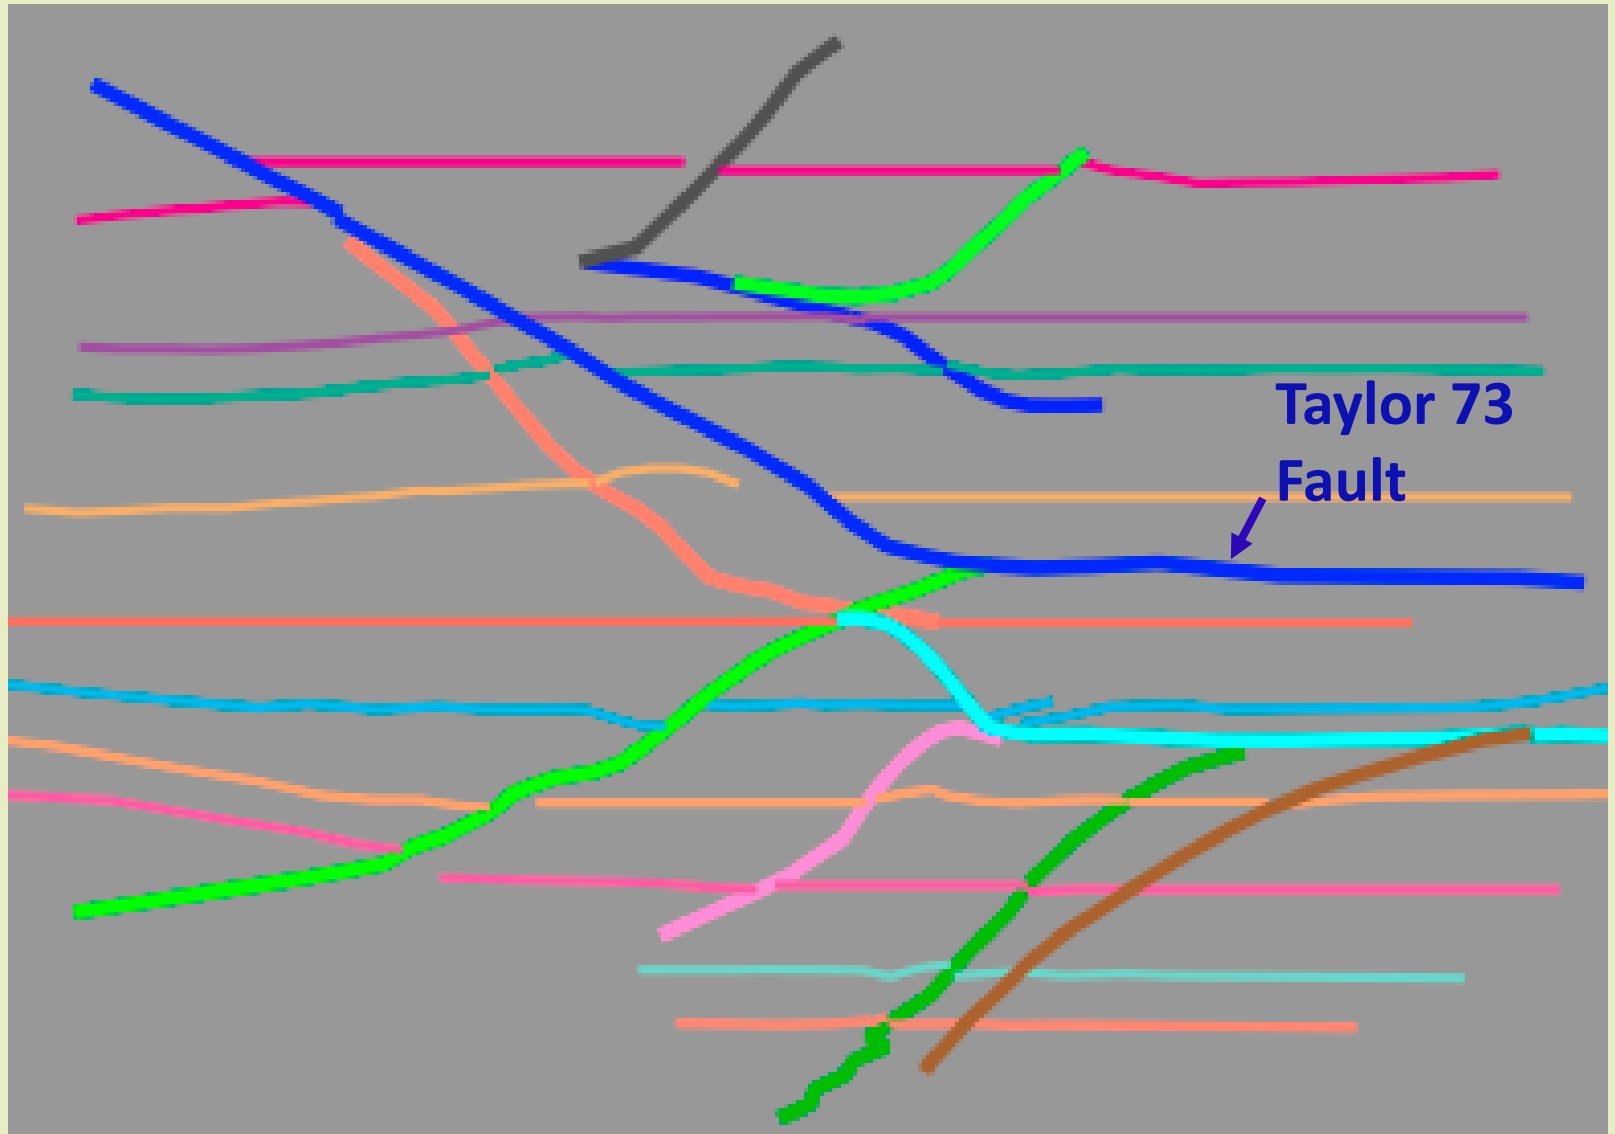
Cross Section Restoration

“Unfolding” the structure using first-pass horizon interpretations and restoring slip on faults reveals geometries generally compatible with fault-bend folds

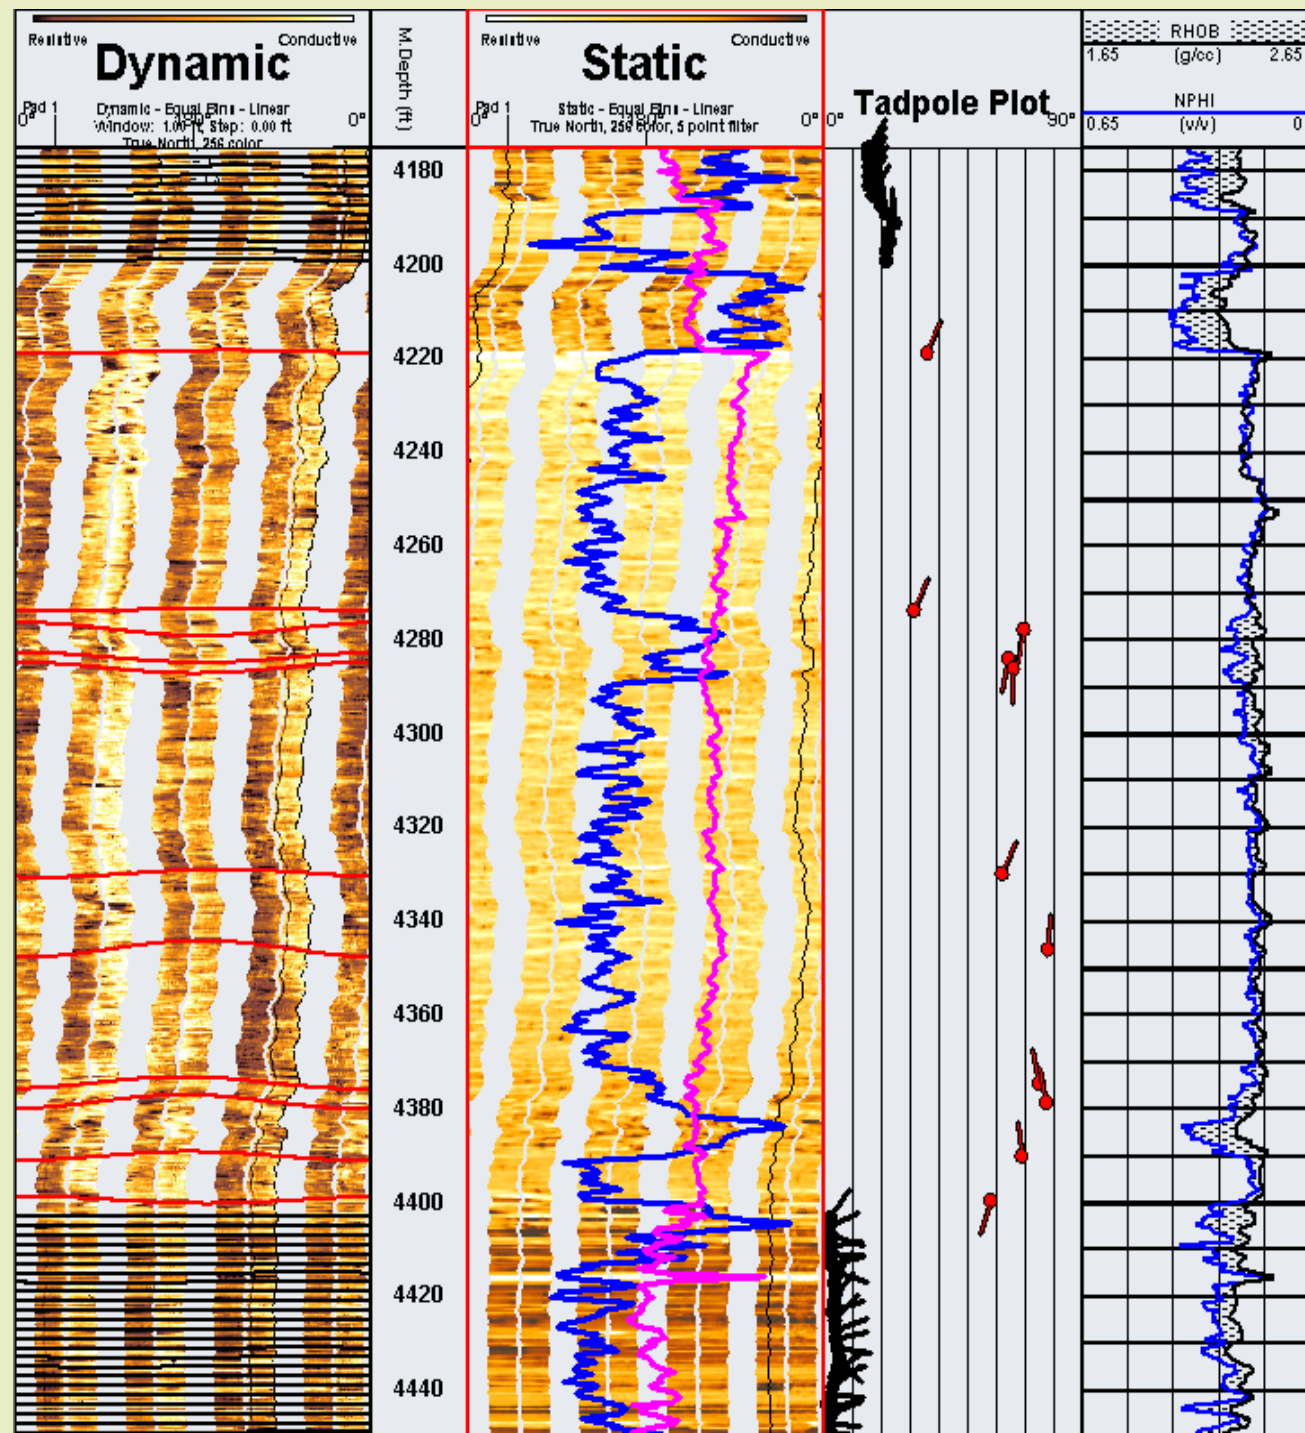
Ramp/Ramp Well #2

- Discrete HW (hanging wall) and FW (footwall) dip panels
- Fault Core and Damage Zone approx. 200' thick
- Mudstones act as boundaries between mechanical layers
- Thick interval of high-resistivity sandstone below upper detachment

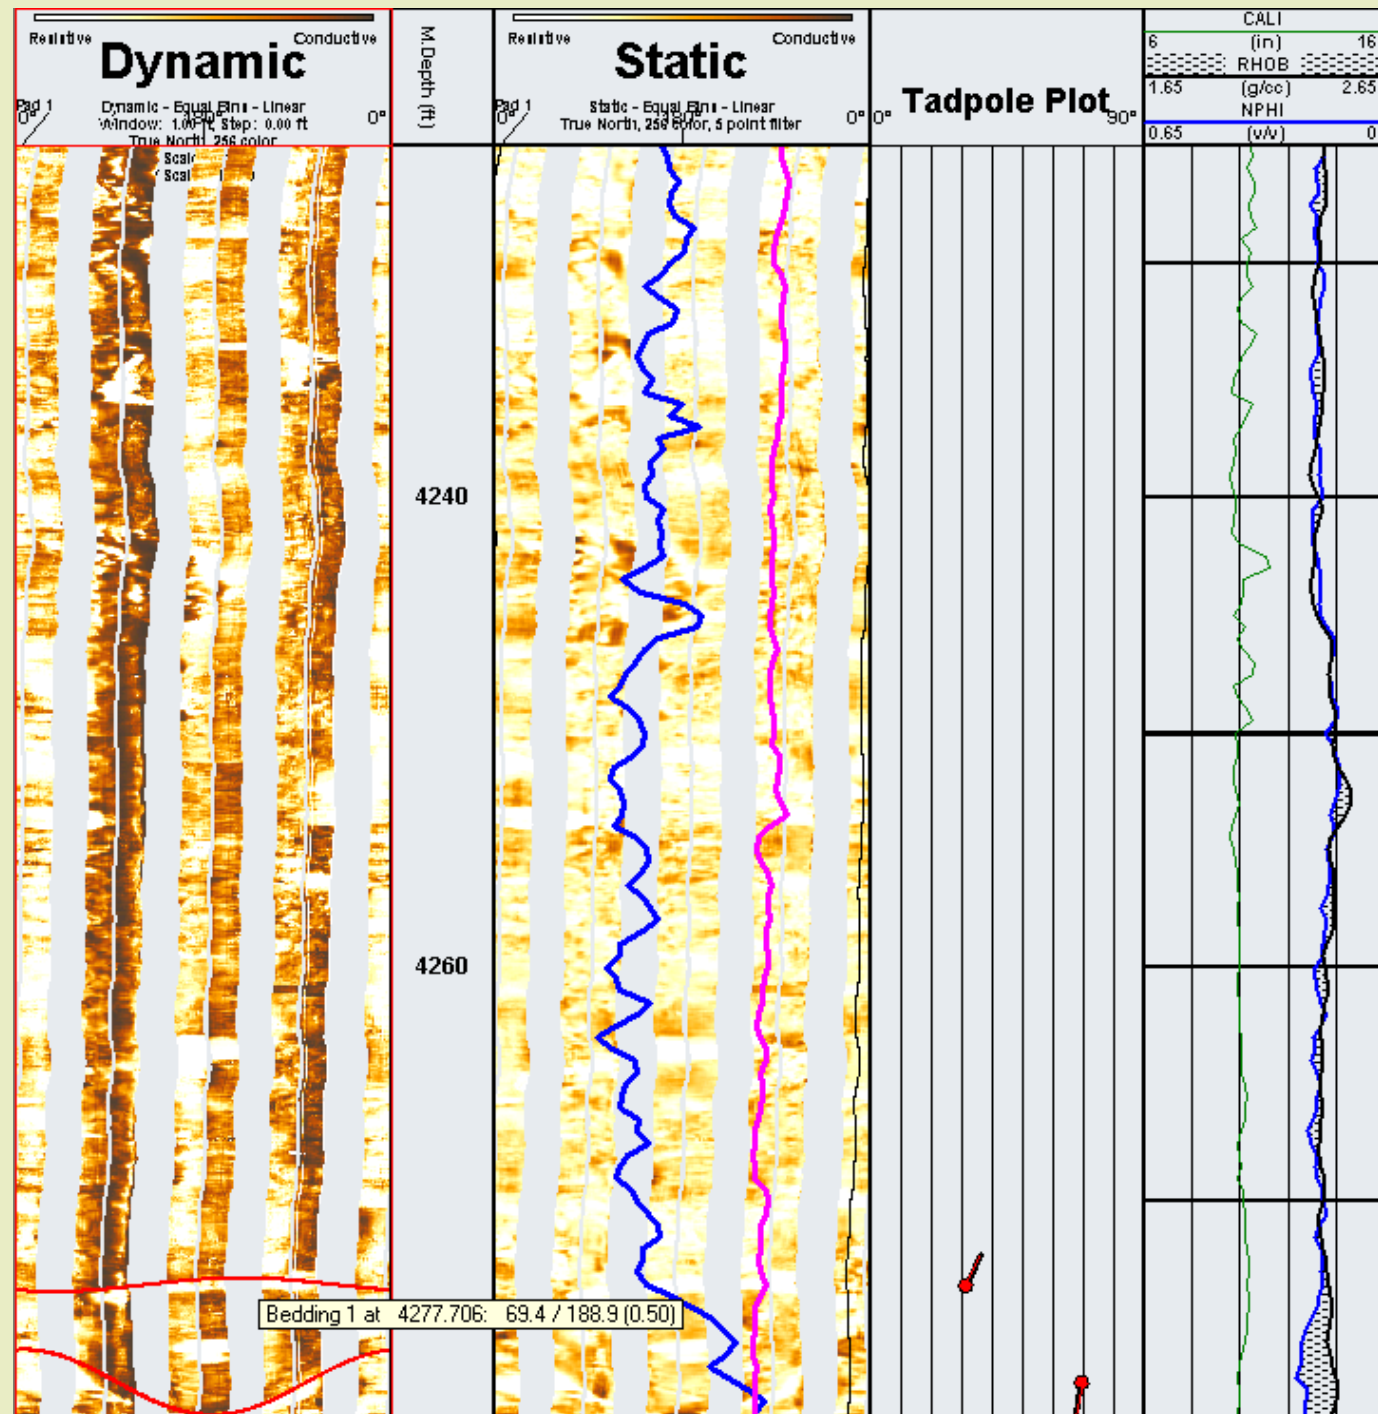
Ramp/Ramp Well #2

Cemented
Sandstone,
Cataclasis?

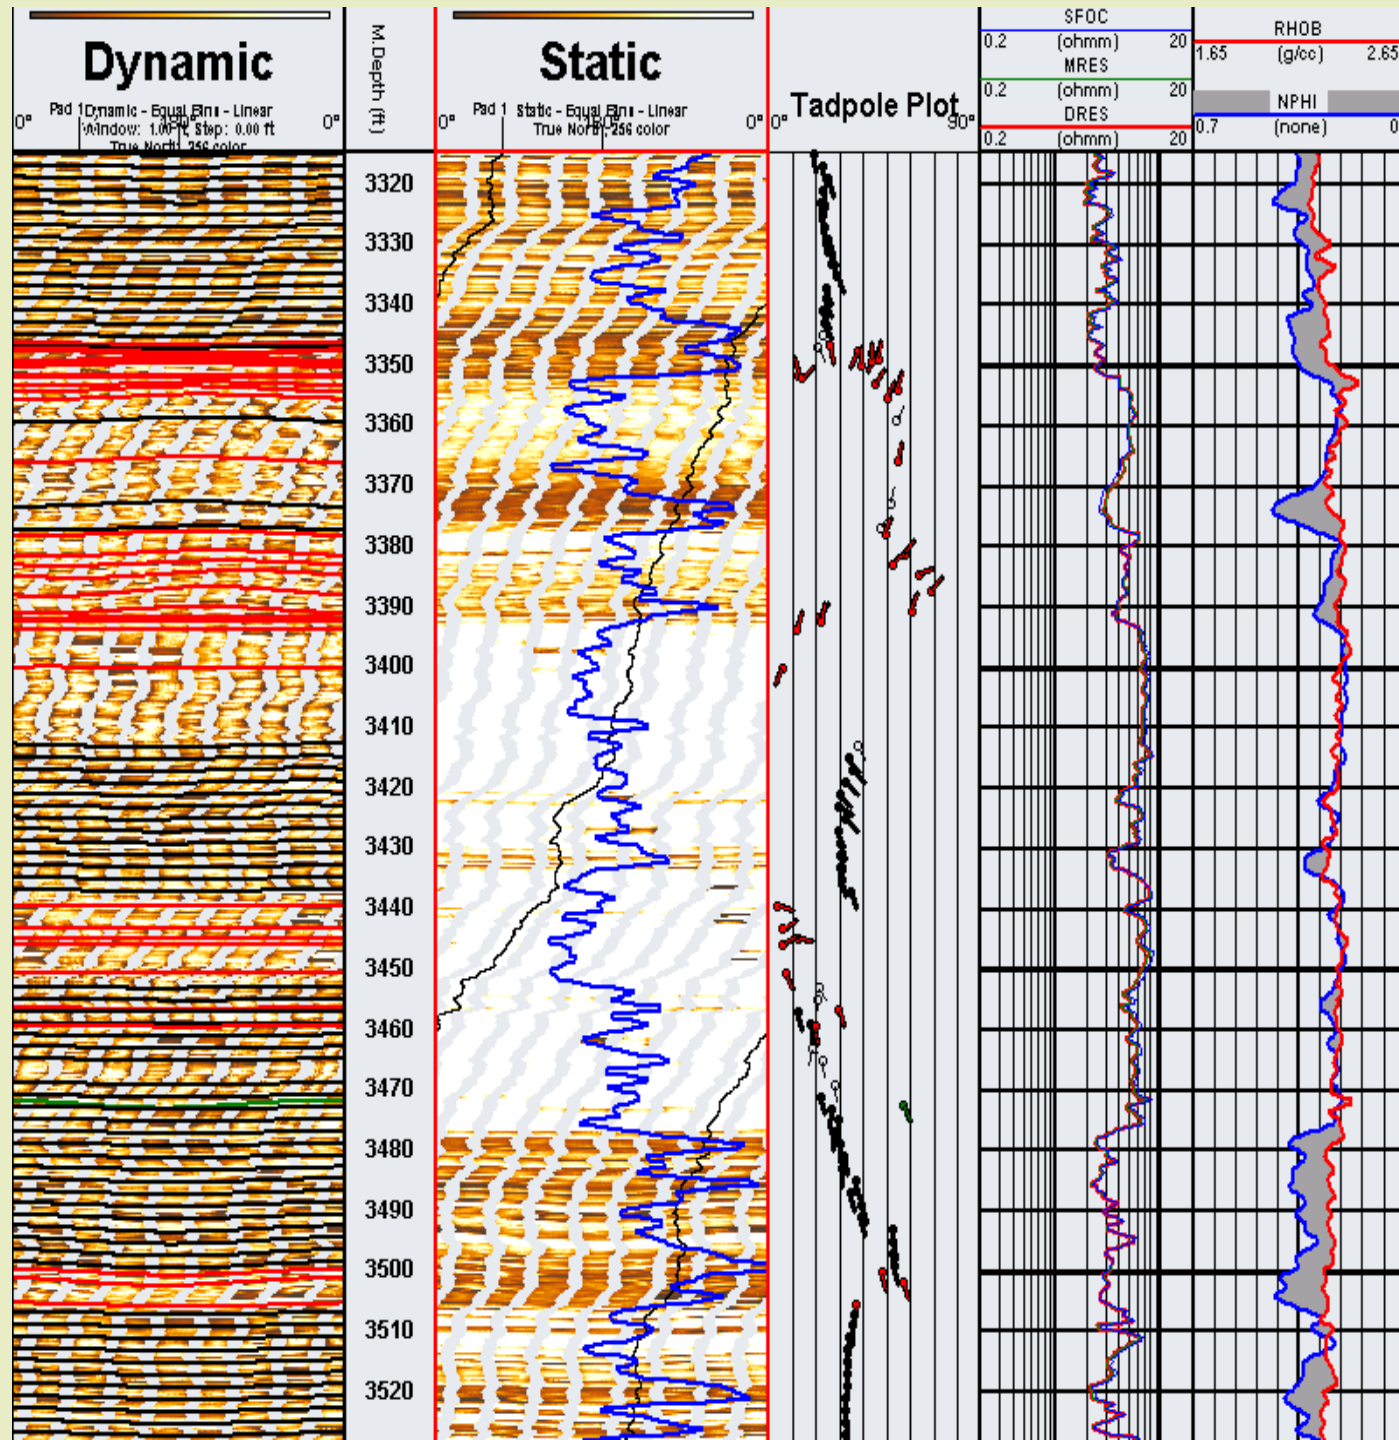
Ramp/Ramp Well #3

- Mudstone layer boundaries
- High-resistivity sandstones
- Rotated blocks

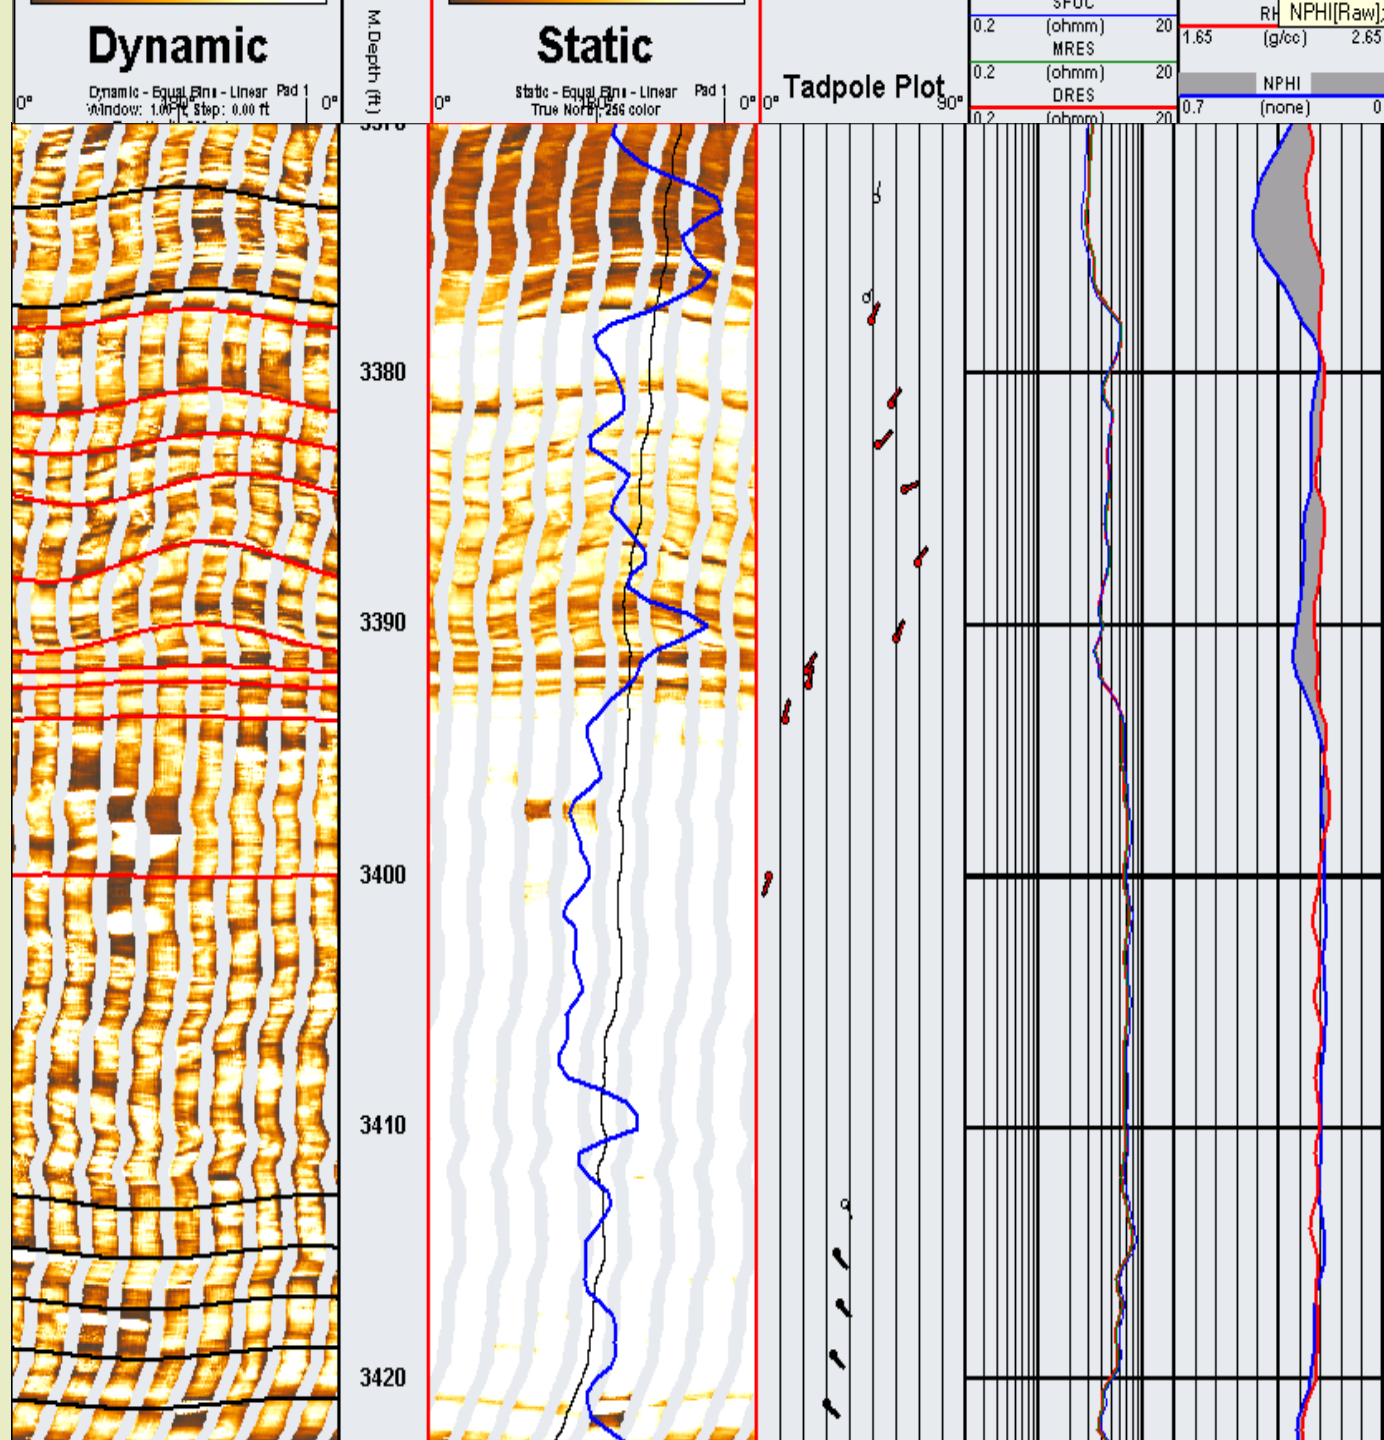
Ramp/Ramp Well #3

Rotated block
with internal
mudstone
detachment

High-resistivity
cemented
sandstone

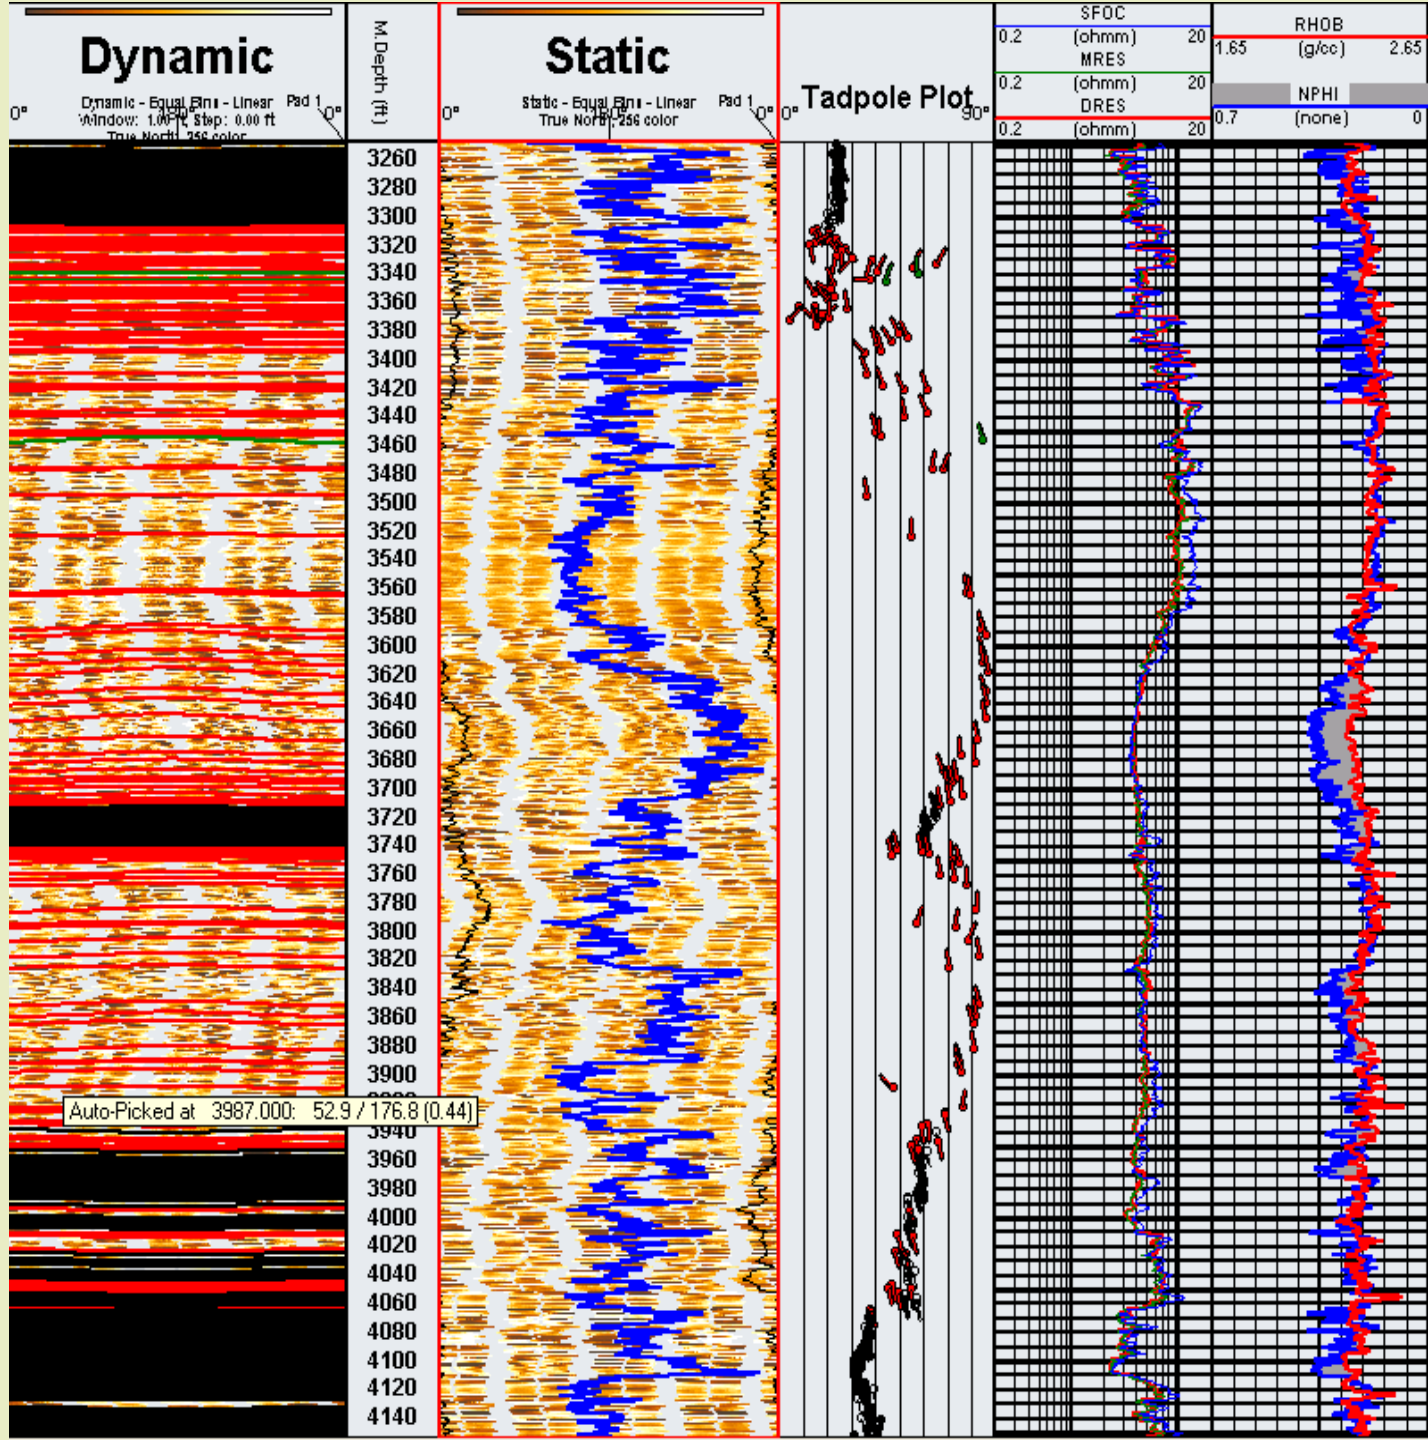
Ramp/Ramp Well #4

Complicated
by proximity
of multiple
faults (relay
zone)
