VLA-31 A CASE STUDY

BLOCK 1 LAKE MARACAIBO

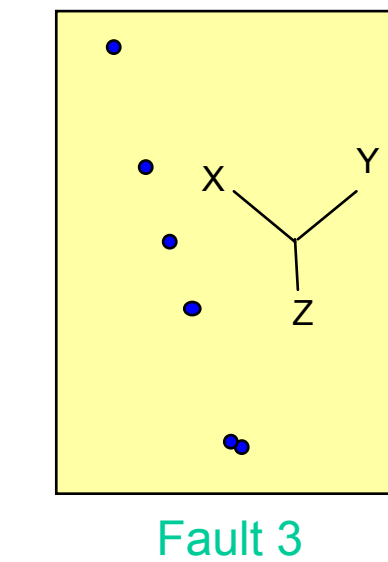
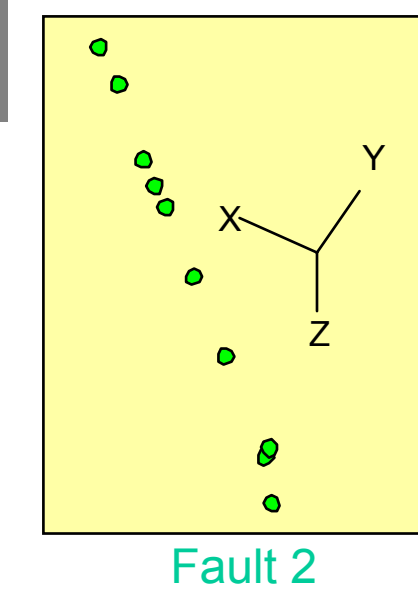
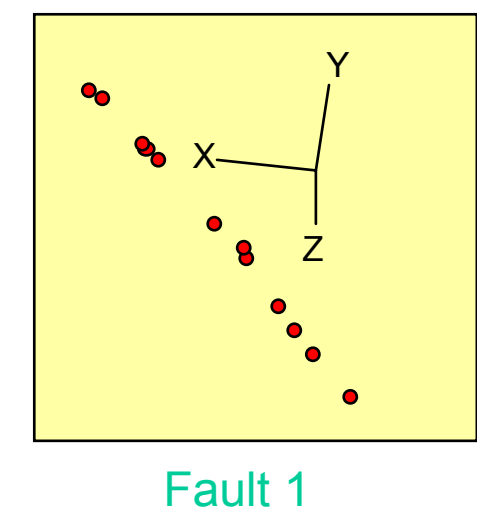
3 groups of wells
With bottom holes
very well aligned
(fault planes?)

All of the points used to create these planes correspond to abnormally shallow TDs

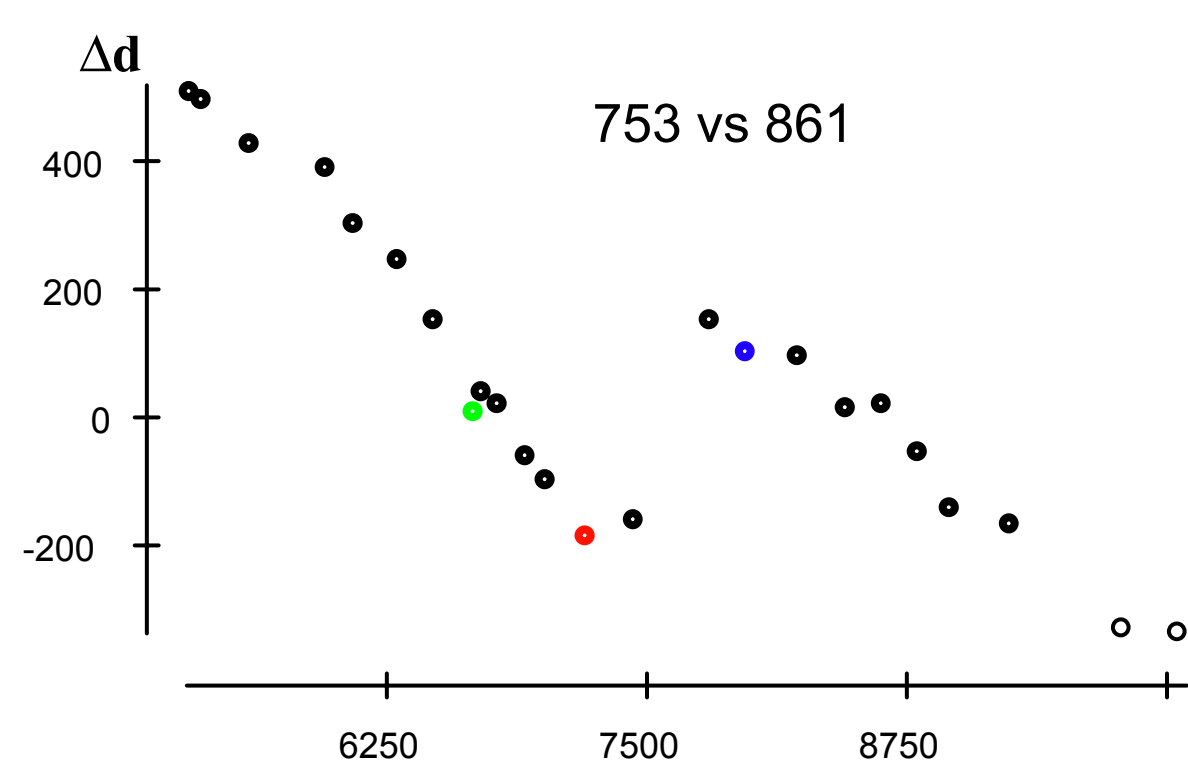
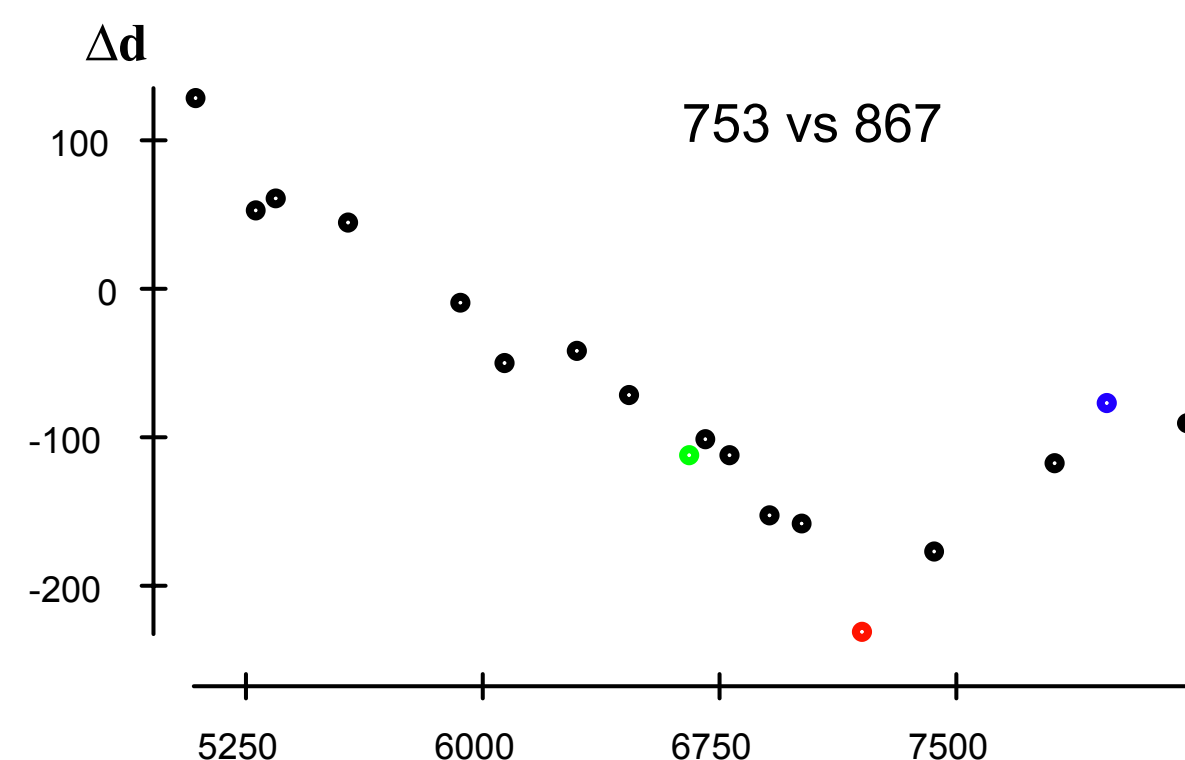
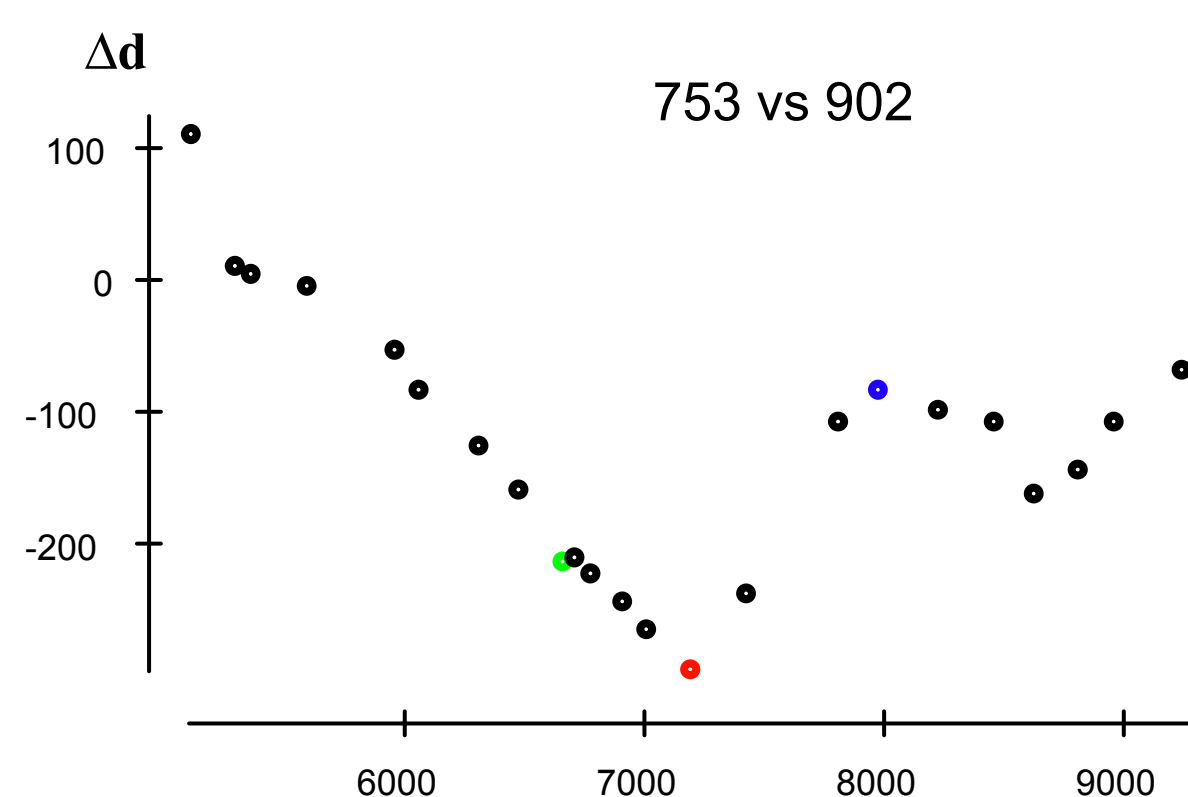
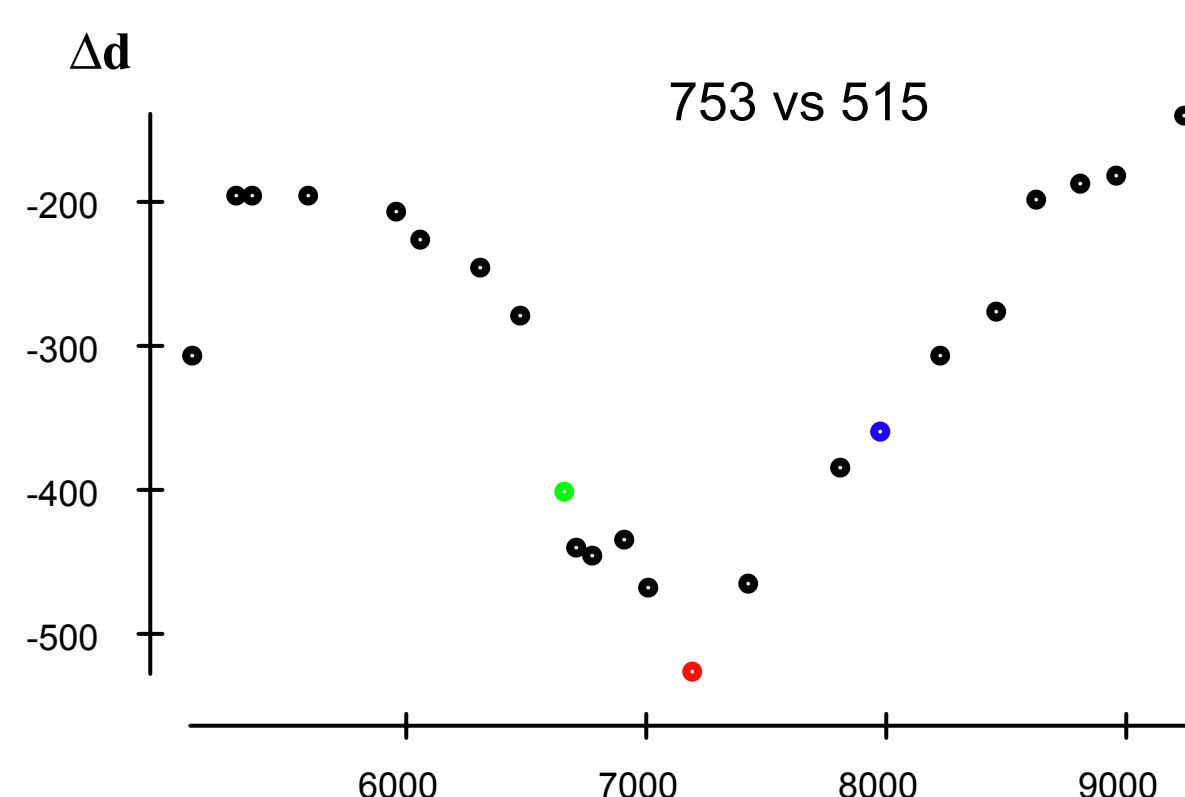
Note that the red stratigraphic marker is systematically an anomaly

Whereas the blue stratigraphic marker is not anomalous in the comparison between well 753 and well 515. That part of the stratigraphy is in the same block for both wells

Results: Match between the fault planes and the MBPA anomalies

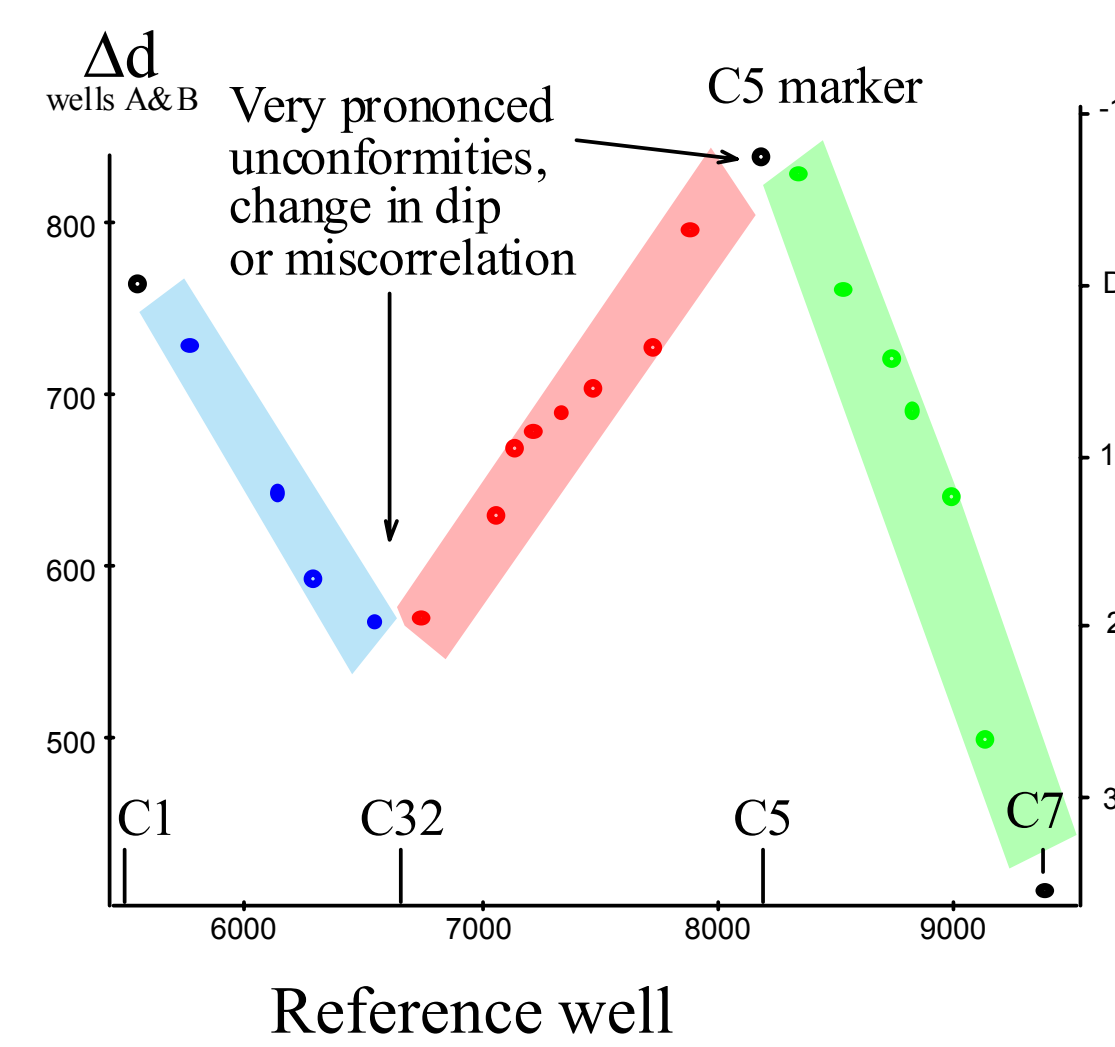
Coherency of the correlation as seen by a Bischke plot

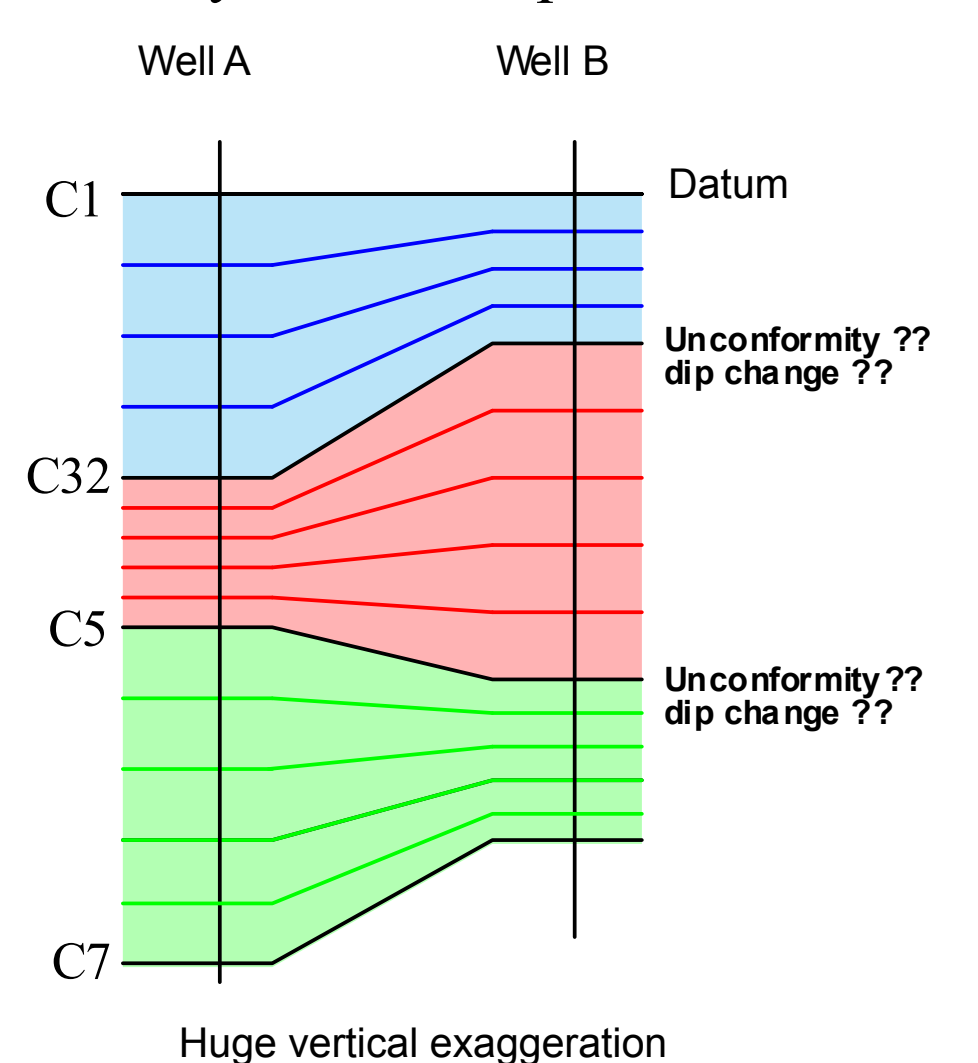
Visualization of a correlation problem through the use of a Bischke Plot

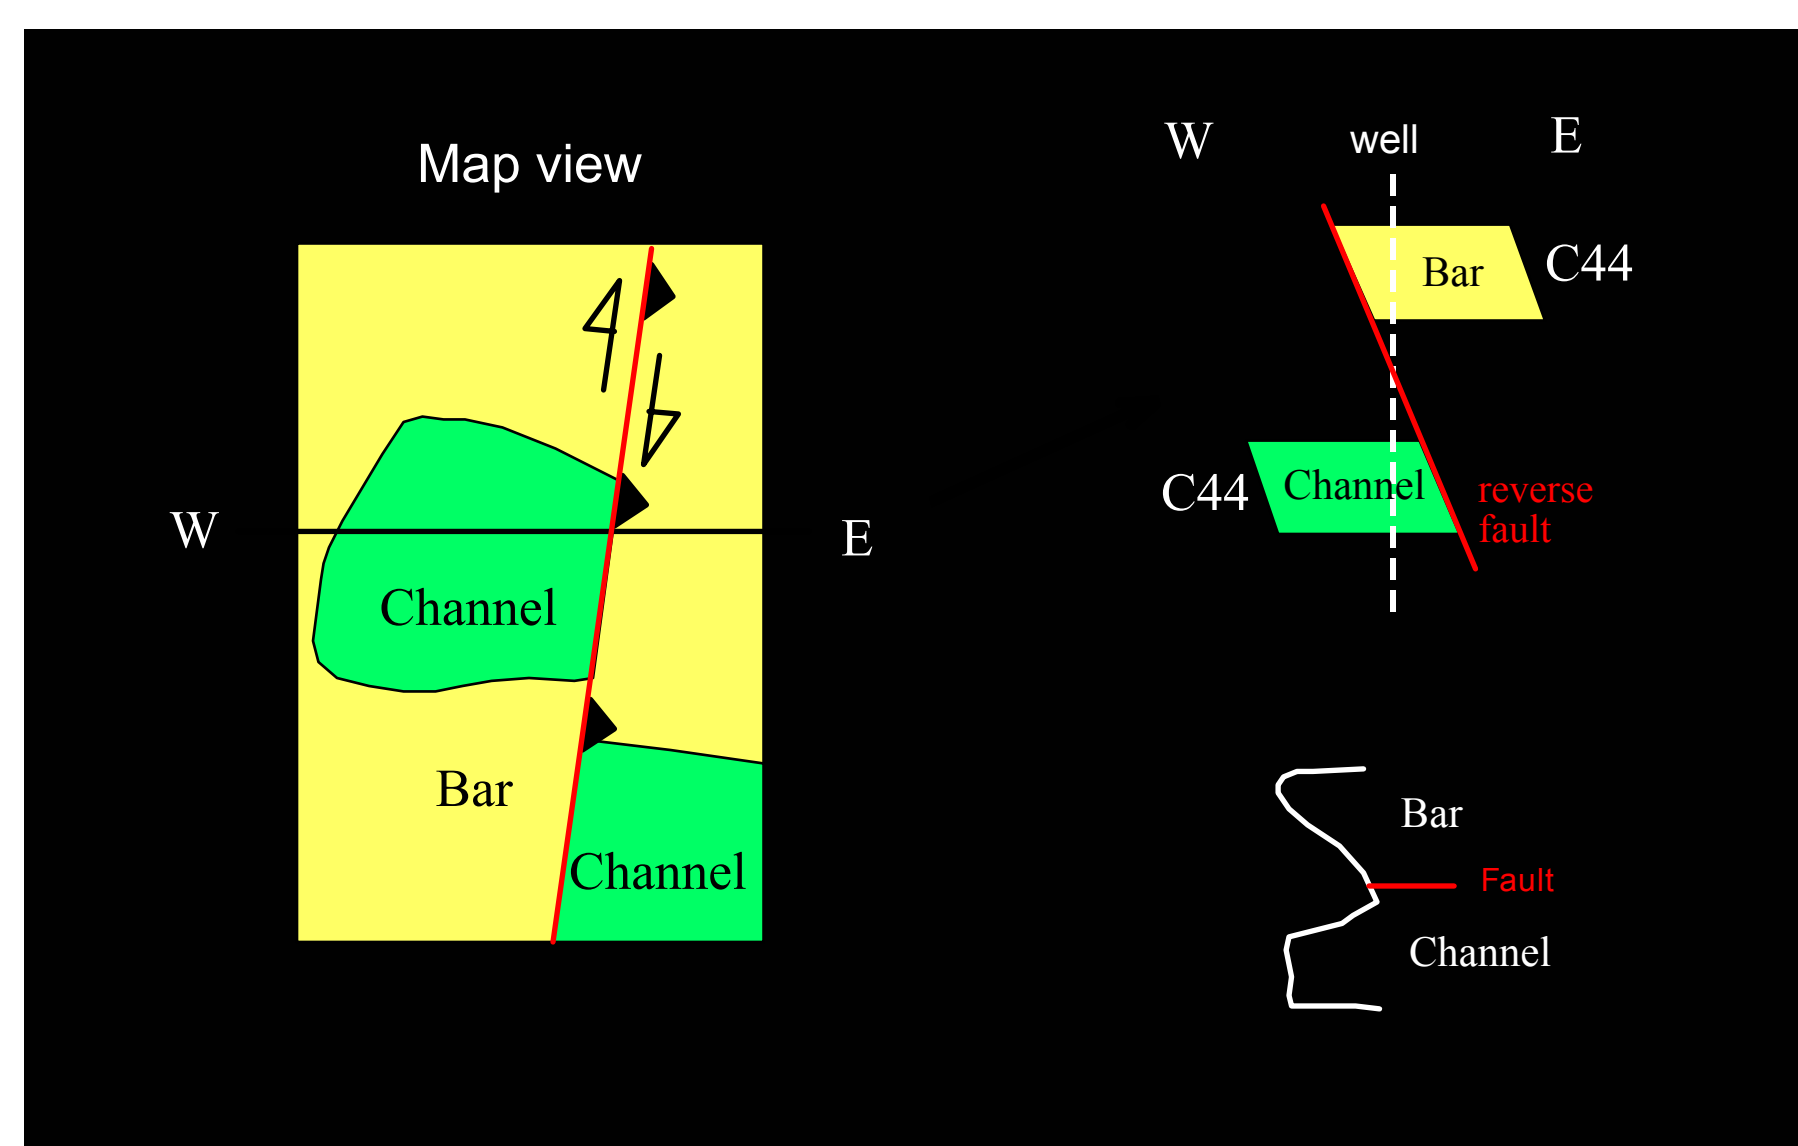
Scheme to explain why no repeated section is associated with any of the reverse faults

The strike-slip hypothesis explains why no repetition was seen in any of the reverse faults.

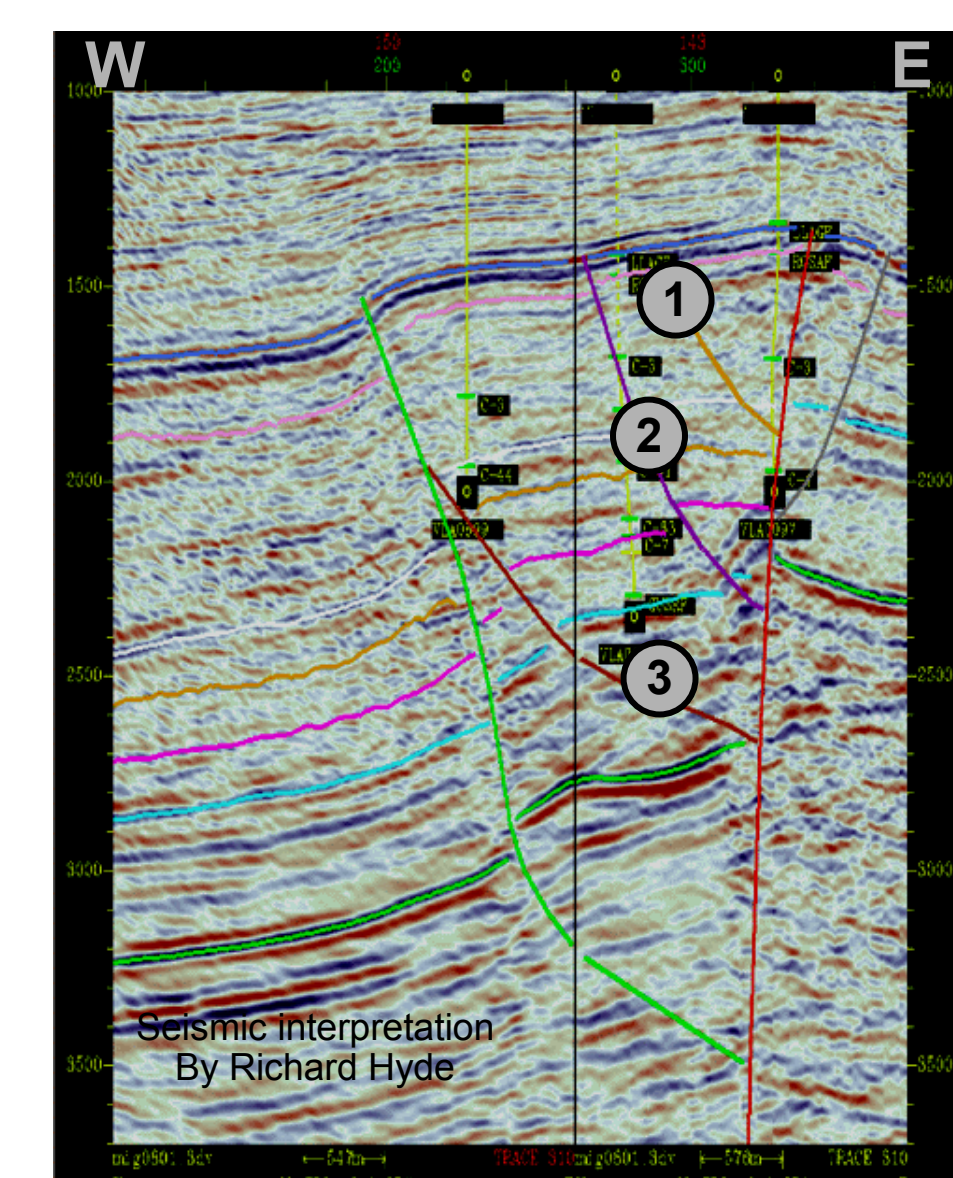
Seismic interpretation indicating the presence of reverse faults

Seismic indicates reverse faults

The hypothetical fault planes confirmed the seismic interpretation.
