## Indications from Shale Cores of Stress and Stress Induced Failure

**John Kieschnick**

*Chesapeake Energy, Oklahoma City, OK*

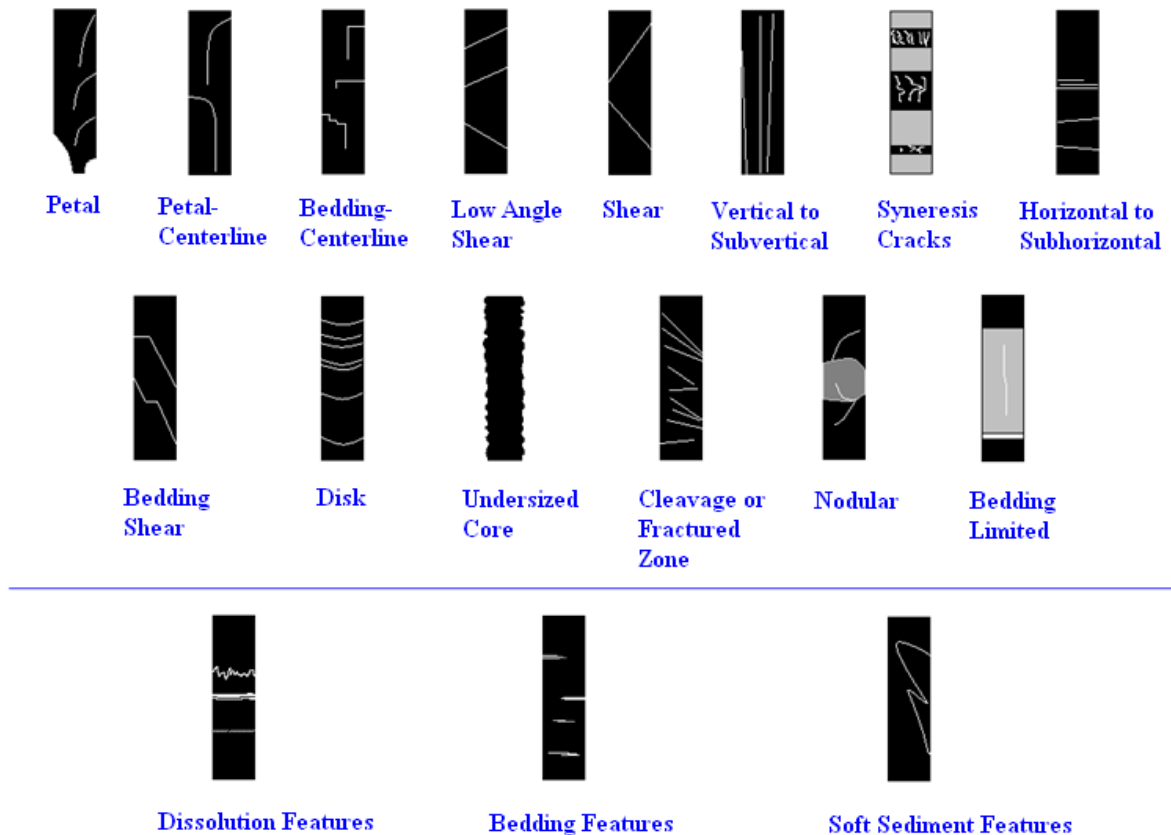
### Common Stress Features in Shale Cores
